Cases of adverse geological and geotechnical conditions in Dam Construction in Khorat Rock Group

DR. NOPPADOL PHIENWEJ

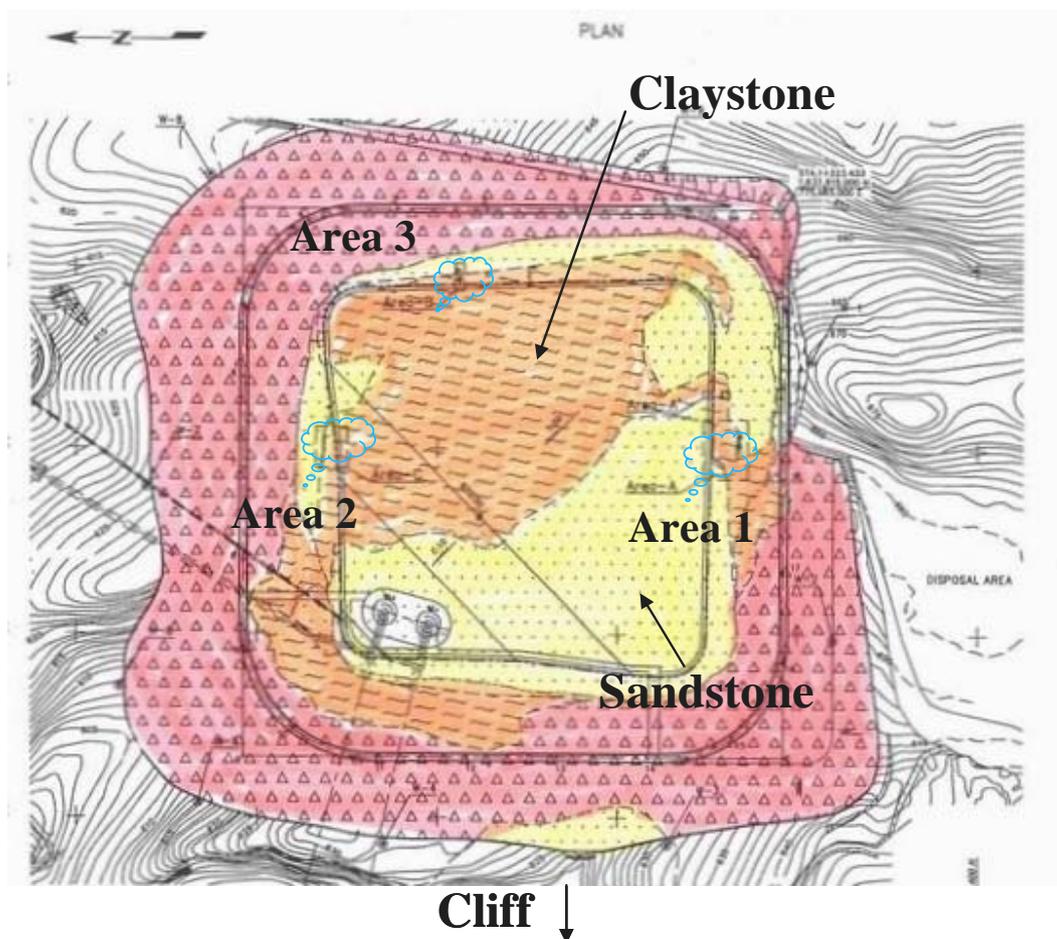
Fig. 3 Layout plan, geology and areas of asphalt face rupture of Upper Pond

Pronounced leakage was detected during the first trial pond filling while the water level reached about a half height of the full supply level. The inspection revealed cracks, bulges and heaves of asphalt face near the toe of the pond slope in three areas, all of which were in rock cut areas where asphalt face was laid on prepared cut slope face in zones of claystone (Fig. 3). A special treatment by means of geotextile sheet cover was adopted underneath the facing layer with the intention to avoid potential problems of deterioration and piping of the claystone when it was in contact with water. Investigation trenching revealed that the problem was induced by the low friction along geotextile/claystone interfacet that led to failure of the asphalt facing system (Fig. 5).

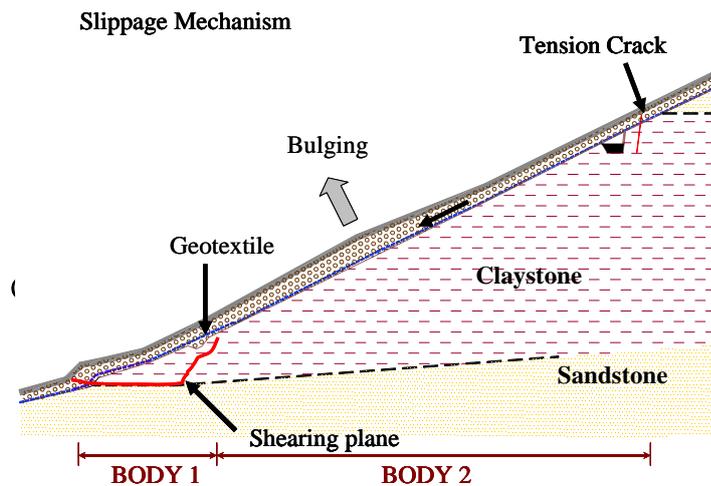
Fig. 5 Slippage mechanism of asphalt face lining over claystone face

Laboratory strength test results on samples of claystone, asphalt facing material and contact between geotextile and claystone were used in the stability analysis which confirmed the inadequate stability of the asphalt facing under that circumstance. The friction angle between the geotextile/claystone contact was as low as 16° .

The remedial measures included

- Thickening asphalt lining in toe areas of the slopes in the damaged zones to serve as buttress and improved shear resistance.
- Omitting geotextile sheet as the separator over claystone (Geotextile sheet created planar sliding surface between claystone and transition layer).

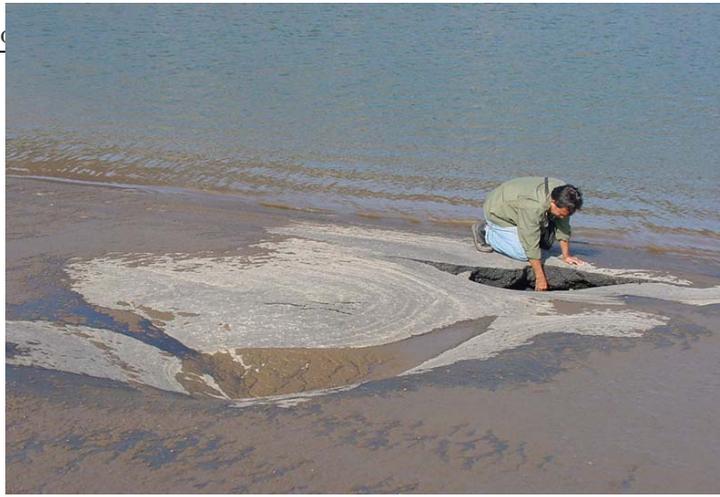
Severe leakage through the drainage tunnel at the pond base was detected during the trial pond filling almost to the full supply level. It was the result of severe cracking in the asphalt floor lining near the penstock inlet. Leaking water caused piping and voids in bedding materials below the asphalt lining leading to severe subsidence and ruptures in the asphalt lining from high water weight over it (Fig. 6). The damaged area was mainly in the area of claystone, whose excavated surface was not protected from slaking. Leveling layer made with mixture of sandstone and weathered materials over claystone bed had low resistance to piping from leakage water underneath the asphalt lining.

Fig.6 Rupture of asphalt lining on pond floor due to piping of leveling material underneath

the relining of the entire pond floor and slope face with a layer of high strength (HDPE) geomembrane sheet, which was expected to give a functional life time of 10-15 years before replacement. The measures prove satisfactory to date (5 year after operation).

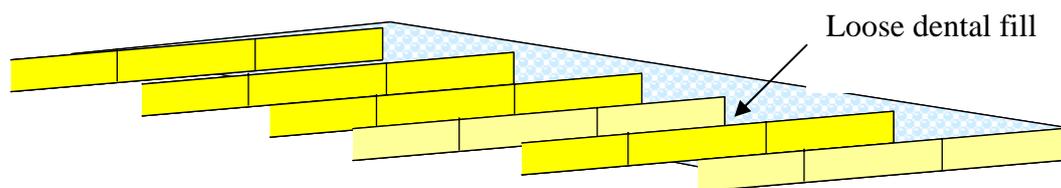
The damage also extended to the zone underlain by a jointed sandstone bed. Stepped sandstone face left after excavation required a dental levelling (Fig. 7). The leveling using fine materials over the jagged rock face resulted in difficulty in compaction and unstable zones below the pond floor against piping. It was judged that the condition and extent of the problem was so severe beyond repair. Similar piping could occur in any areas below the pond floor owing to false design of the under-drainage system that did not match with the foundation rock conditions. It was then decided to adopt

Fig. 7 Smoothing of closely stepped sandstone cut face with dental fill

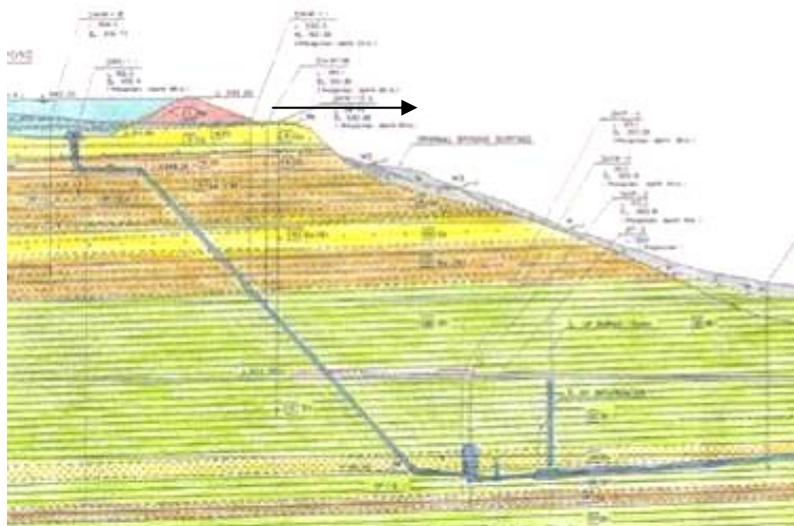
The third problematic performance of the pond was the large and continuing deformation of the sections of the rockfill embankment that led to significant cracks and settlement of the dam crest. Post construction settlement reached 1.6% of the dam height in seven years and the present rate of increase is still high. The lateral displacement is also high. The amount of settlement is on the high side compared with those of other rockfill dams (Hunter and Fell, 2003). The problem was more pronounced in the cliff side of the pond. The cause of the displacement which continued to increase with time is being investigated. The possible causes as identified include high time-dependent compressibility behavior of the Zone 3C materials consisting of unstable claystone, siltstone and weathered sandstone, and sliding toward the cliff face along the near horizontal claystone bed left underneath the dam base (Fig. 8). Creep behavior of the claystone may also have created the pronounced time-dependent lateral movement of the rockfill embankment toward the steep cliff face, located just a short distance from the toe of the dam. Up to present the exact cause has not been clearly identified. However, it is mostly likely that the problem is attributed to the progressive deterioration of the compressibility and strength of the claystone, siltstone and weathered sandstone used in Zone 3C of the

Fig. 8 Possible lateral sliding of embankment over claystone bed toward cliff face

embankment. The construction recorded showed that Zone 3C was not required to be heavily compacted (density of only 19-20 kN/m³) because a gentle slope was adopted in the design of the rockfill embankment of the pond.

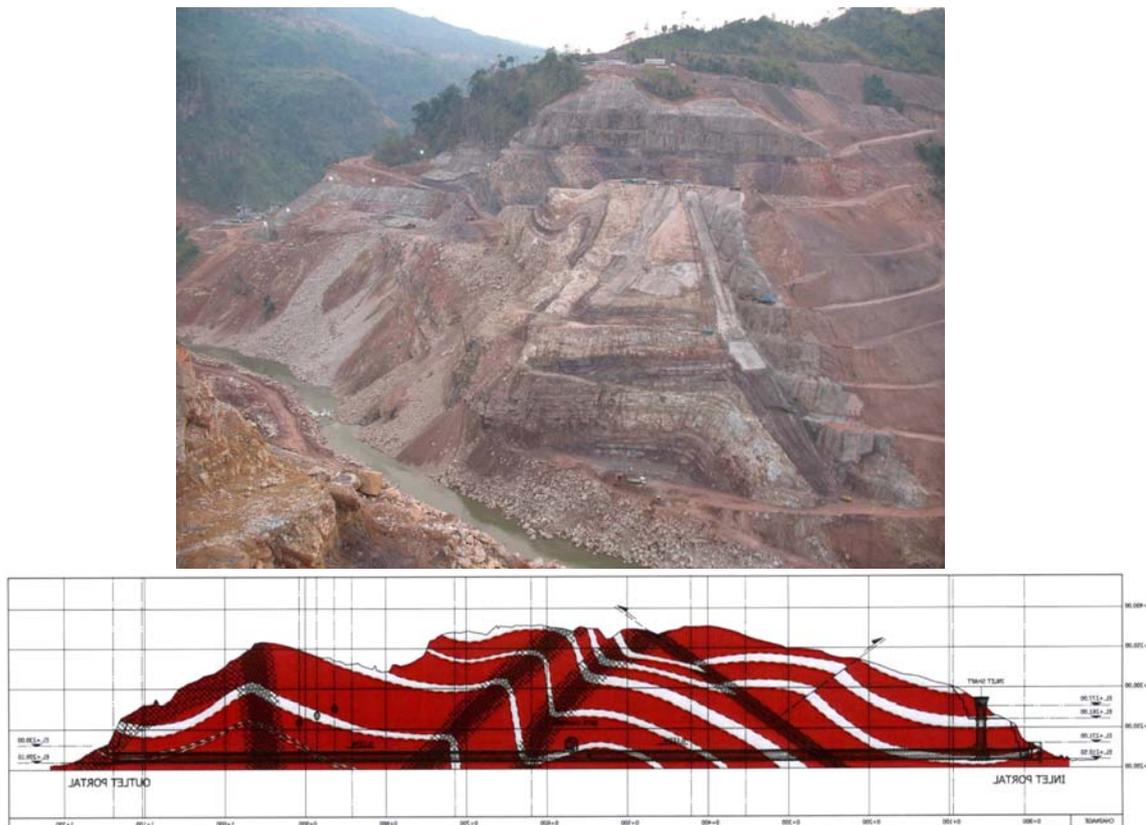
Fig. 10 Geologic structures along NN2 dam abutment

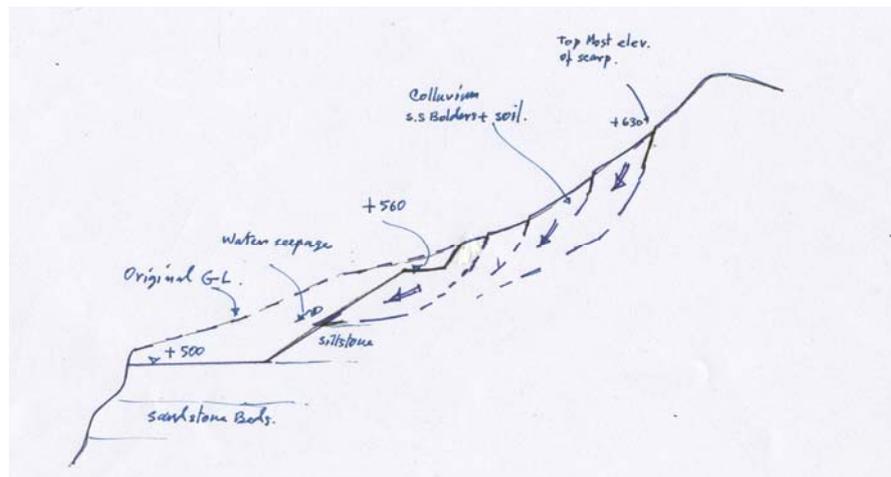
beds, the concealed existence of steeply inclined bed of tight folding was unearthed in the rear part of the quarry area. Shearing along weak bedding shear in siltstone in the presence of seeping groundwater caused the reactivation of this old massive landslide. The depth the slide was more than 100 m (Fig. 11). That was just one of the samples of a number of landslide problems experienced at the project. In the initial geological investigation report, landslide was not foreseen as a significant geological hazard at the project site.

Fig. 11 Major landslide in quarry development excavation due to concealed tight fold and thrust fault behind horizontally bedded cliff face
