Deformation Characteristics after Impounding of Nam Ngum 2 Concrete Face Rock Filled Dam (CFRD) in Laos PDR

Warakorn Mairaing^{1,*} and Chinoros Thongthumachat²

^{1,2}Geotechnical Engineering Research and Development Center, Faculty of Engineering, Kasetsart University, Bangkok, Thailand

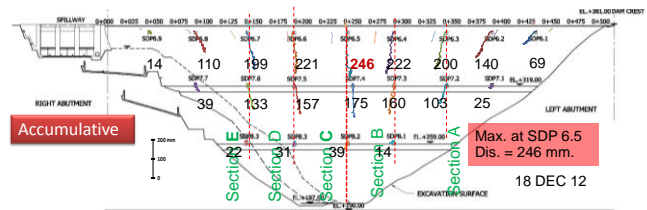
Fig. 7 Settlement of dam crest and downstream after impounding.

Settlements of dam crest and dam surface were measured by surface displacement points on dam crest and dam slope. Fig. 7 and 8 indicated the settlement after the reservoir impounding until December 2012. The larger settlement occurred on the upper part of the dam and on the central zone of the valley. The maximum settlement was 246 mm. on SDP 6.5. This value is equivalent to 0.15% of the dam height. However from statistical records this value is still well below the critical deformation (0.4 to 1.0%) that can possibly causes the crack in the slab. The directions of movement are quite normal as they tend to move toward the depth section of the valley. There is no significant abrupt change of surface movement at any area which leading to the sliding or cracking phenomena.

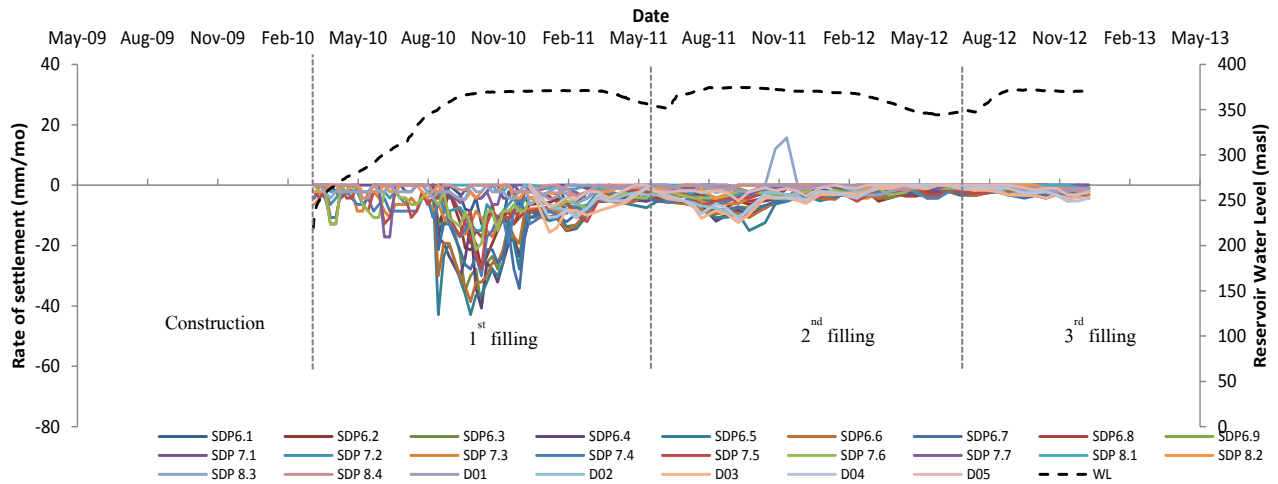
Fig. 9 Rate of dam settlement affected by the reservoir impounding

The rates of settlement of all points are related to the reservoir impounding as shown on Fig. 9. Settlement rate started to pick up when the water level of higher than 50% of the storage level and reached to the maximum as the level up to 97% of maximum storage on October 2011. On the first filling, the average of maximum settlement rate was 42 mm/month in October 2010. Then it decreased to 4 mm/month in March 2011. On the second filling, the pattern was repeated as the settlement increasing to 15 mm/month in October 2011 and then slowing down to 2 mm/month in March 2012. On the third filling, the rate of the settlement was decreased to 4.8 and 2 mm/month in October and December 2012 respectively.

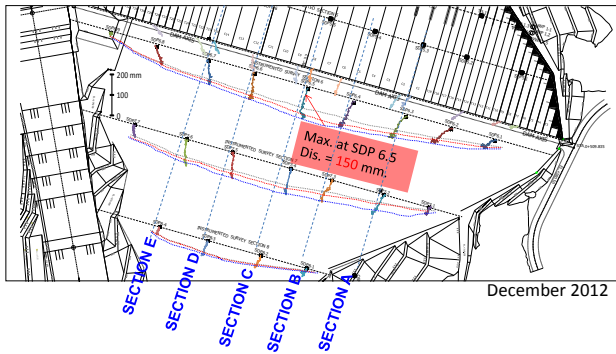
Fig. 10 Lateral movement of dam slope after 2 years of impounding.

Fig.10 shows the plan view of horizontal displacement on downstream slope after 2 years of impounding. The slope has moved to downstream ranging from the maximum of 150 mm. (SDP6.5) on the central of the river channel to about 40-80 mm on the abutments (SDPs 6.1 and 6.8). The displacements toward the valley have been measured only 60 mm as comparing to 100 mm in case of Campos Novos dam.

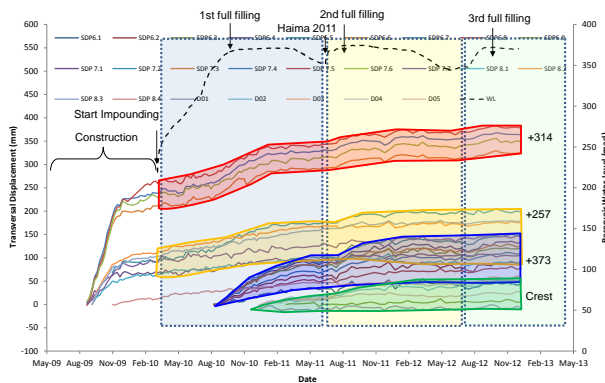
Fig. 11 Rate of displacement affected by reservoir impoundings.

The effect of reservoir water pressure on the displacement of downstream surface can be seen from Fig.11. The maximum rate of displacement along the slope is 4 mm/month at the end of 2012. Until present, no sign of possible sliding or excessive movement was detected as instability of the dam slope.

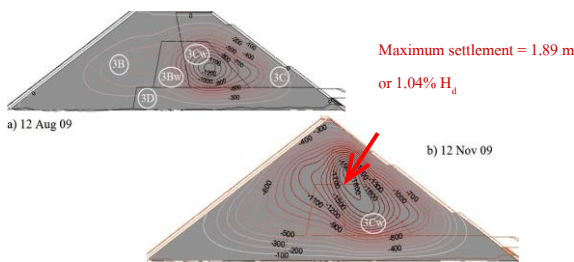
Fig. 12 Settlement in Dam Body During Construction

Settlement within the dam body was monitored by Hydrostatic Settlement Cell (HSC) and Magnetic Settlement Ring installed during the construction. HSC in the maximum section indicated the maximum settlement of 1.89 m. or 1.04% of dam height to the end of construction. The maximum settlement is concentrated on the top of Zone 3B and 3C of special zone that allowance for increasing of sand content.

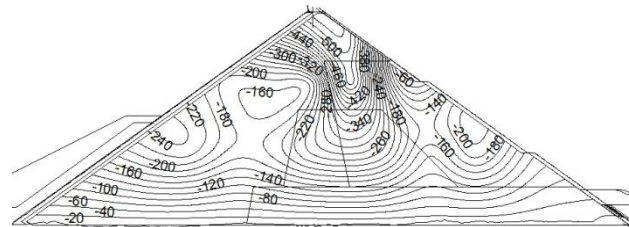
Fig. 13 Additional Settlement in Dam Body after Construction until June 2011

The settlement continued at the slow rate with additional of 0.25 m. or 0.138% on waiting period from November 2009 to March 2010 before first impounding started. During first year of impounding from March 2010 to June 2011, the maximum additional settlement of 0.54 m. or 0.29% of dam height is recorded. The distribution of settlement can be illustrated by the settlement contour as shown on Fig. 13 on June 2011. Notice that the maximum settlement zone was shifted to the top of the dam.

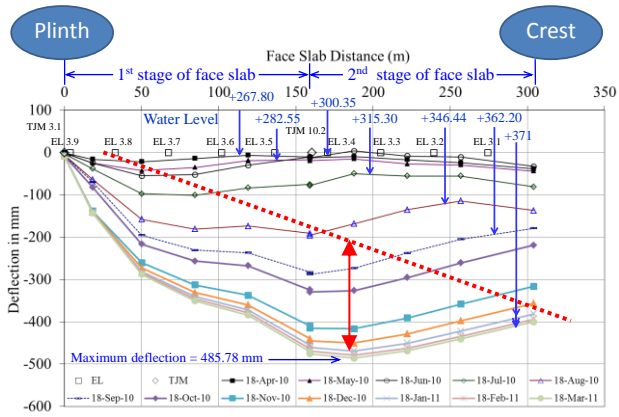
Fig. 15 Deflection of the face slab at deepest section on dam.

Reservoir water pressure caused the deflection of the face slab. Electro-levels on the face slab detected this change of curvatures just after impounding. Fig. 15 shows deflection of the face slab at various times on deep section. At the end of first impounding, the maximum deflection was 485 mm or 1/620 of the length (304m) at elevation +310 m.asl or mid length of the slab. Comparing to the anticipated deflection from the design analysis is of 457 mm. So the actual slab deflected slightly more than the design analysis.

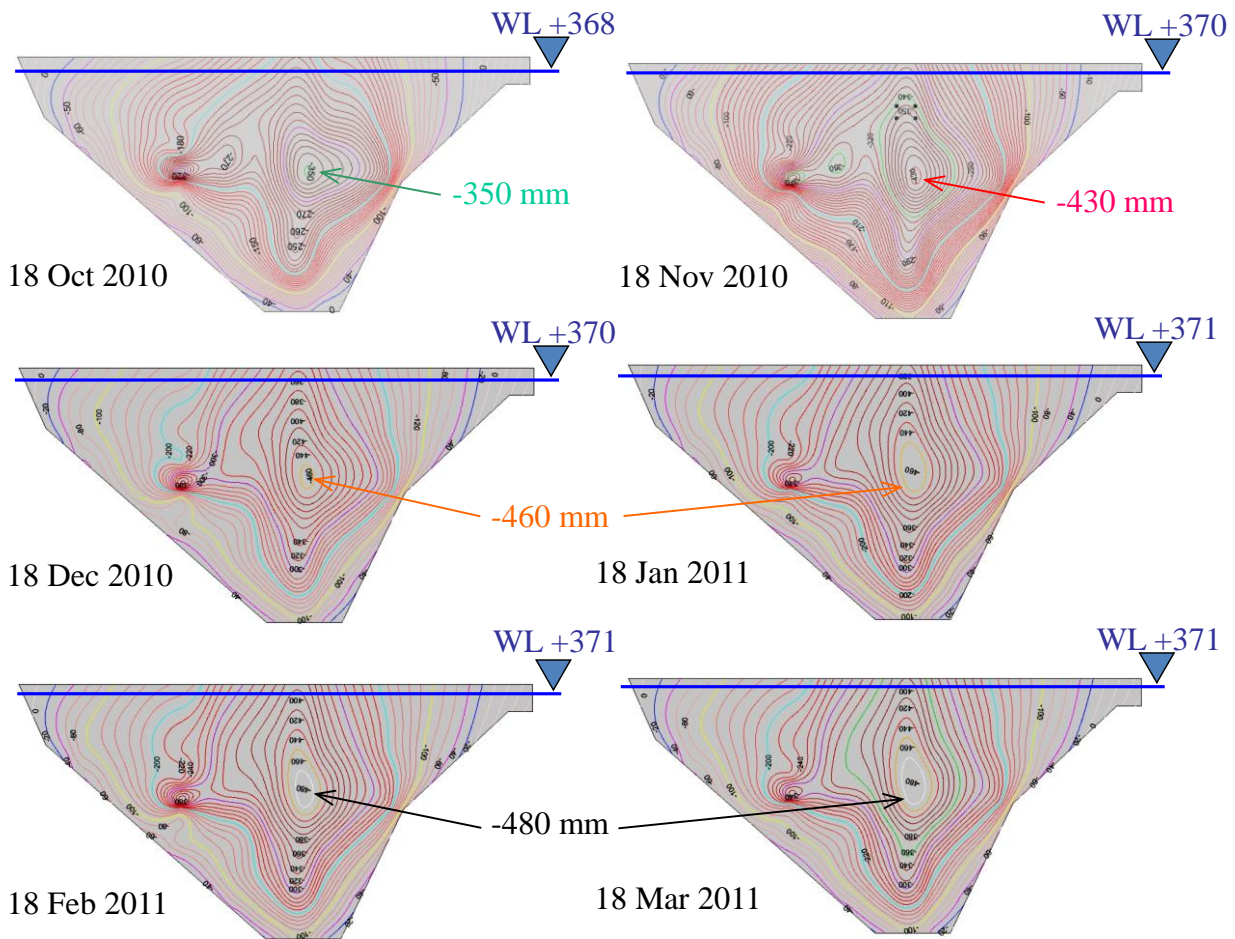
Fig. 16 Contours of face slab deflection on first impounding.

The movement at lower end was started at zero on the first impounding at 18th March 2010. The deflected shape of the concrete face slab on first impounding is highly dependent on the water level. As the water level reach to +371 m asl on March 2011, the maximum deflection was 486 mm. Considering the movements at the toe of 9 mm and at the crest of 400 mm, the effective deflection at mid height is only 230 mm or 1/1,320 of the slab length. The contours of the slab deformation can be plotted from 4 observed sections and the boundary condition on the plinth.

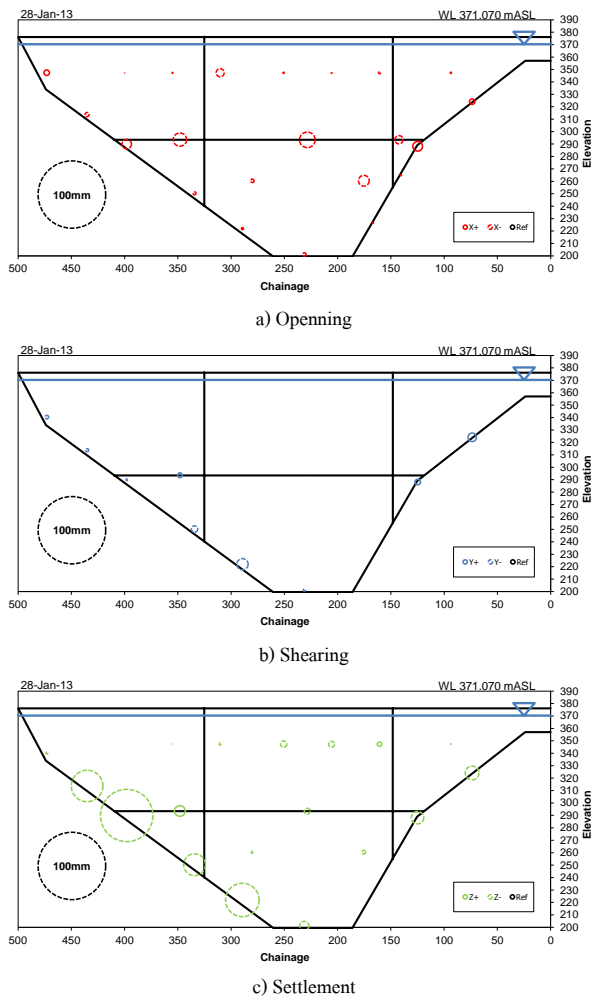
Fig. 17 Face Slab Joint Movements

At the end of construction, the perimetric joint movements were small in the range of 0.2 and 10 mm. On the early state of impounding, displacement of the joints were increased ± 2 mm after the construction. However the reservoir water pressure started to induce the significant joint settlement at some location on the left abutment. The maximum of settlement was about 80 mm near the horizontal joint at elevation 290 m asl. as shown on Fig.17. The rate of the movement was at peak of 38 mm/month on August 2010 and slow down to a constant on November 2010 as shown on Fig. 18. The behavior of joint on this location was

carefully monitored and it was normal and stable without any sign of leakage.
