# OBSERVATION OF BUILDING DAMAGE PATTERNS IN KATHMANDU DUE TO EARTHQUAKE- DRAFT REPORT

Mr. Kiran Acharya  
acharyakiranraj@gmail.com

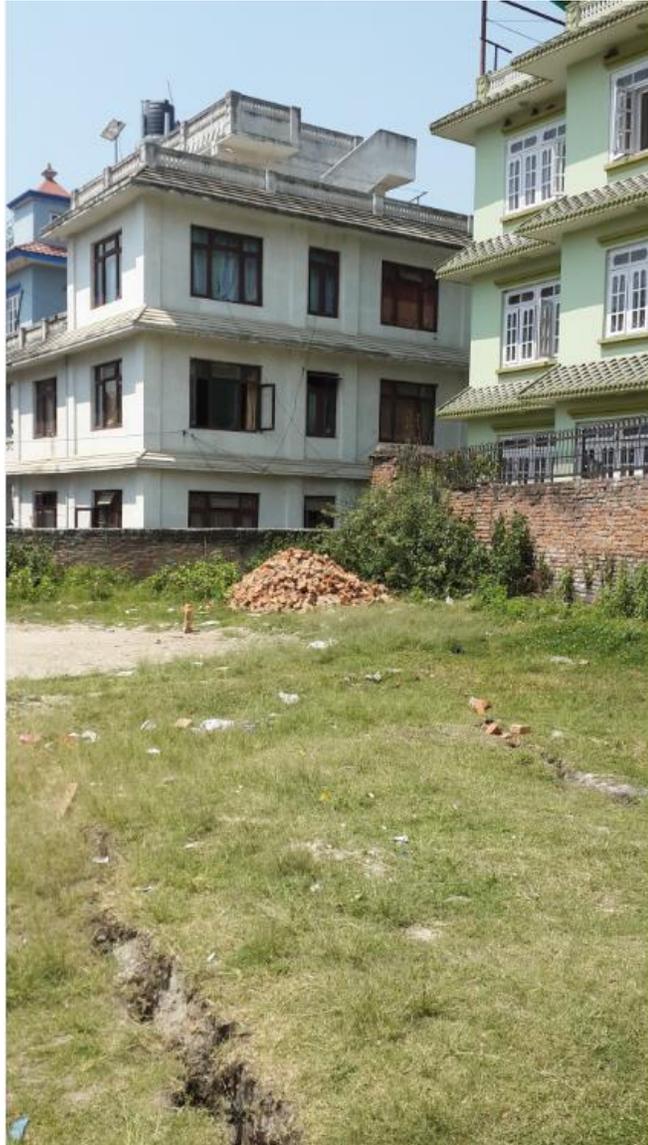
Figure- Ground fissures in Bhaktapur district. There is no damage in the nearby houses seen in the photo

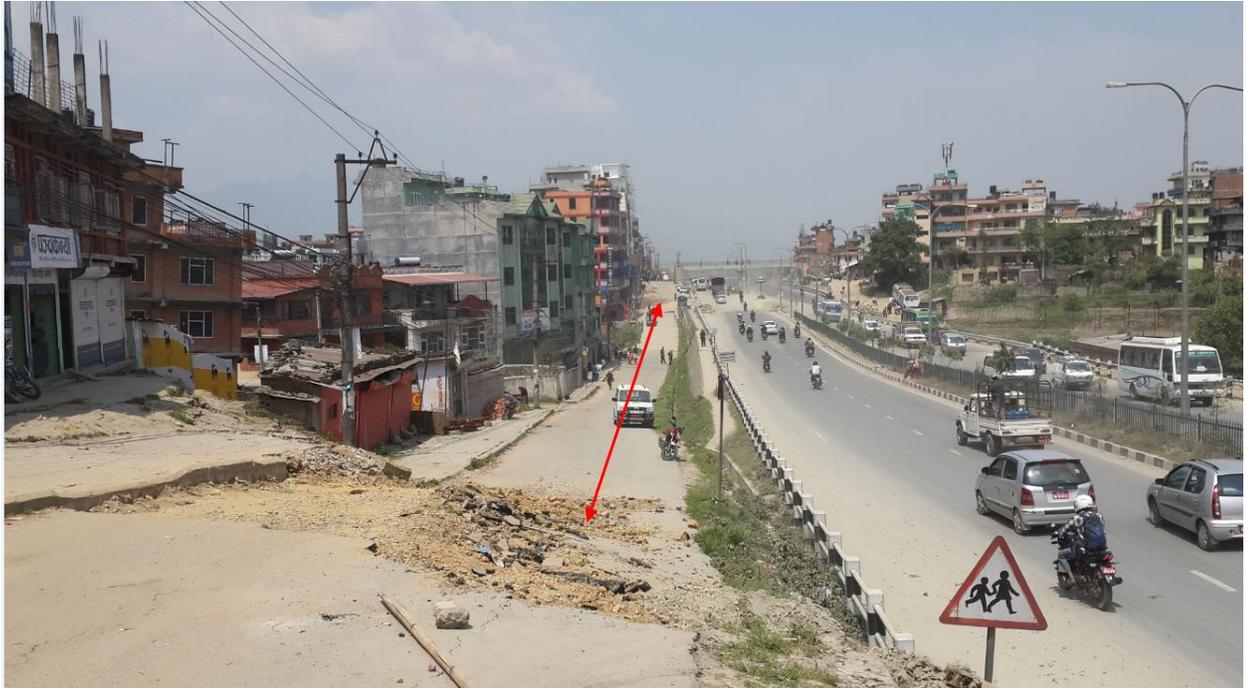
The land along the marked width, (approx. 80 m.) has been settled by around 1.5 m. No major cracks in the surrounding houses except tilting and shifting of the affected house.

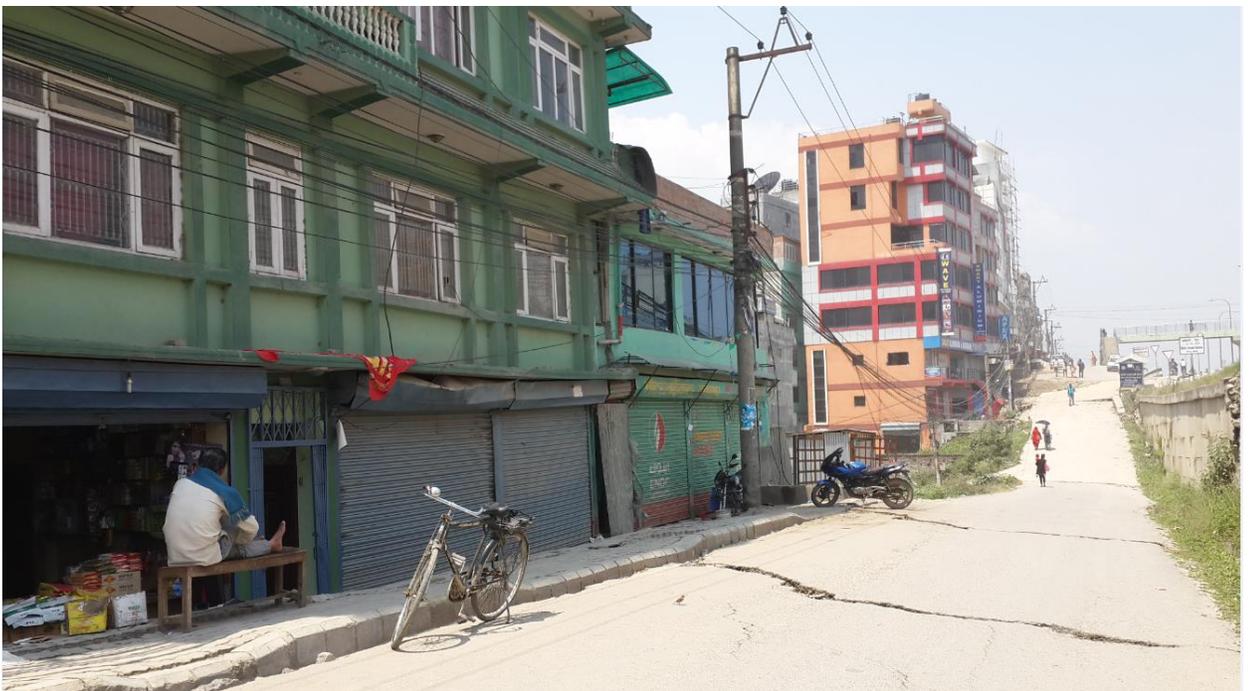
Surface ruptures in the settled part of the land

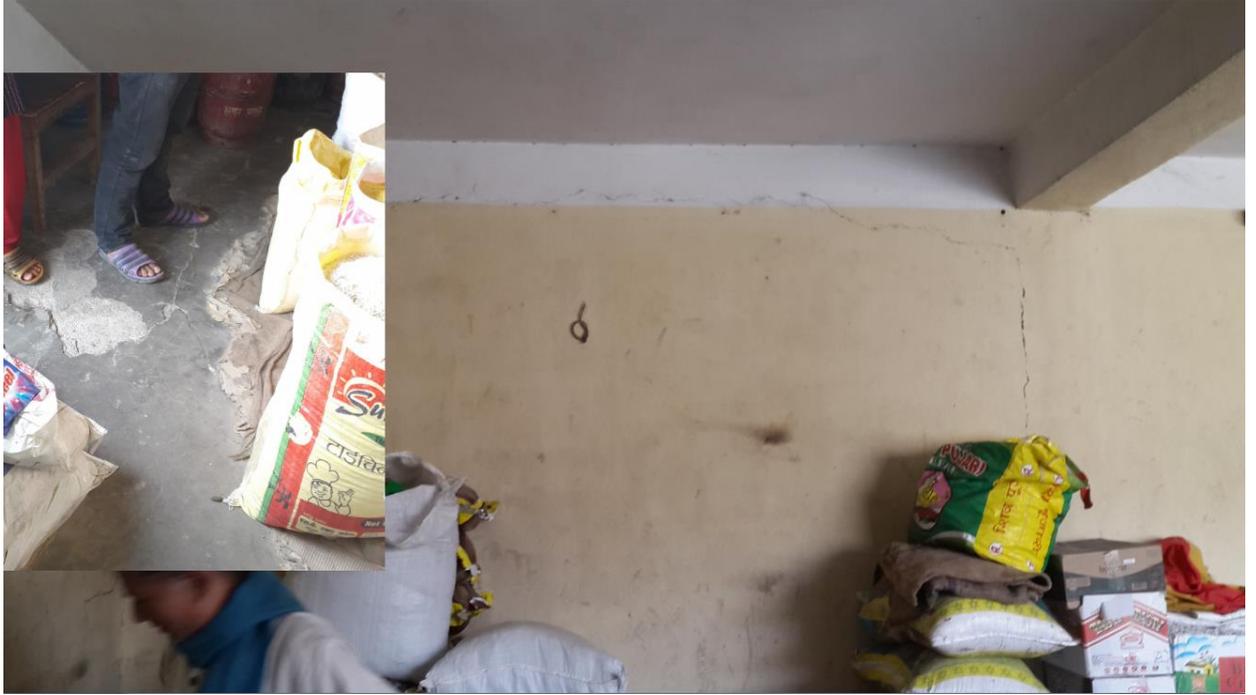
Maximum damages on the walls and floors of the green house seen in the previous figure.

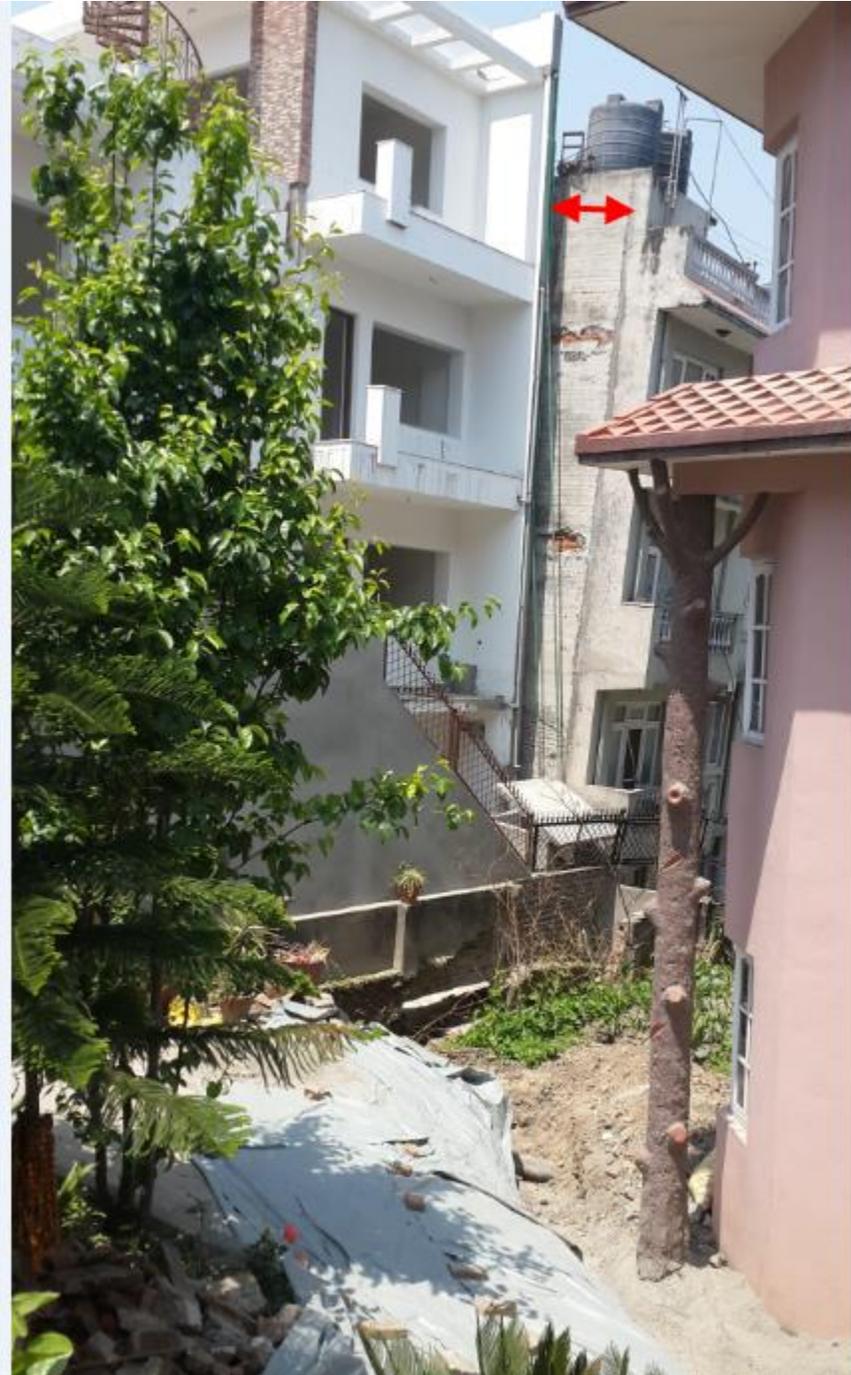
Tilting of the house by around 1 mt. near the surface cracks

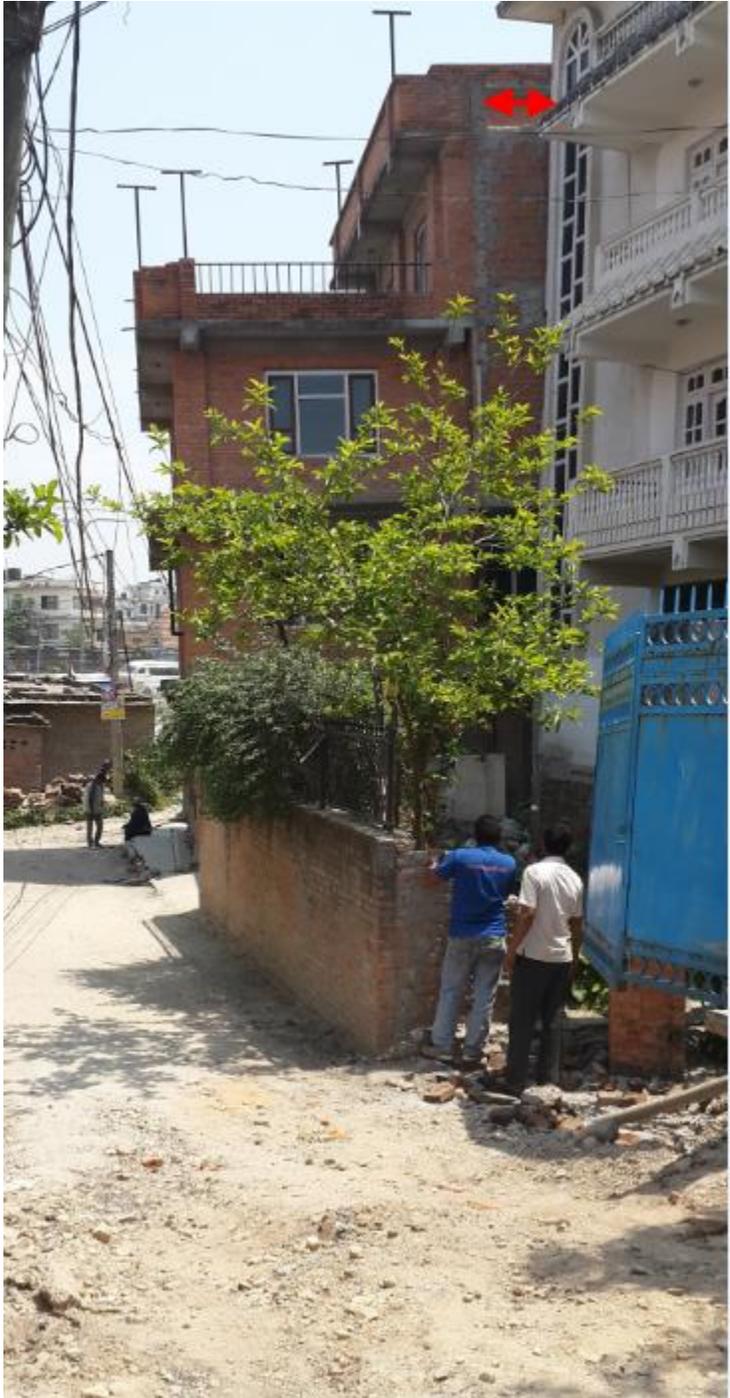
Tilting of the red house. No structural damage in the white house

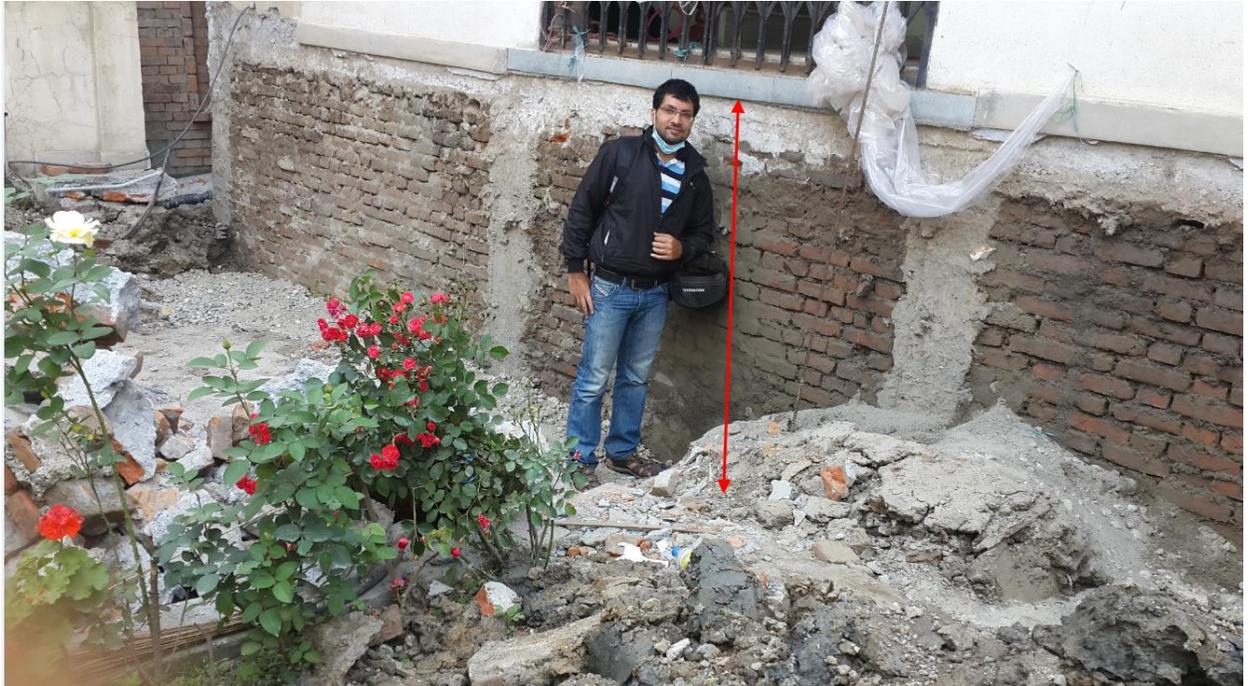
Settlement of the front garden of the white house seen in the previous figure by around 1.5 m.

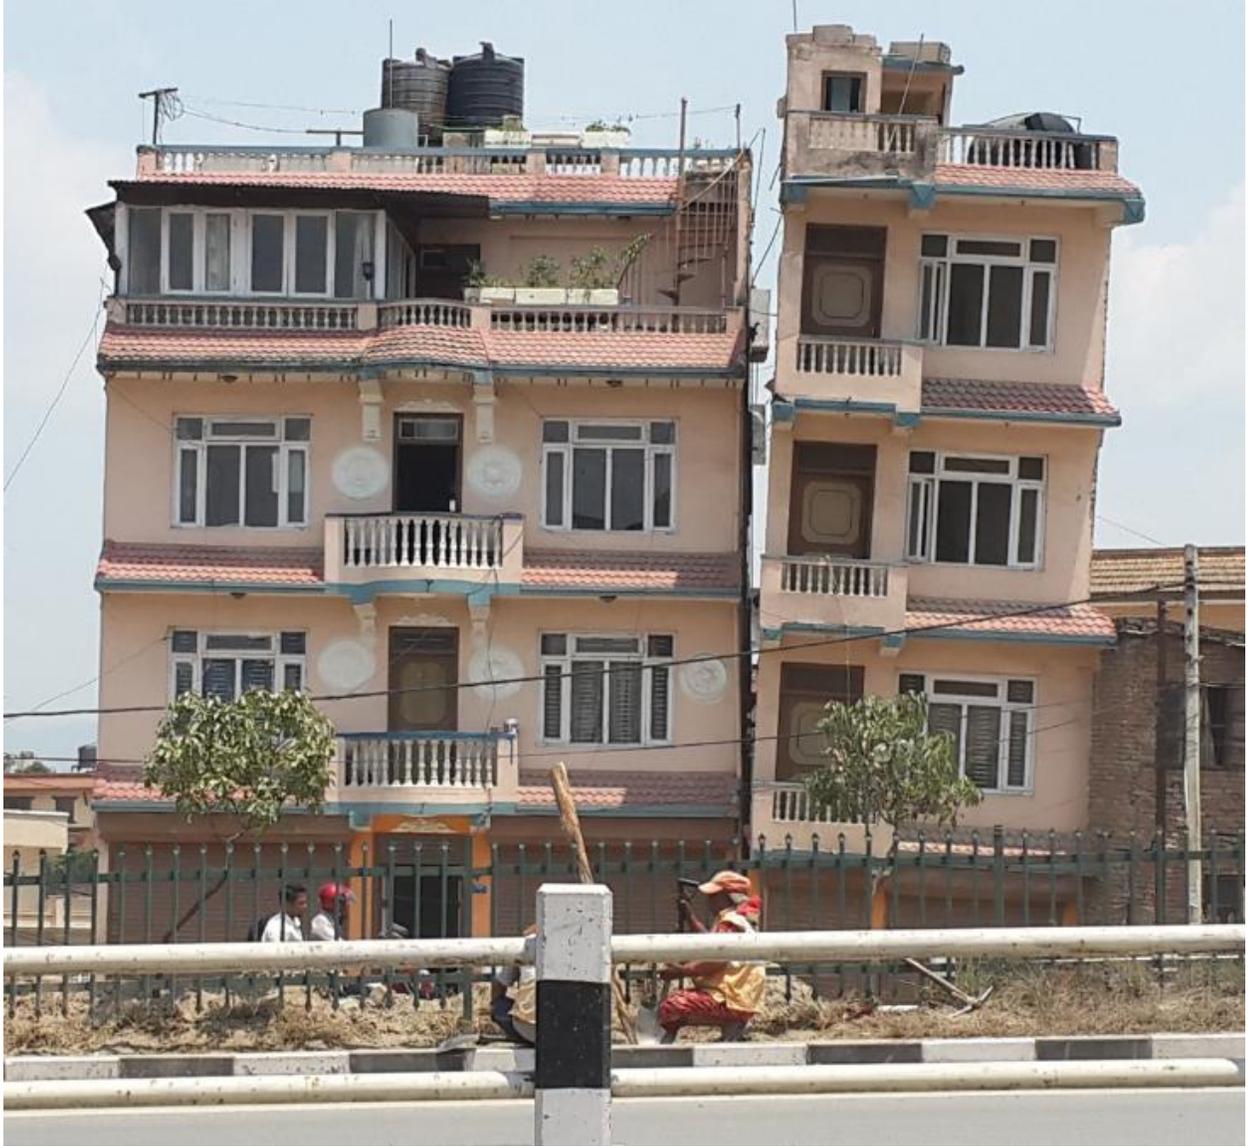
Houses near the surface rupture. These are two different houses.

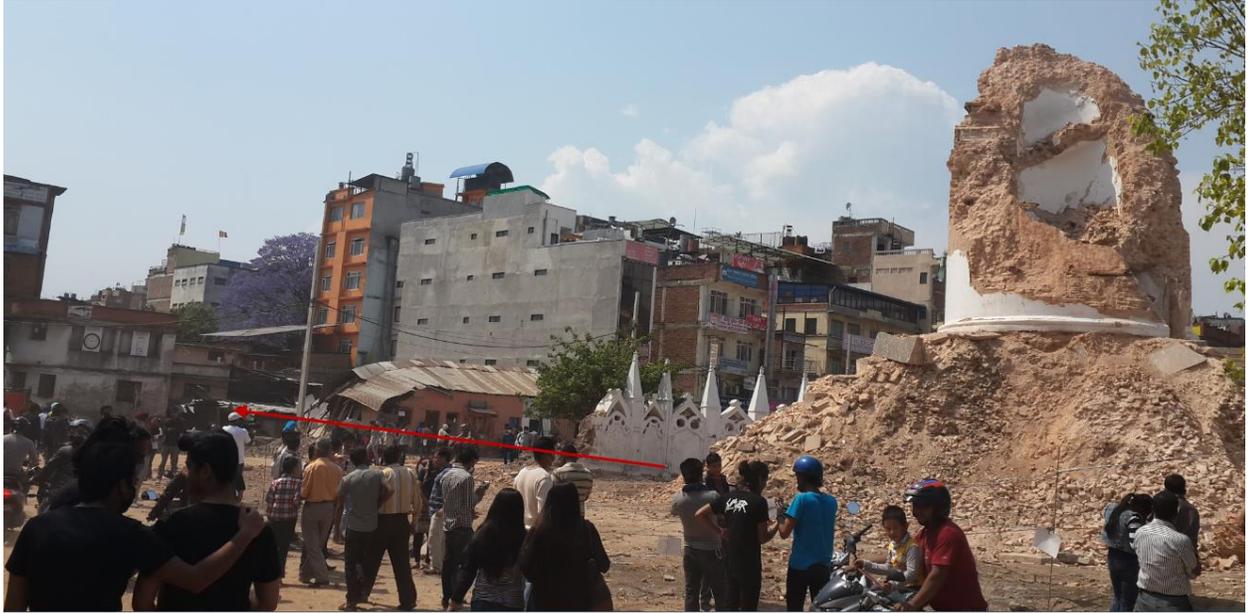
Stump of the 9 storey tall Dharahara tower. It felled down towards the marked direction.

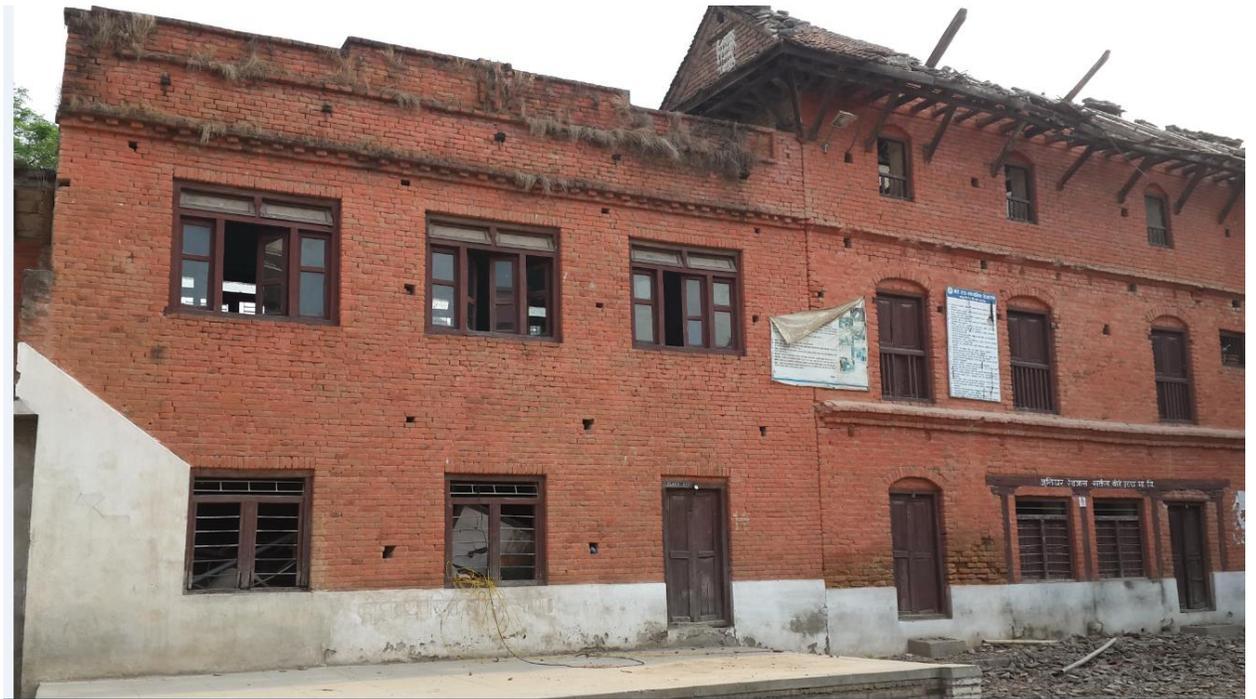
Damage in the roofs of a school in Bhaktapur. There are not even minor cracks at other locations

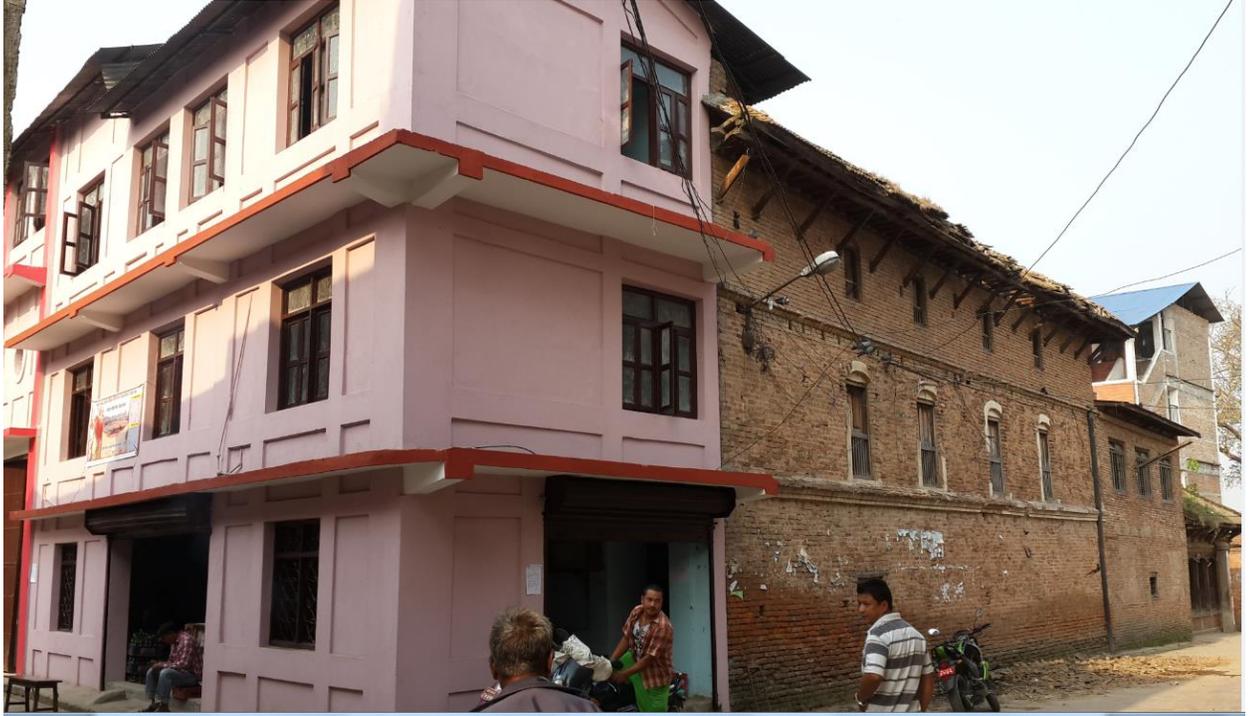
Pink colored is the retrofitted part of the school while the other had not been retrofitted.

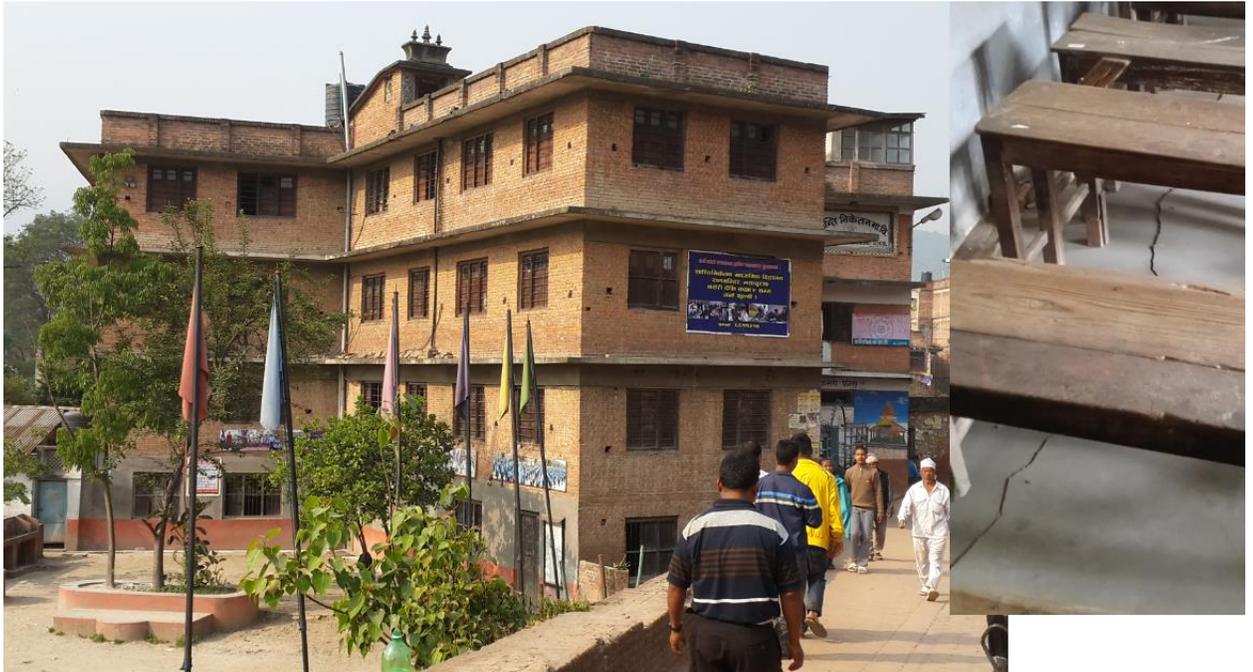
This “Y” Shaped 4 story school building has no cracks on the walls except on the floor of one room on ground floor, shown aside.

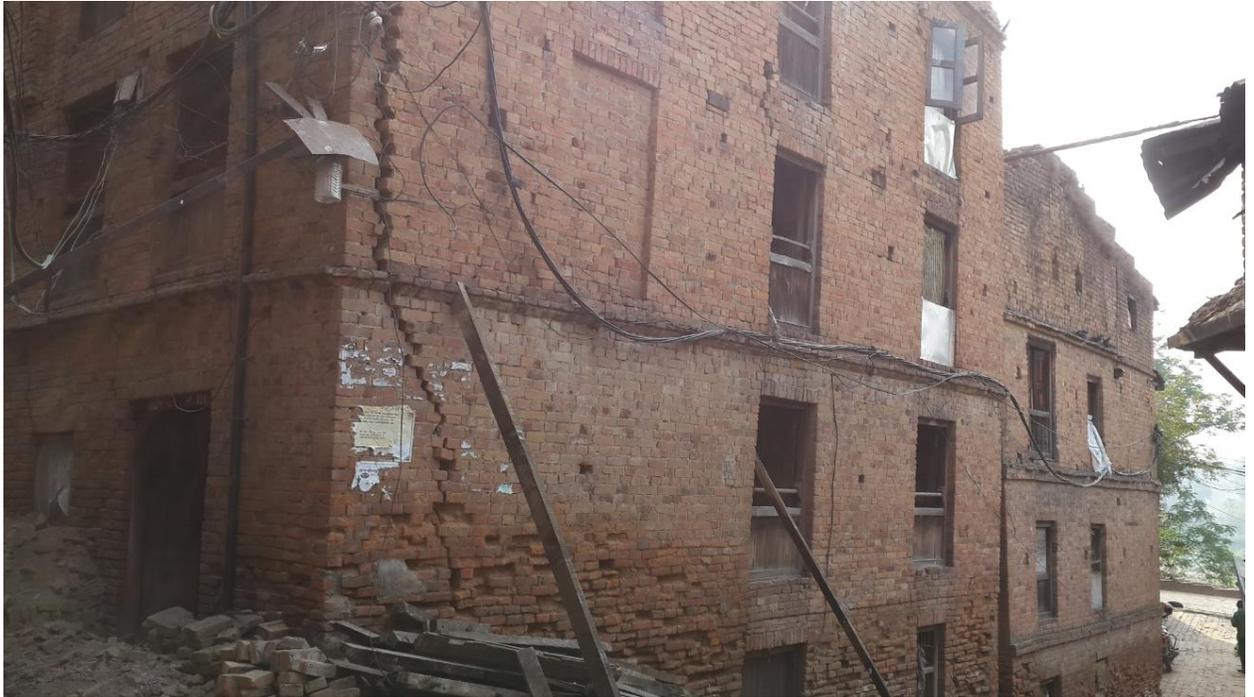
Damaged house near to the “Y” shaped school building.

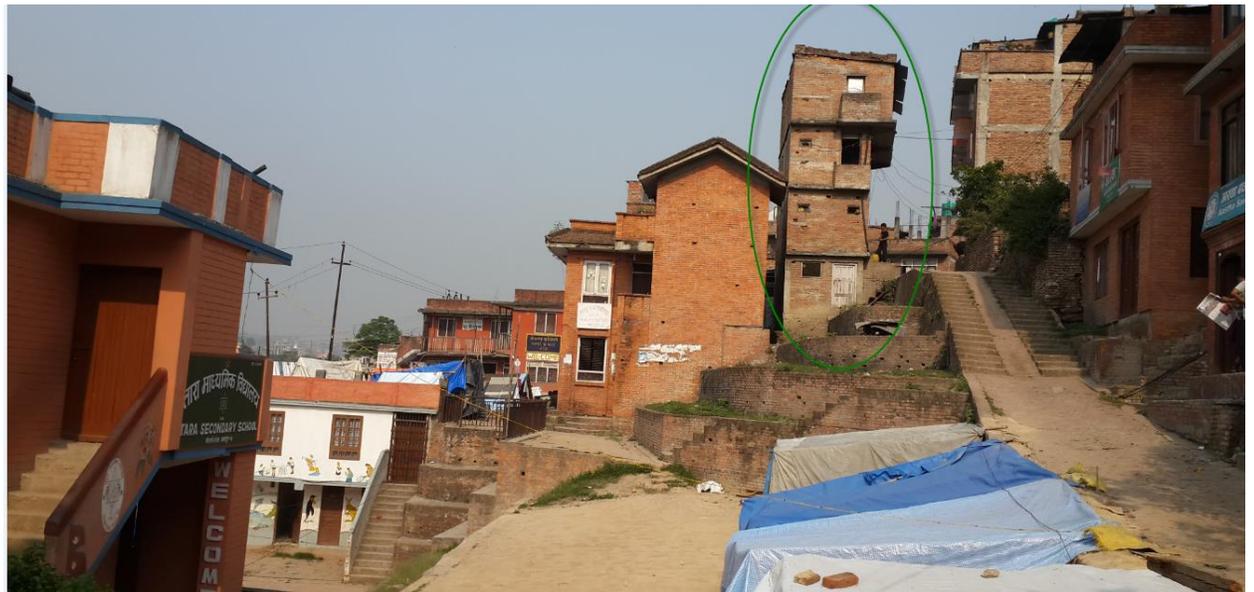
No damage in the marked house, near to the above cracked house. The building on the left corner of the photograph is the retrofitted school building which has no damage at all. The retrofitting was done by both side wall jacketing.

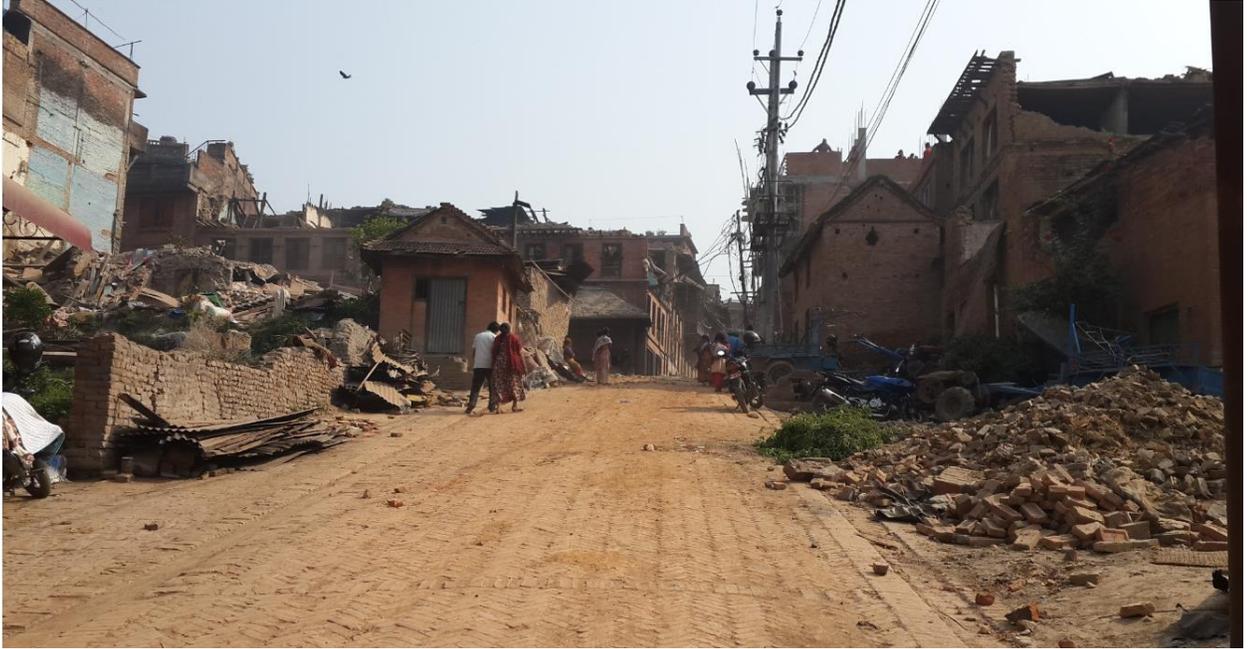
Damaged old houses in the village of Bhaktapur district

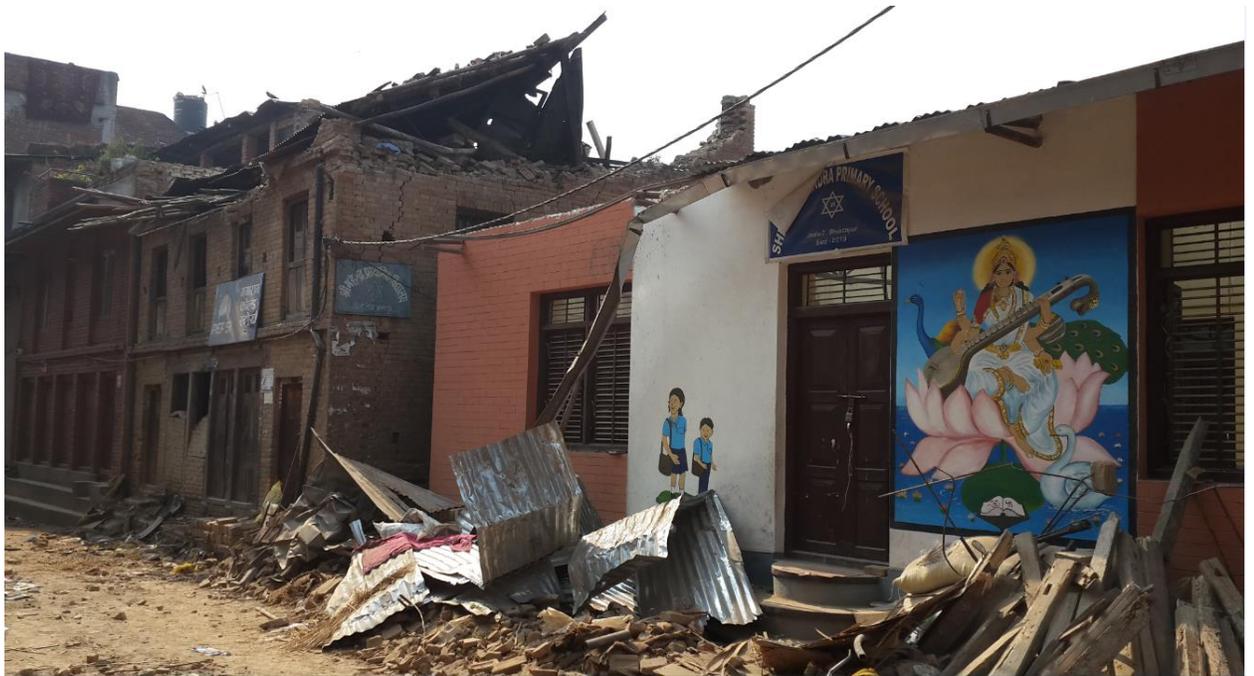
Roof of the retrofitted school building is damaged by the adjacent house

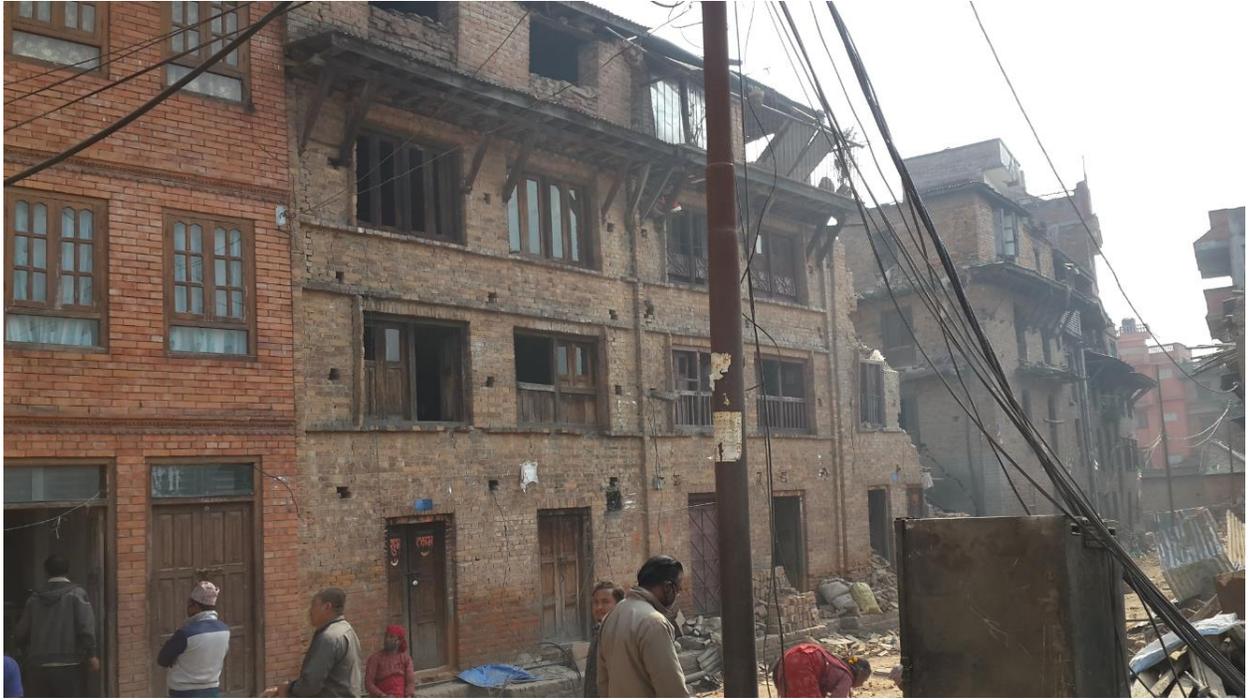
Relatively new buildings suffered no damage at all.

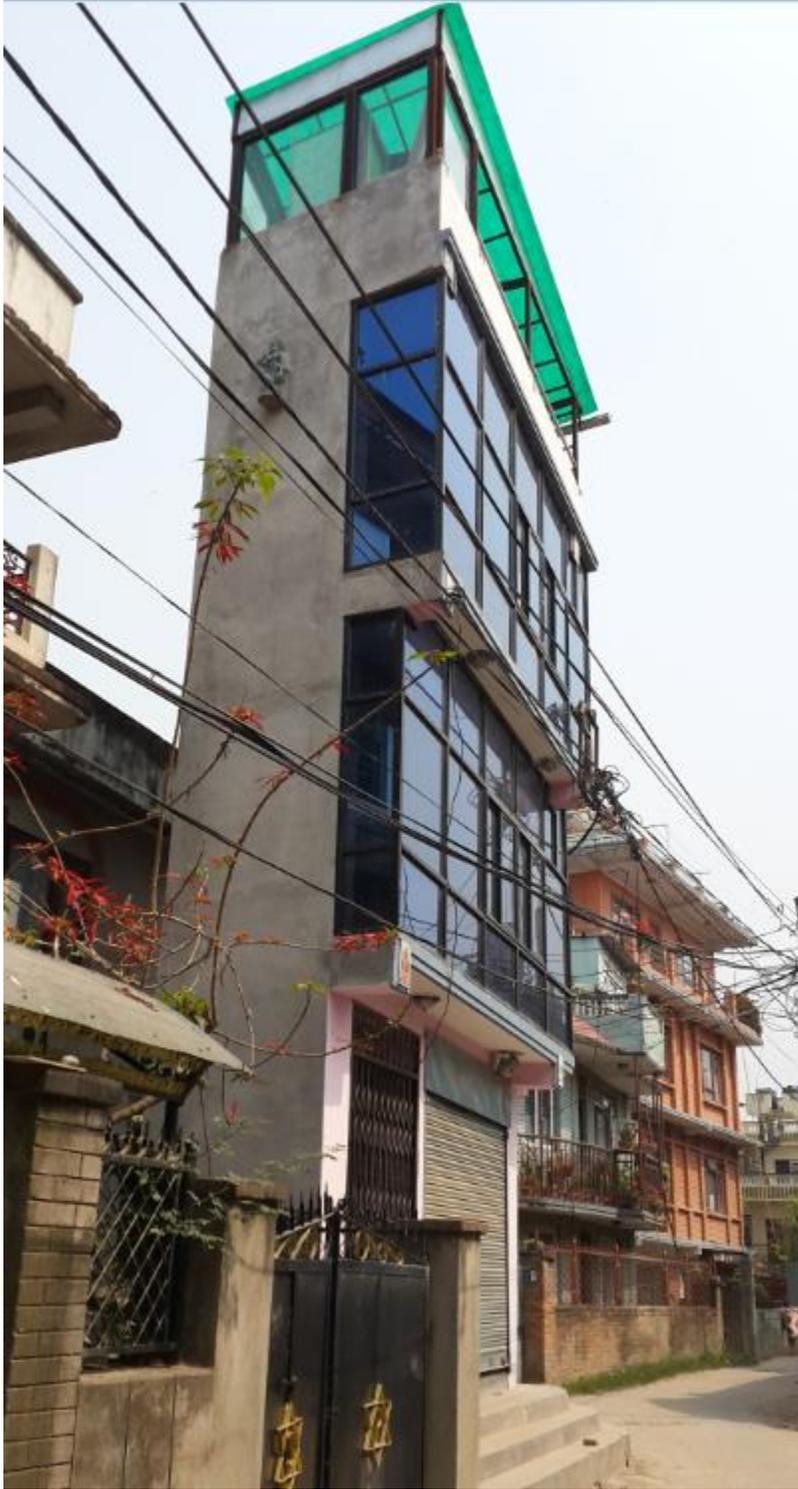
No external cracks are seen in such building in Bhaktapur district.

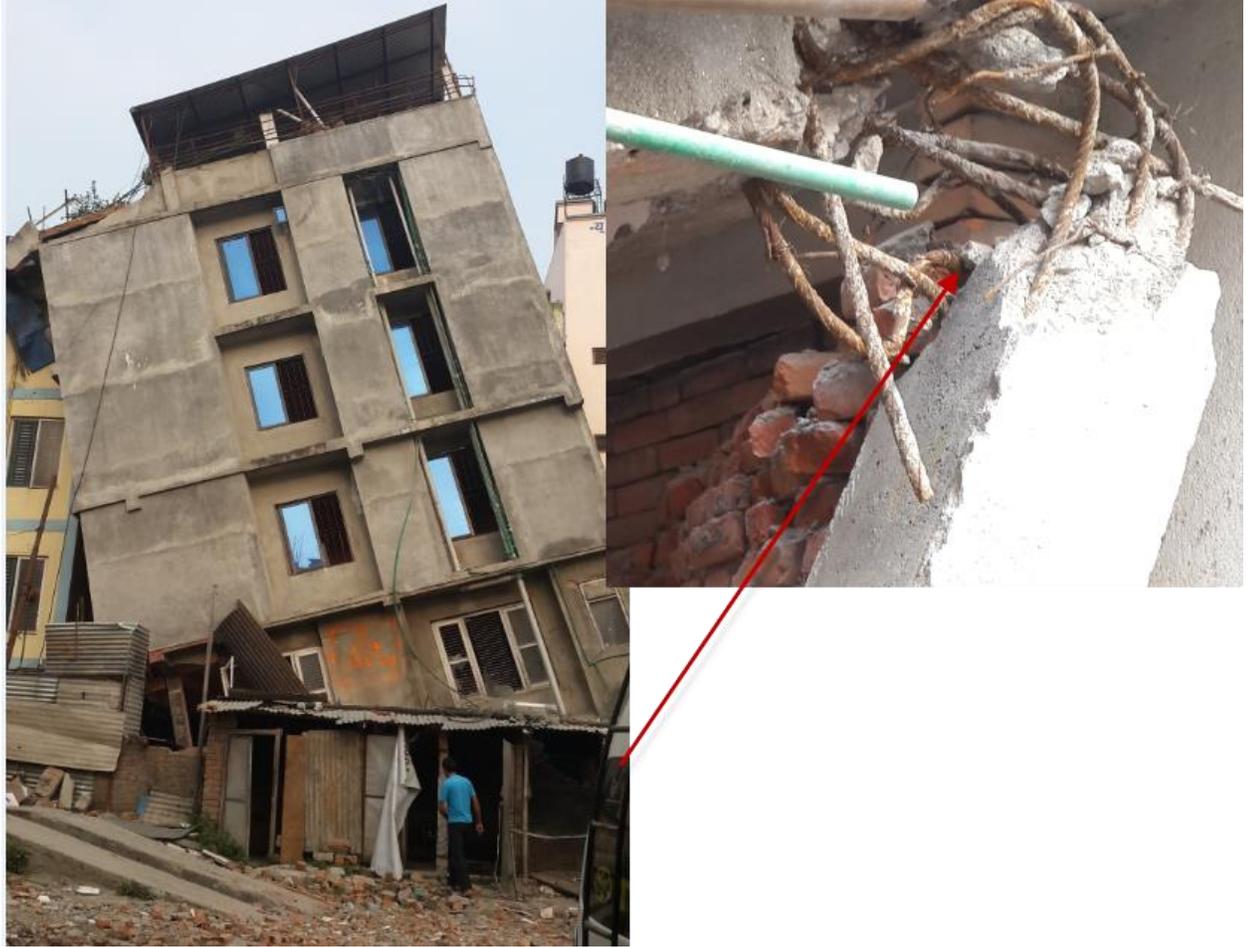
Column failure on the ground floor of the house in Kathmandu, Balaju area

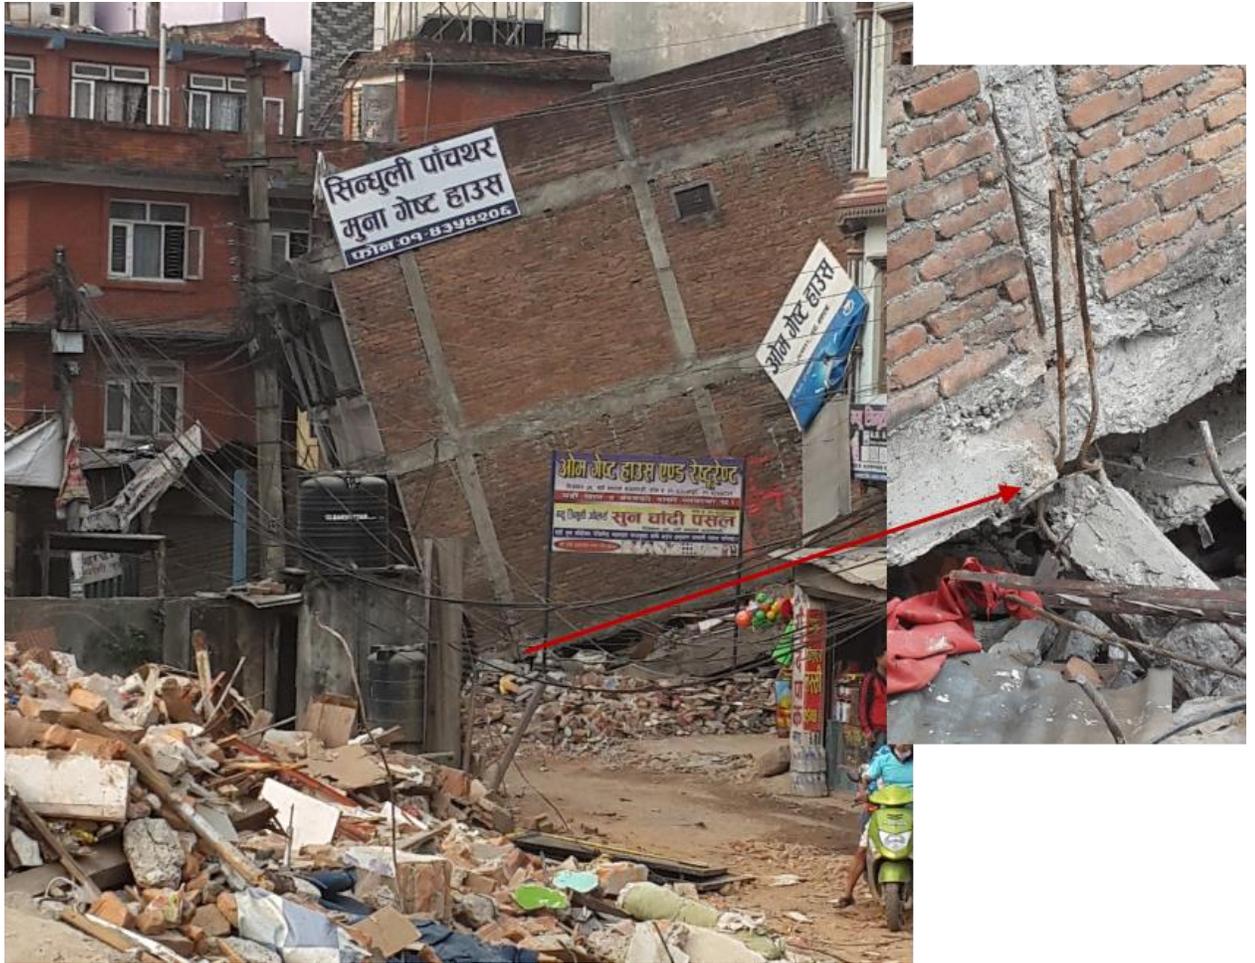
Damaged column of the house in Kathmandu, Balaju area

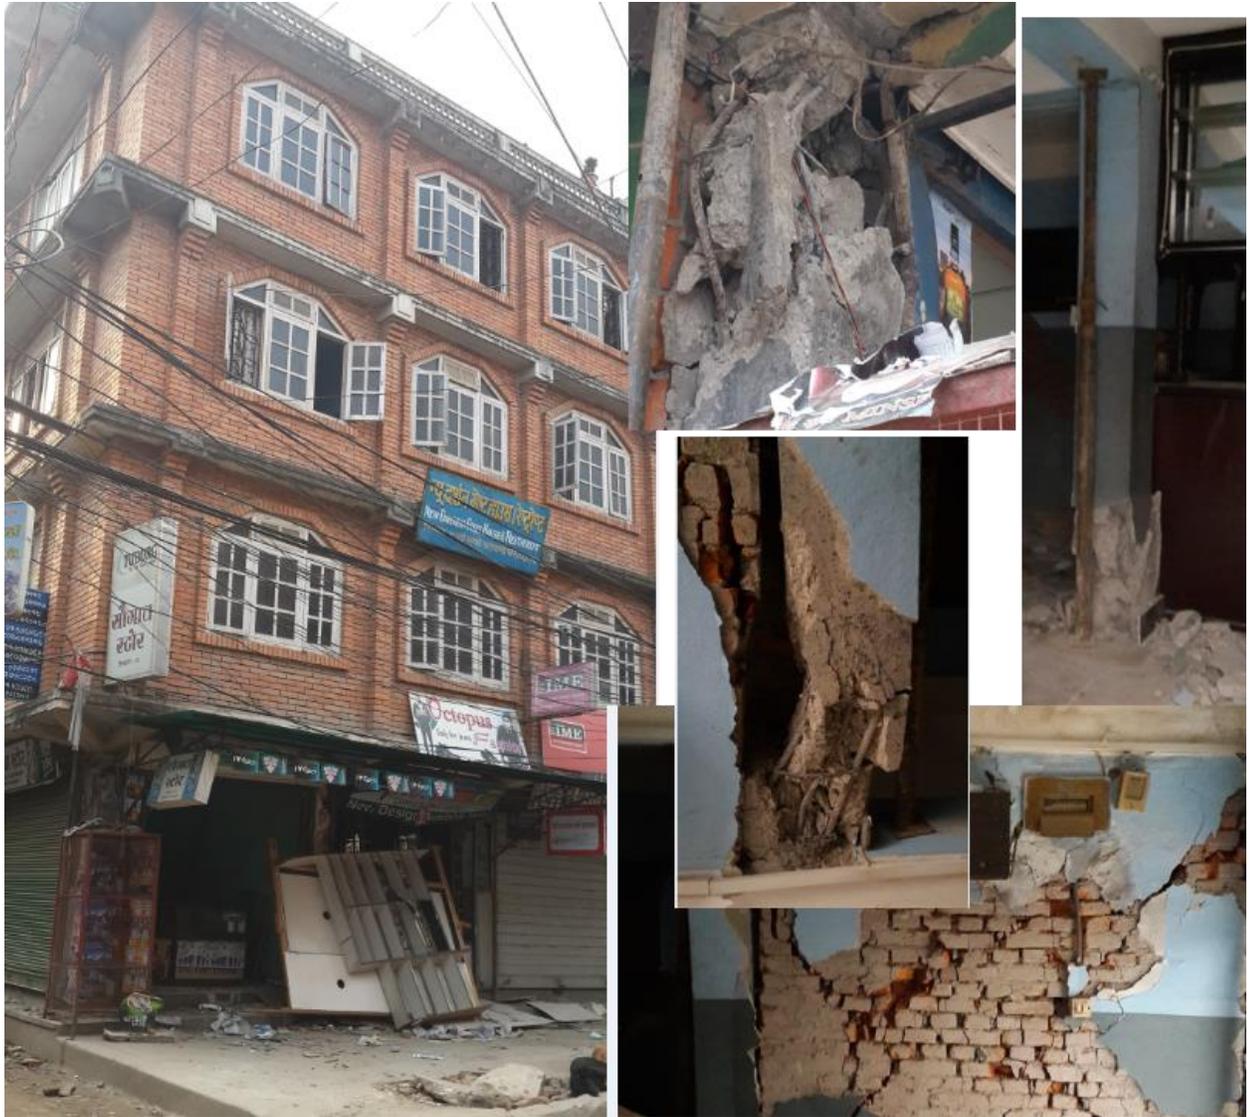
Damages in the interior walls and columns of the house in Kathmandu, Balaju area. Longitudinal rebars are buckled after concrete crushing at the beam column joint and at column base.

- f) In some buildings it is observed that the building could not resist the overturning moment due to lap splice failure on the tension side.
- g) Most of the columns are failed by crushing of the concrete at below the beam or at column base leading to the subsequent buckling of the longitudinal bars.

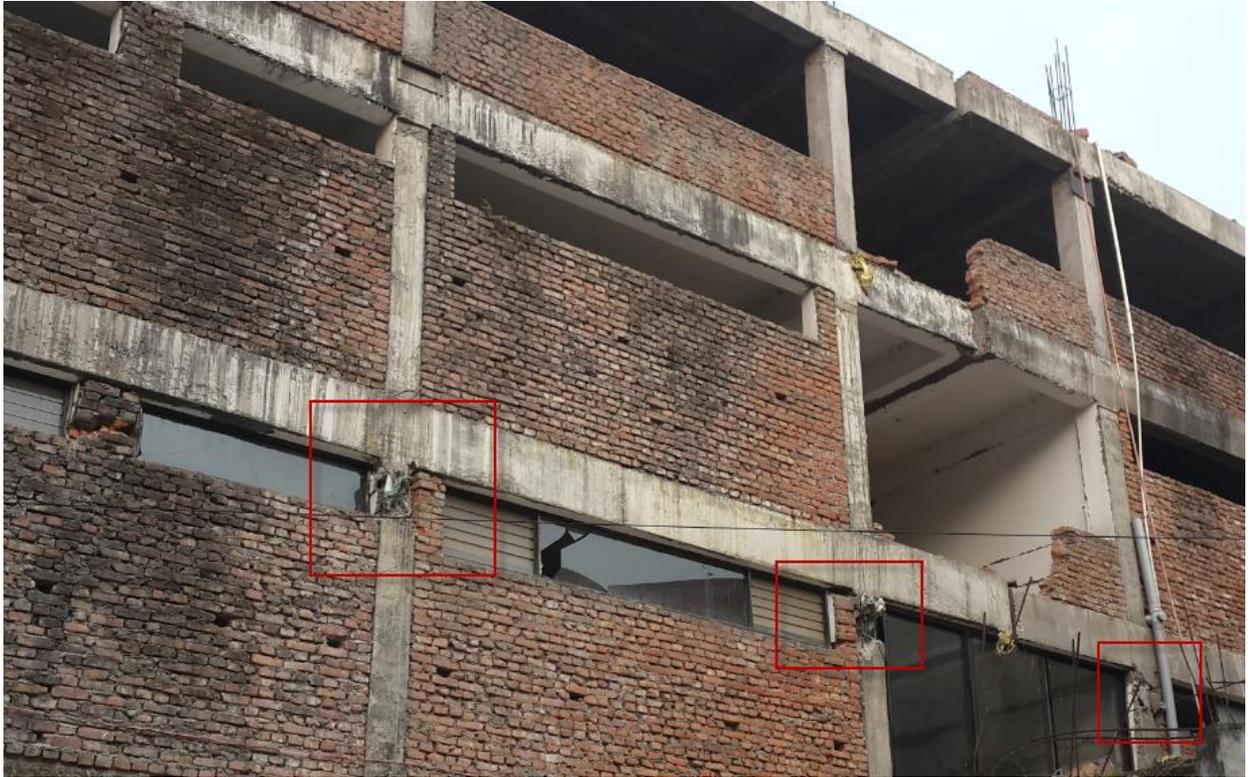
Shear failure of the columns on ground story at beam column joint location due to short column effect induced by the infill wall in Kathmandu, Balaju area

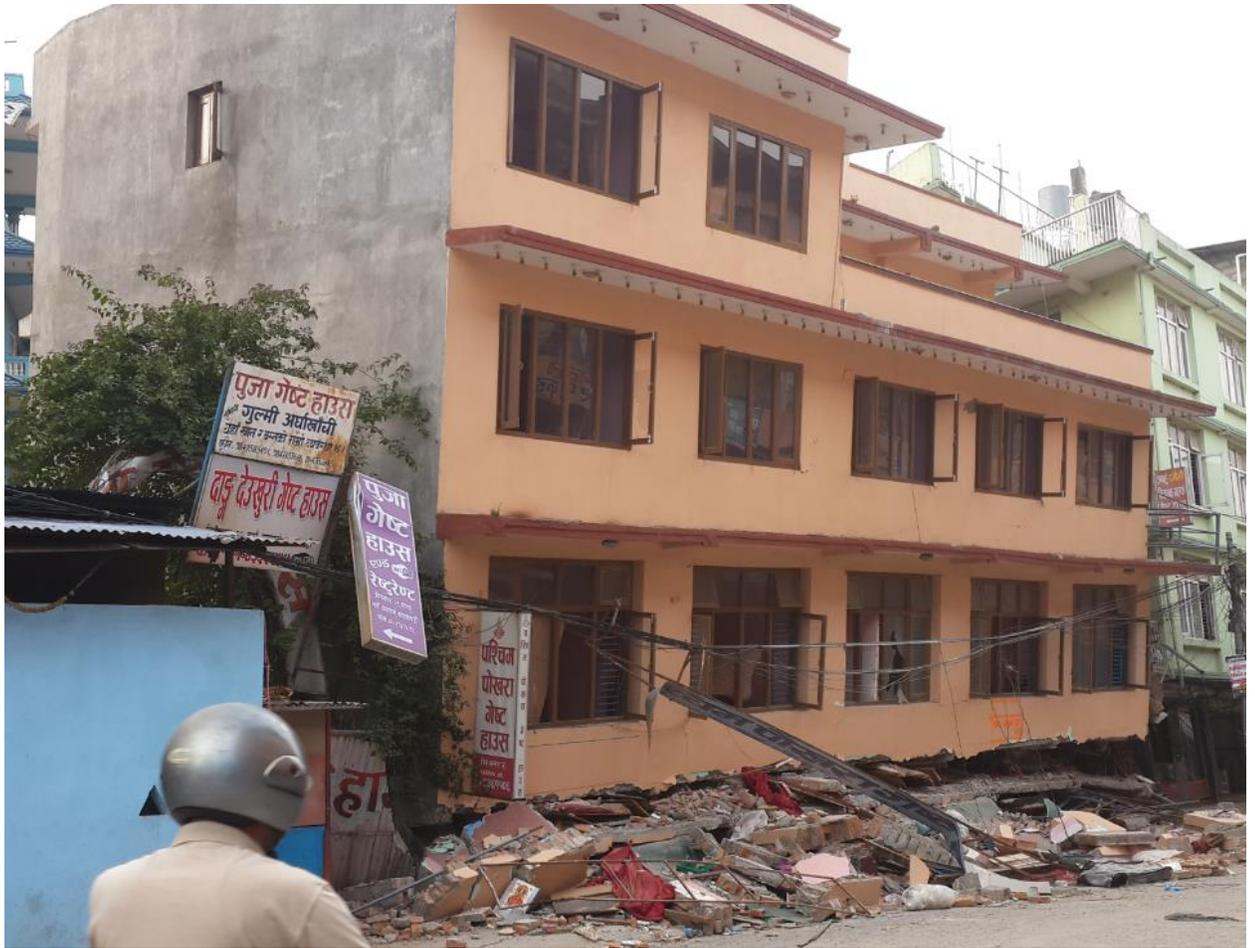
Complete collapse of first two story of a five story house in Kathmandu, Balaju area, due to soft storey effect. There were no infill walls on the ground floor.

- e) Complete collapse of the ground floor and in some cases up to 2nd floor of mid-rise buildings (4 to 6 story tall) due to soft story mechanism. This kind of buildings did not have infill walls on the periphery grid on ground floor for commercial purpose and the column sizes were 9"x9".
