# OBSERVATION OF BUILDING DAMAGE PATTERNS IN KATHMANDU DUE TO EARTHQUAKE- DRAFT REPORT

Mr. Kiran Acharya  
acharyakiranraj@gmail.com

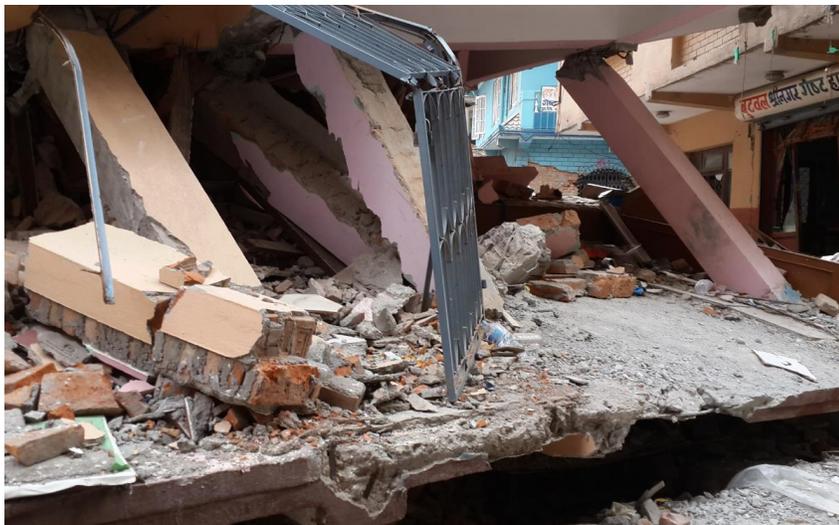
Close up view of the damaged columns of the previous building

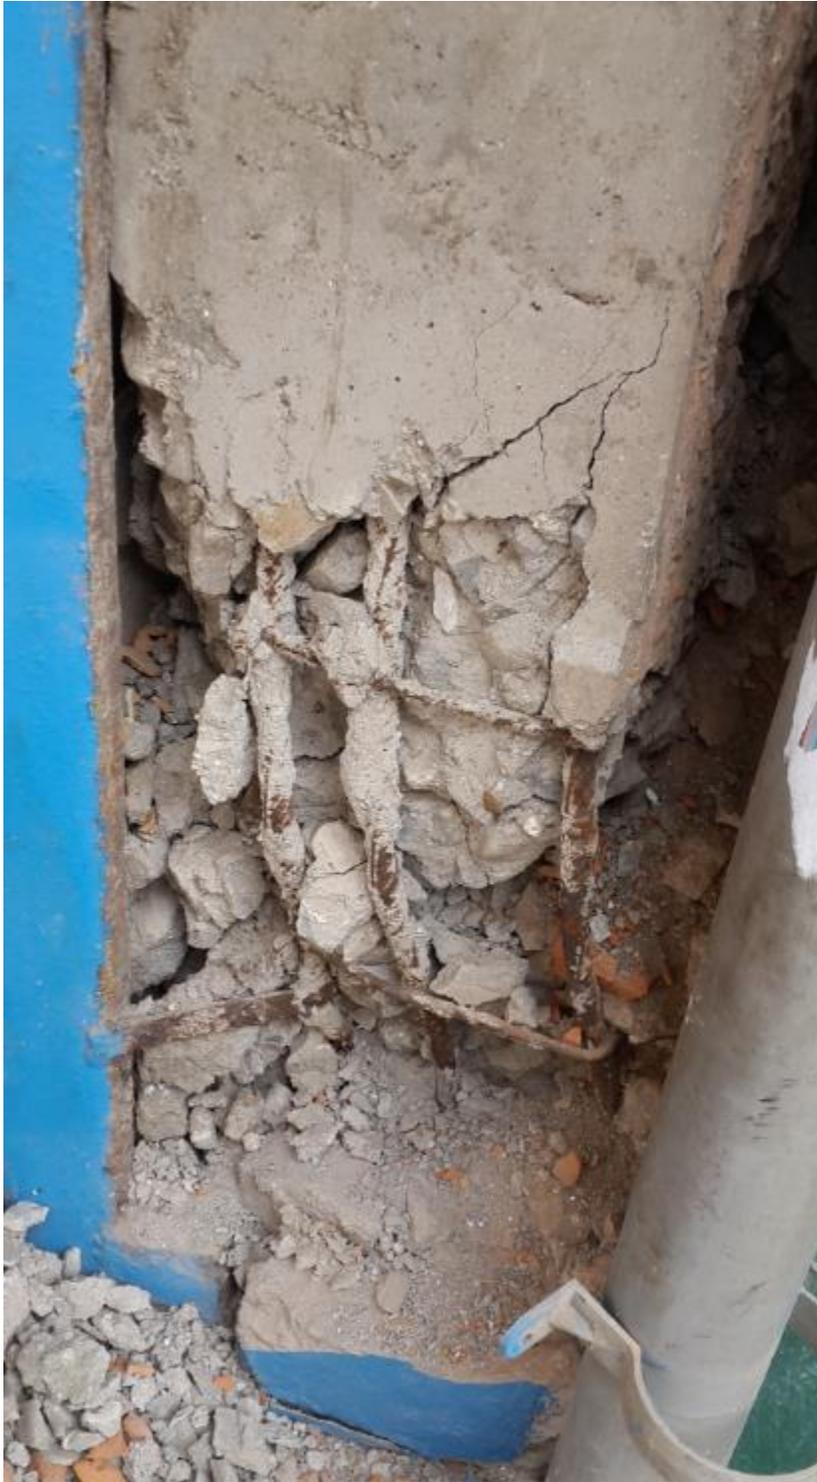
Buckling of longitudinal rebar at column base of other building in Kathmandu, in Balaju area.

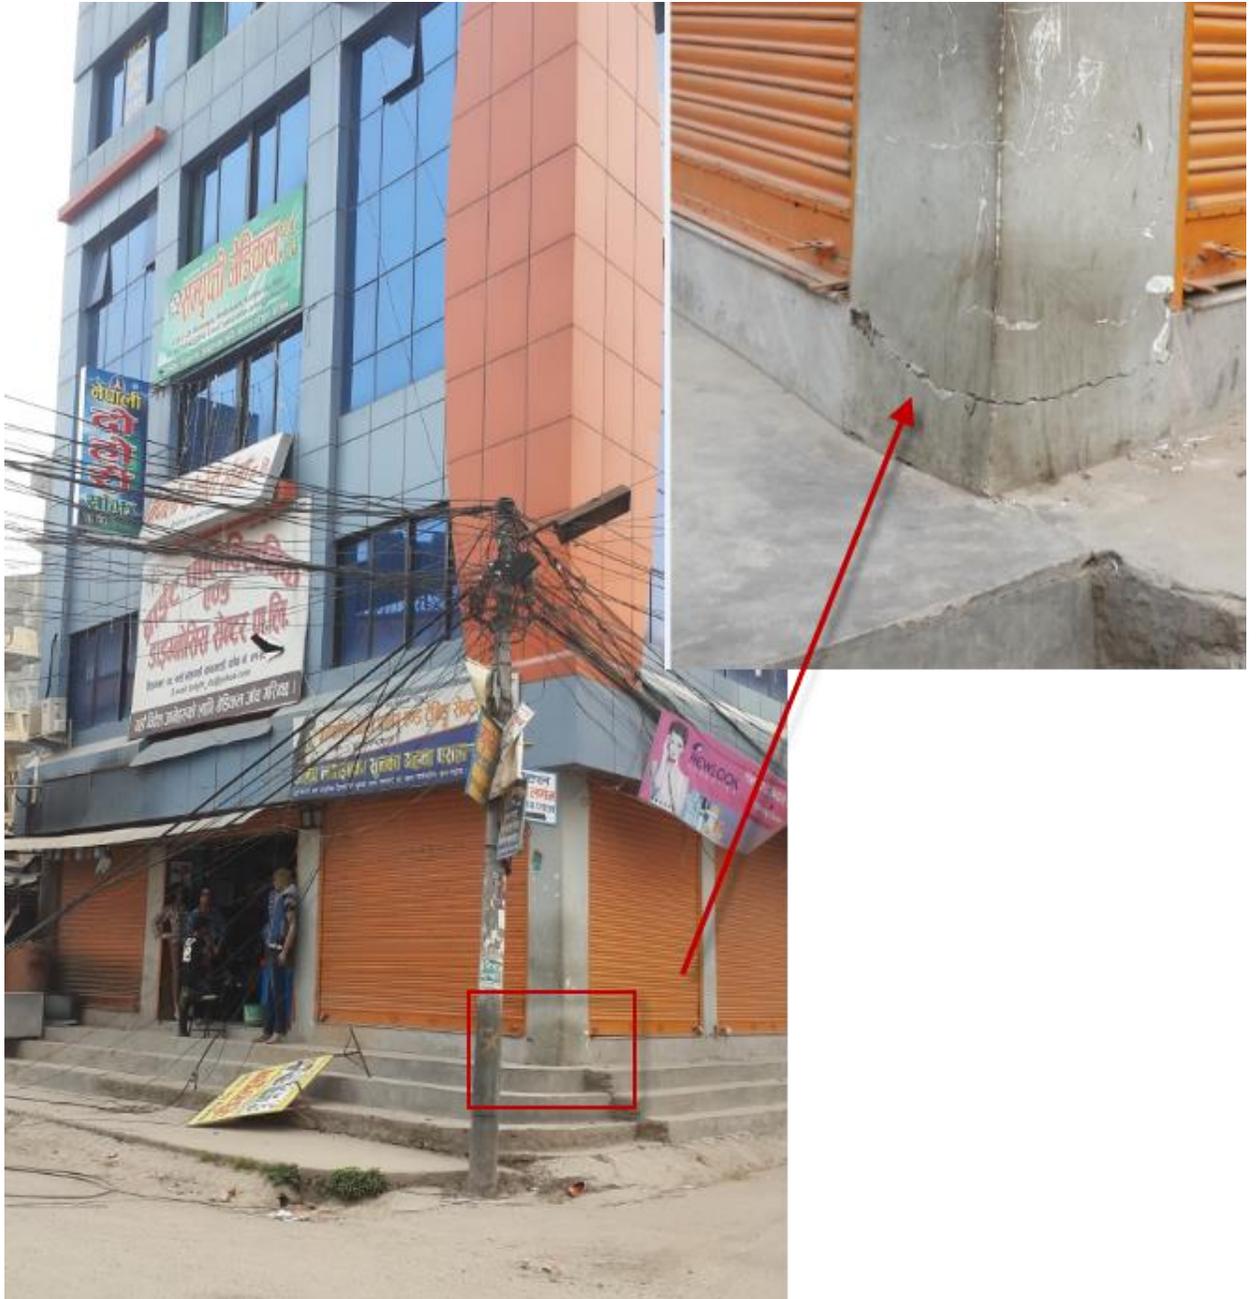
Critical flexural crack at the column base in the building in Kathmandu, Balaju area.

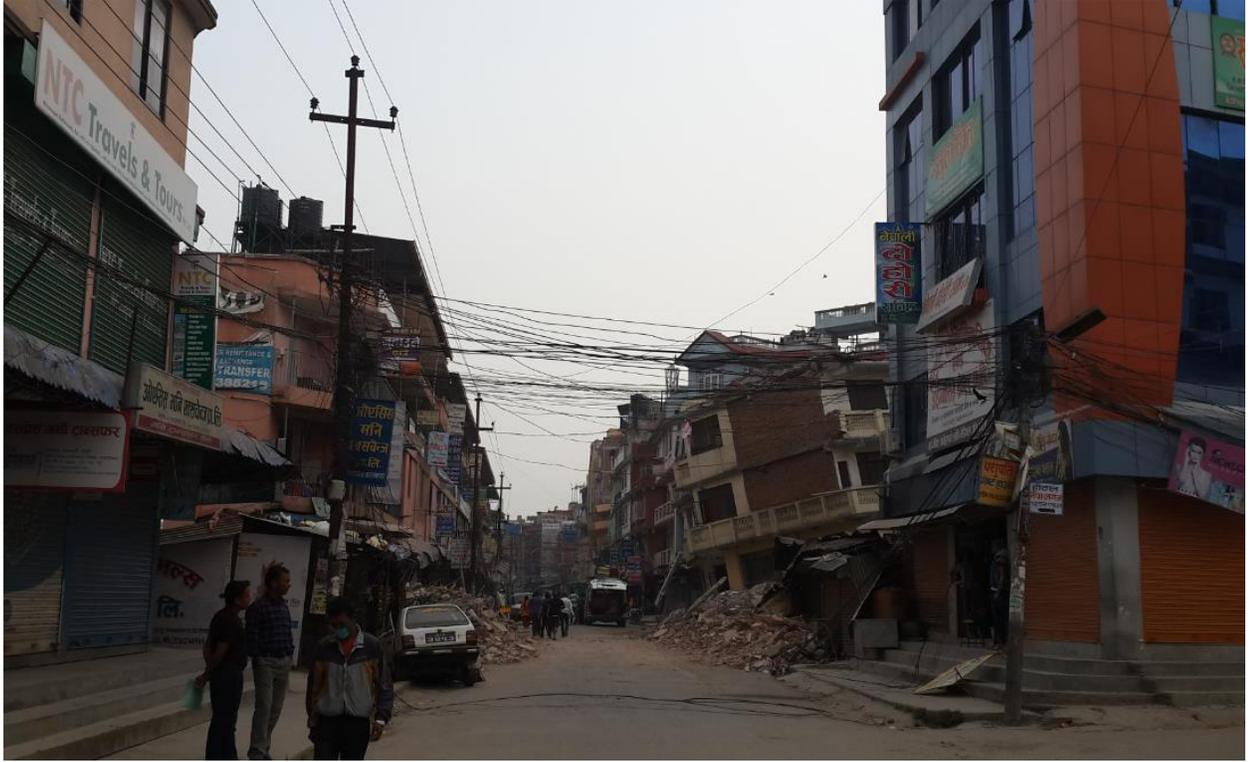
More damage in the buildings on right side than on the left side of the road in Kathmandu, in Balaju area

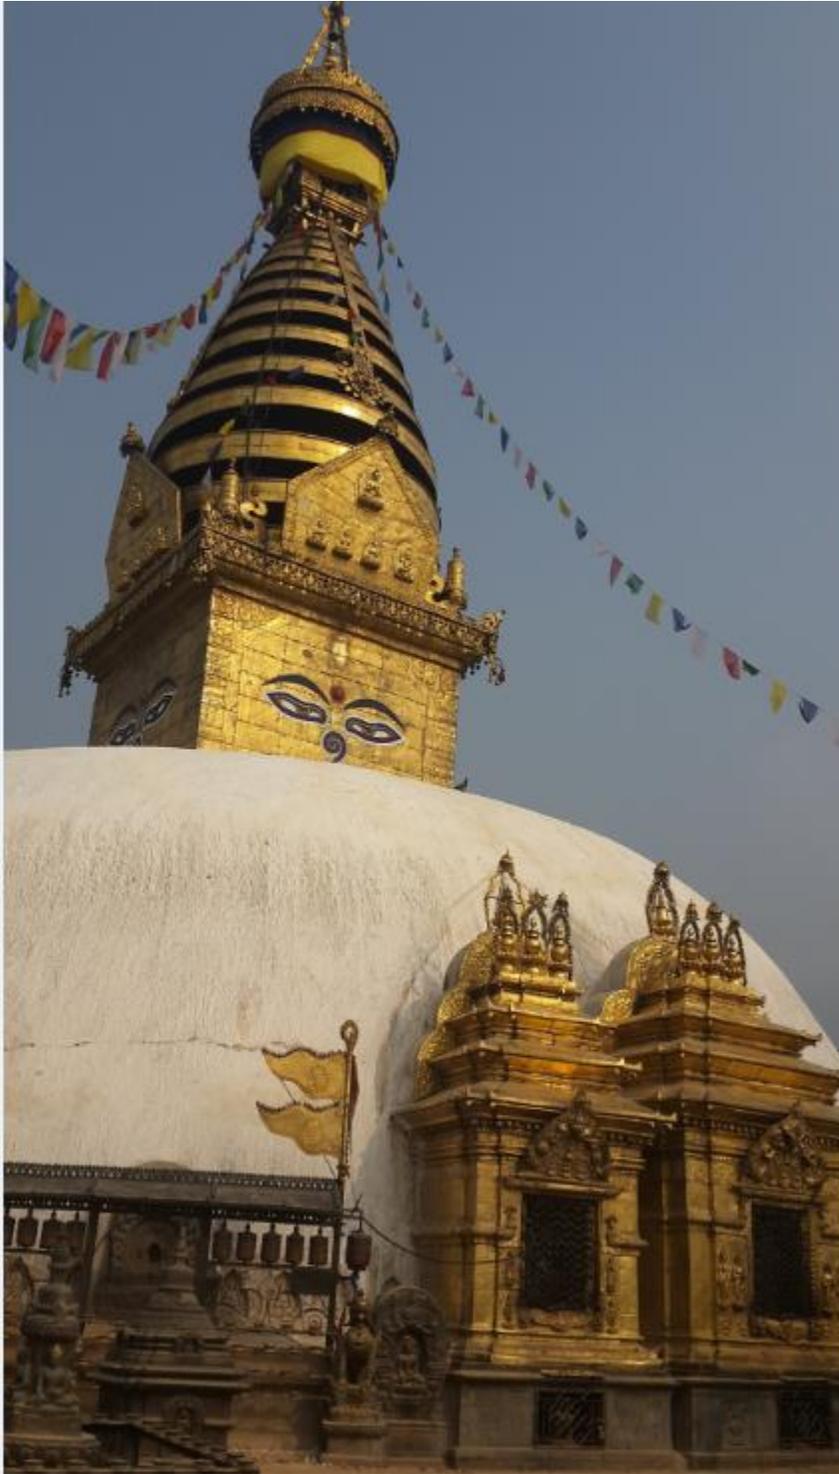
Horizontal cracks in Swyambhu stupa, Kathmandu

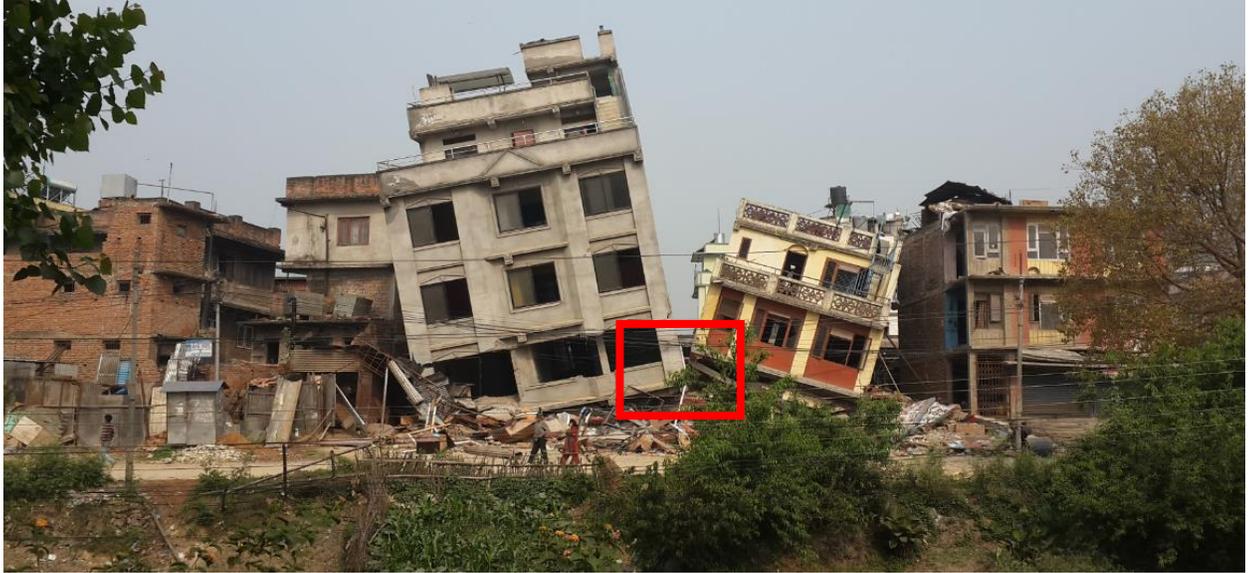
Collapsed buildings in Kathmandu due to soft storey effect.

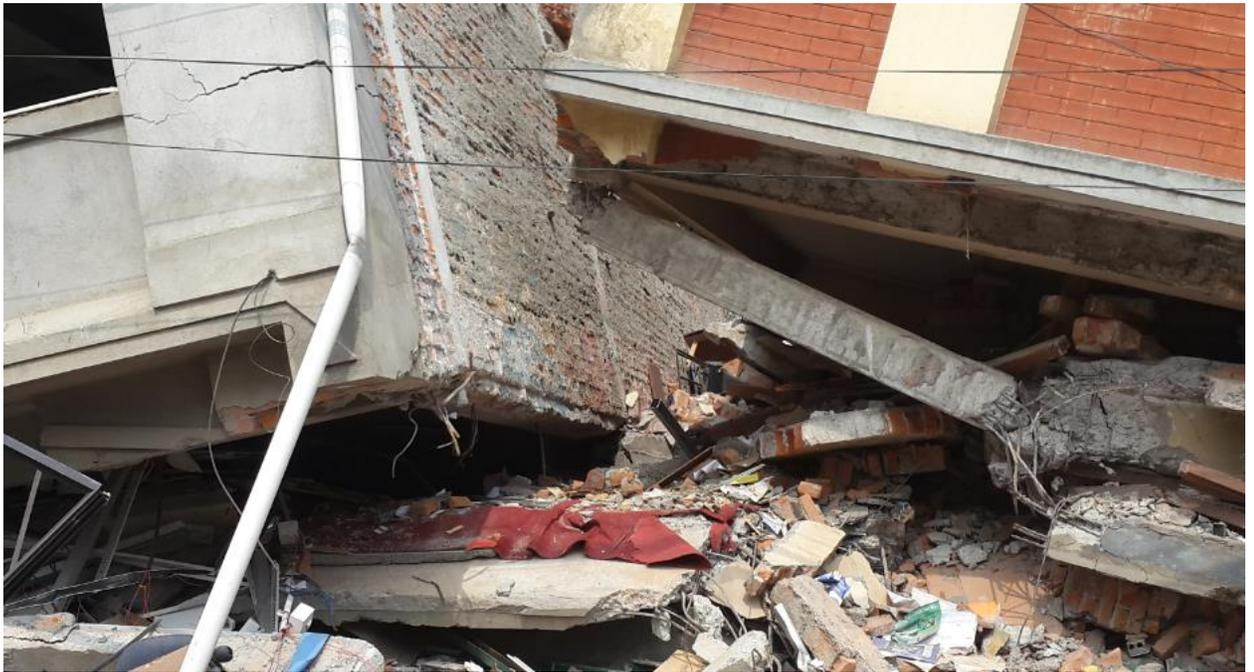
Damaged columns at the marked location of the previous photos.

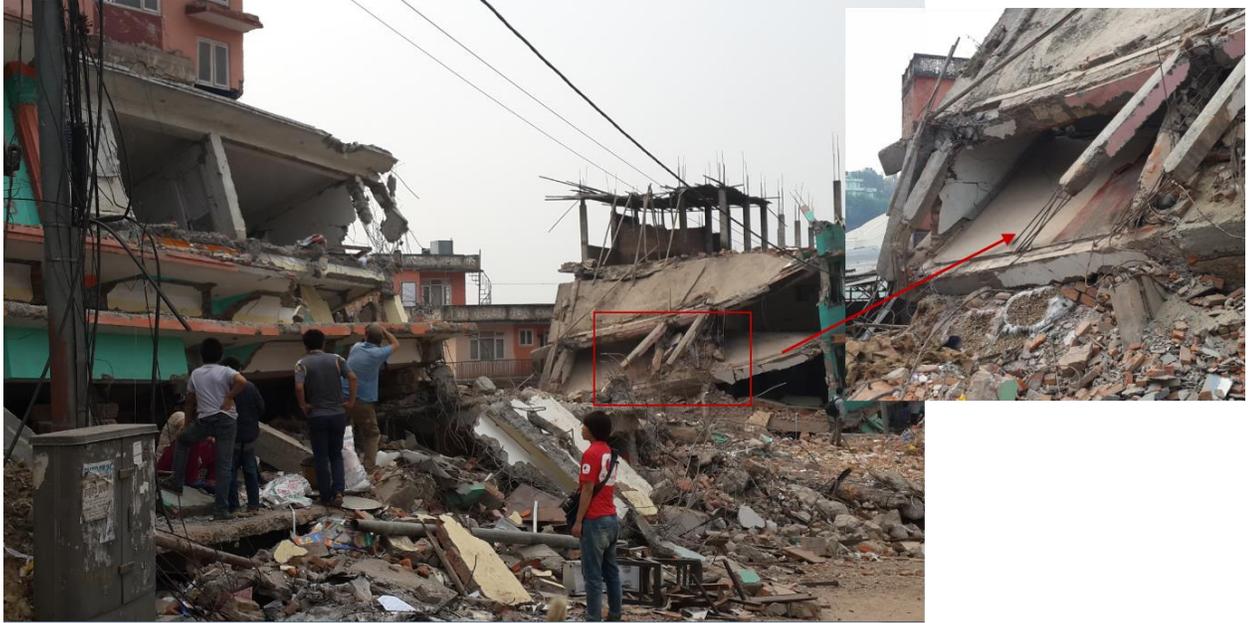
Collapsed building in Kathmandu, Sitapaila area. All the rebars are spliced at the same location in the column as marked in the diagram.

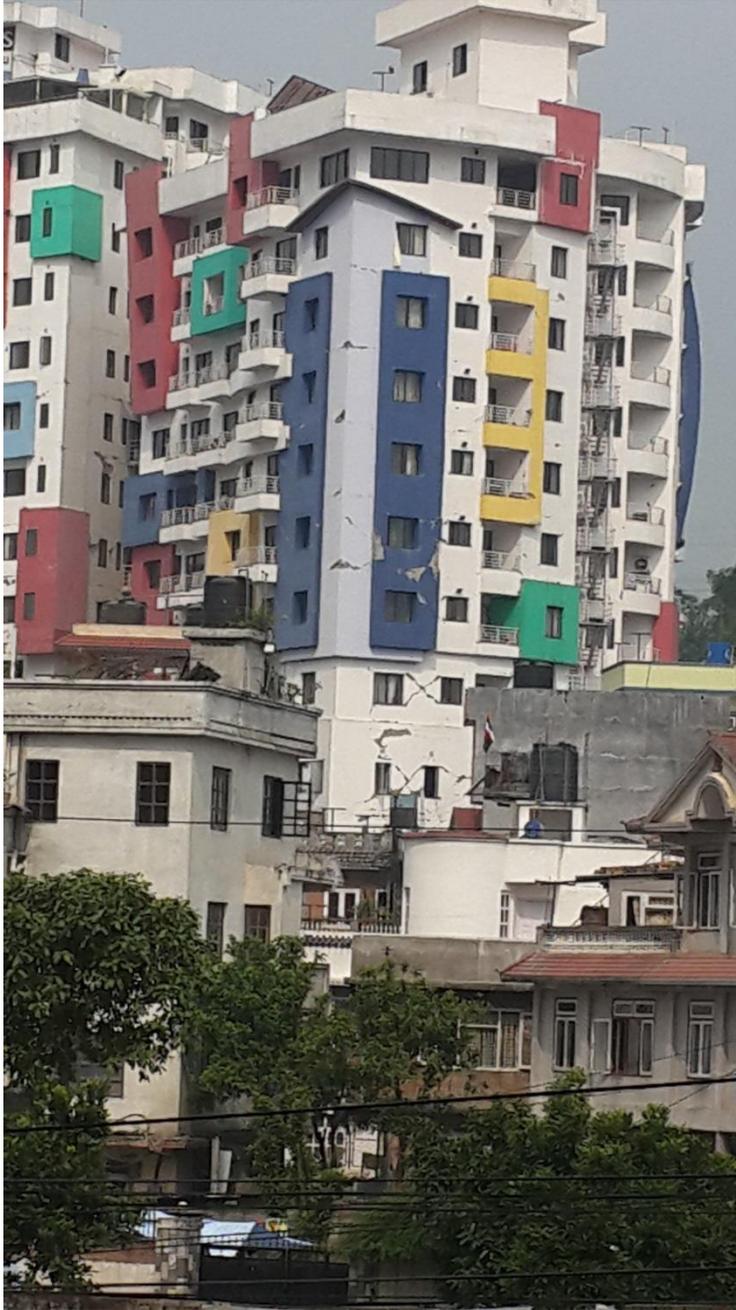
Damages in the infill walls and at the corners of the high rise apartment buildings in Kathmandu, Sitapaila area

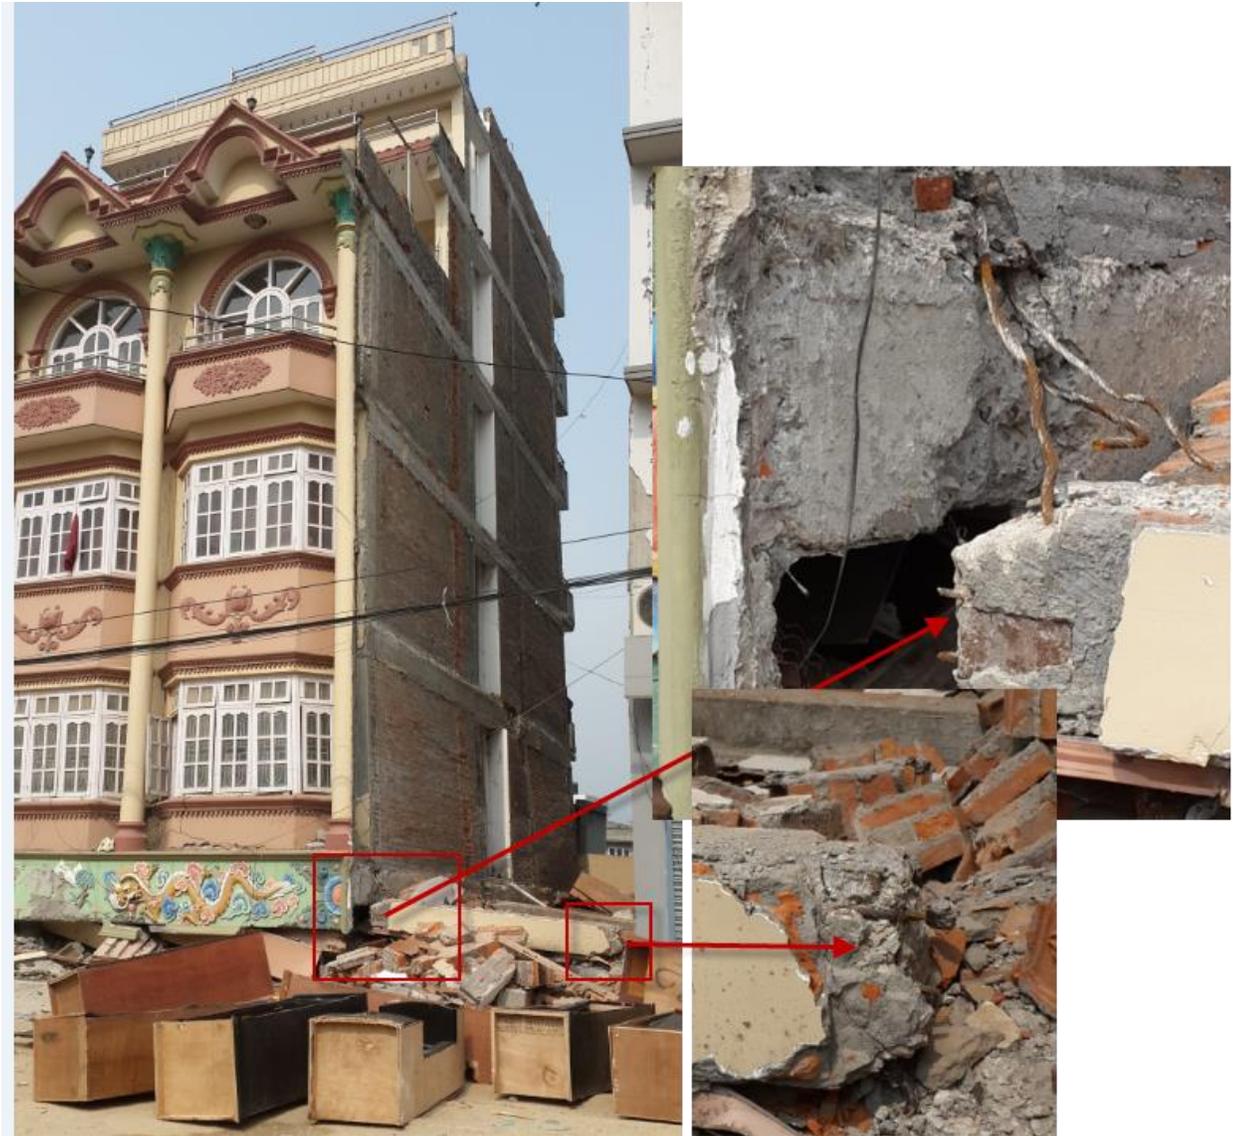
Soft story collapse of a building in Kathmandu, Sitapaila area

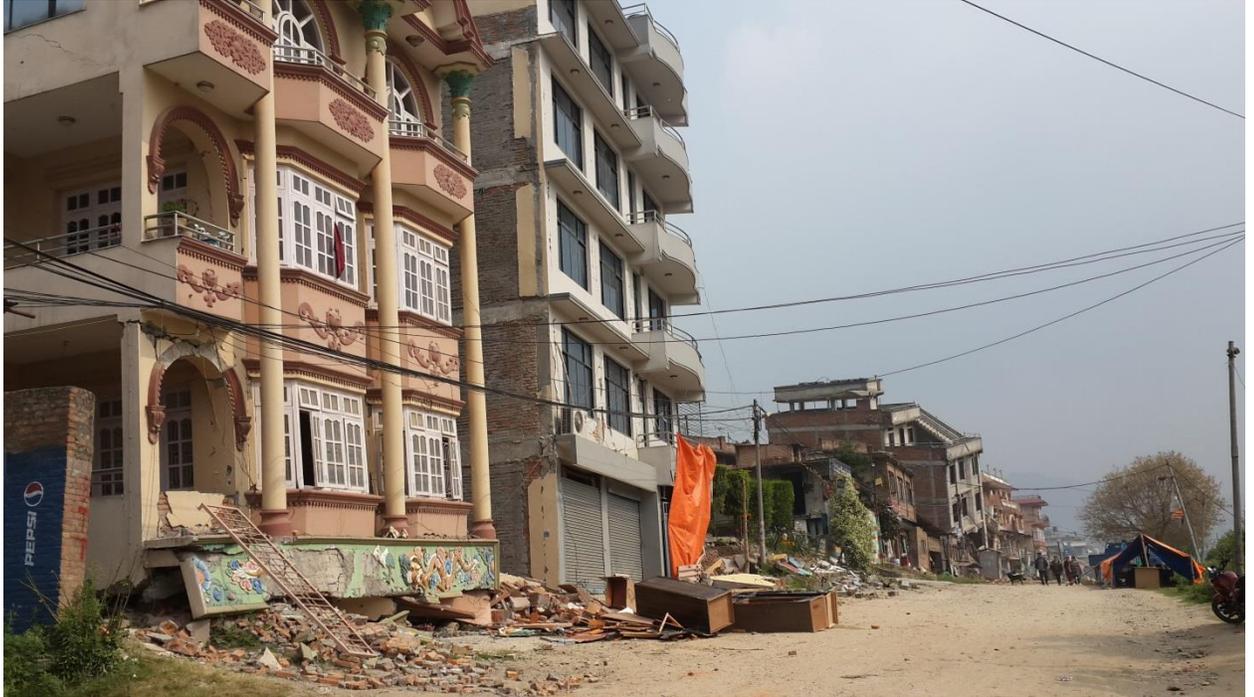
Collapsed houses in Sitapaila area, Kathmandu

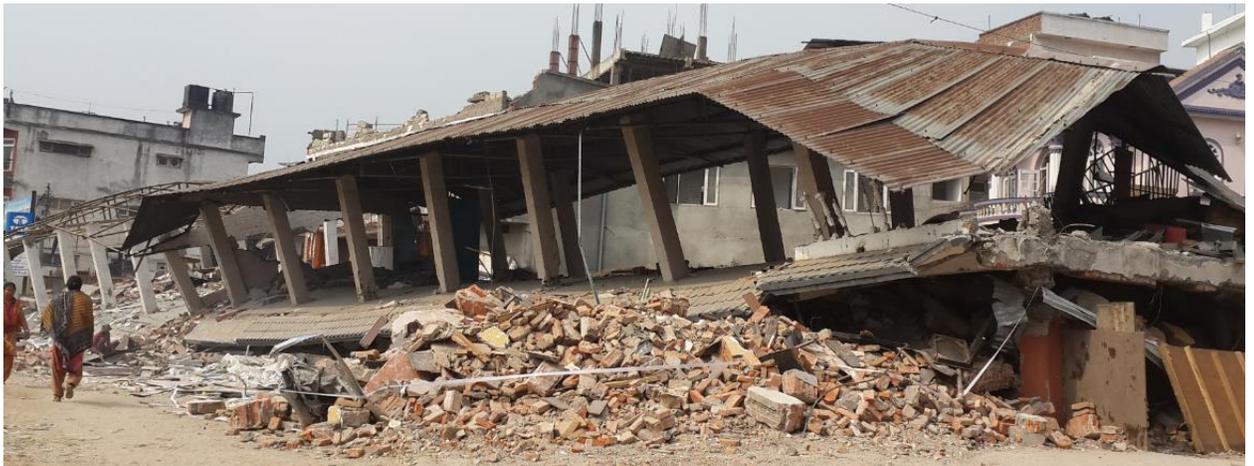
Collapse of a two storey frame structure in Sitapaila area, Kathmandu. Column base on the upper story are also damaged.

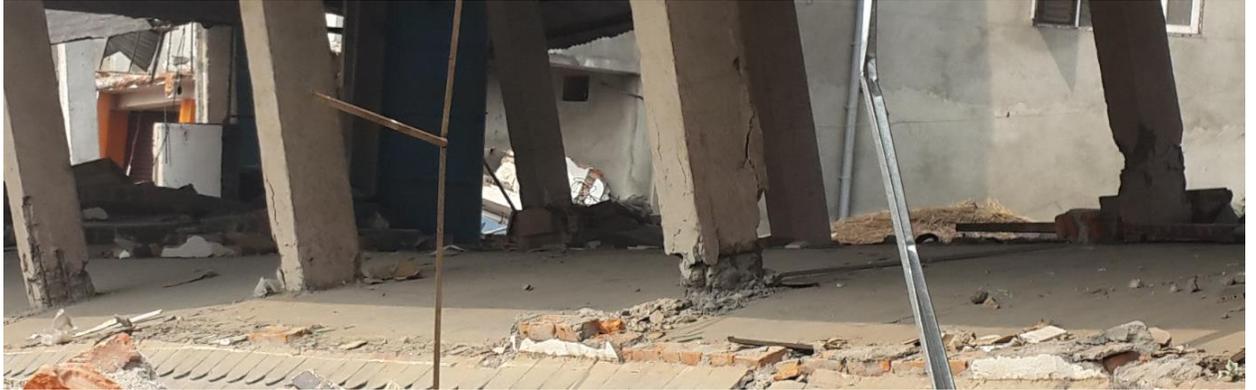
Damaged column bases on upper story of the previous building.

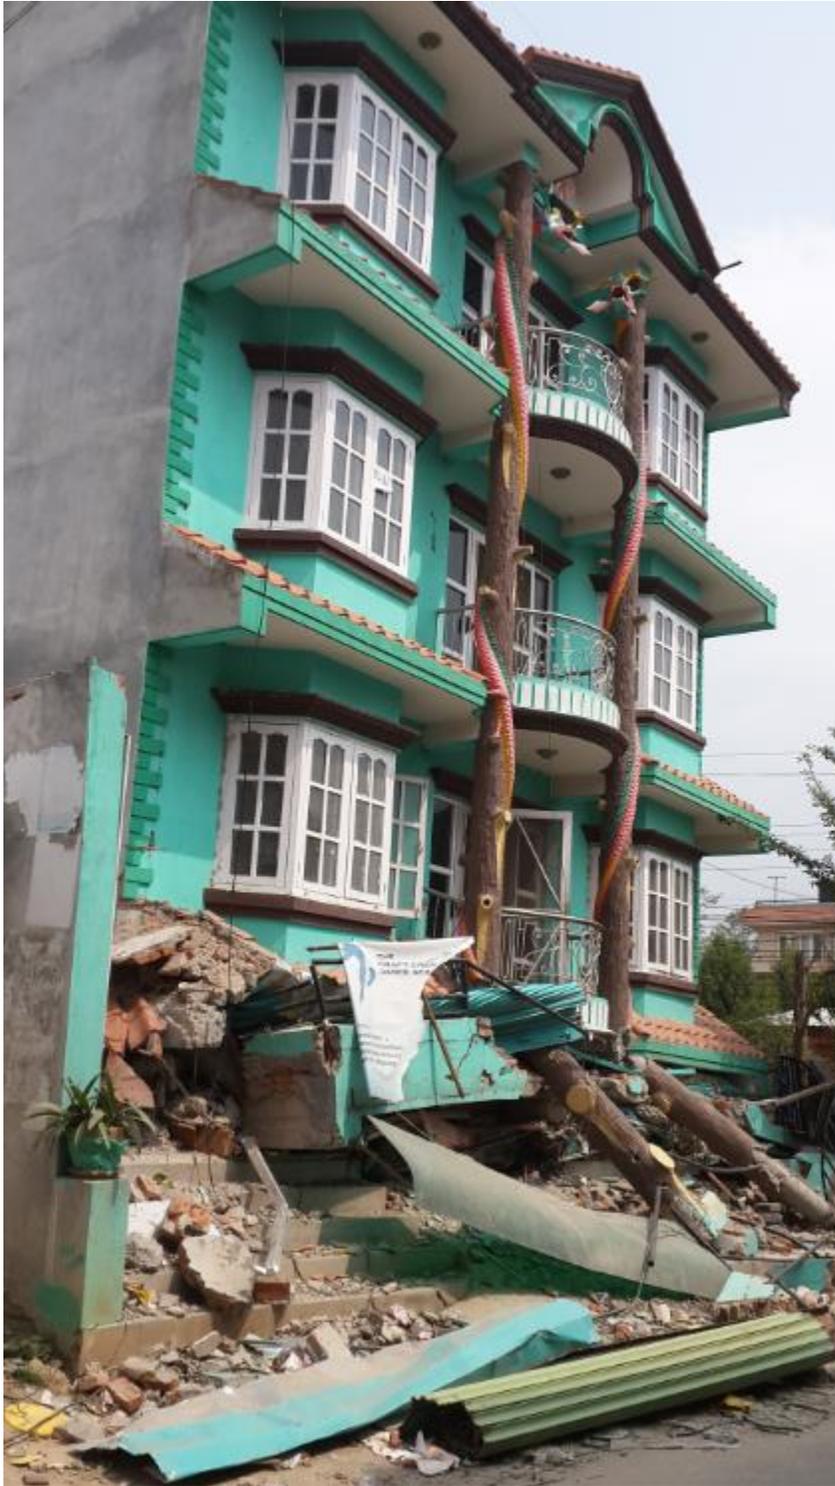
Soft story collapse of a 5 story house in Dhapasi, Kathmandu

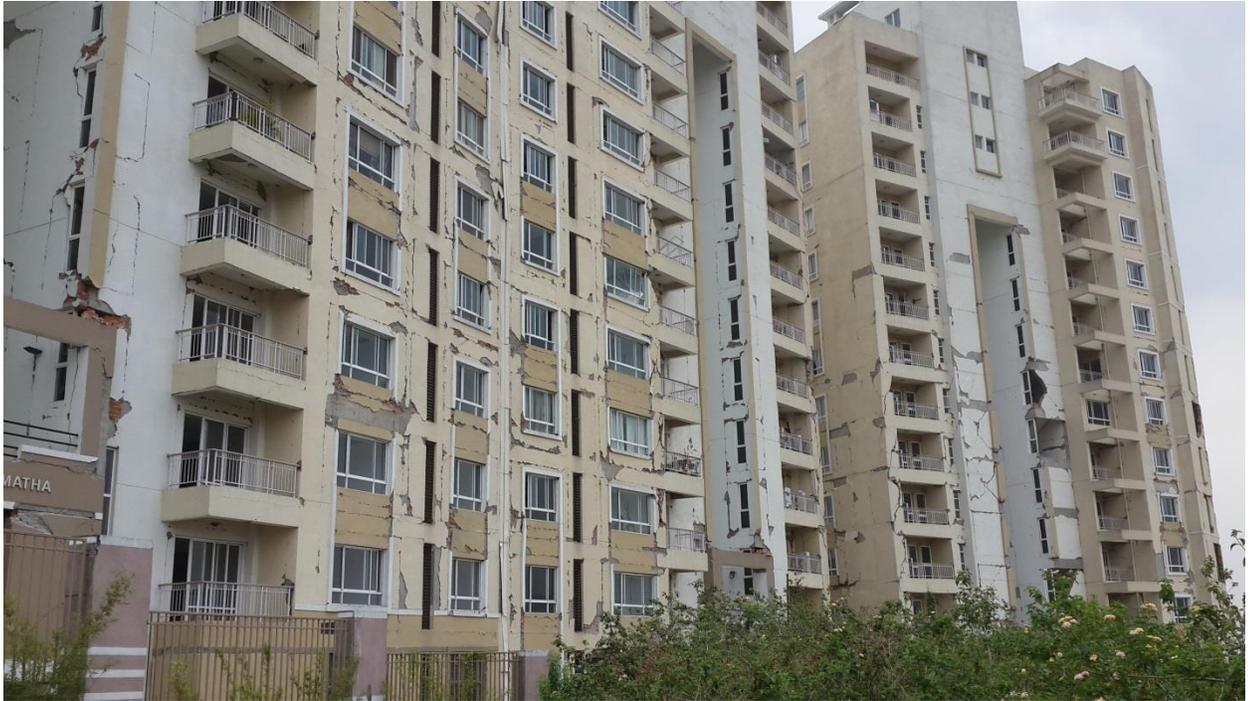
Infill wall damage of a 17 storey tall apartment building in Kathmandu (Right face of the building)

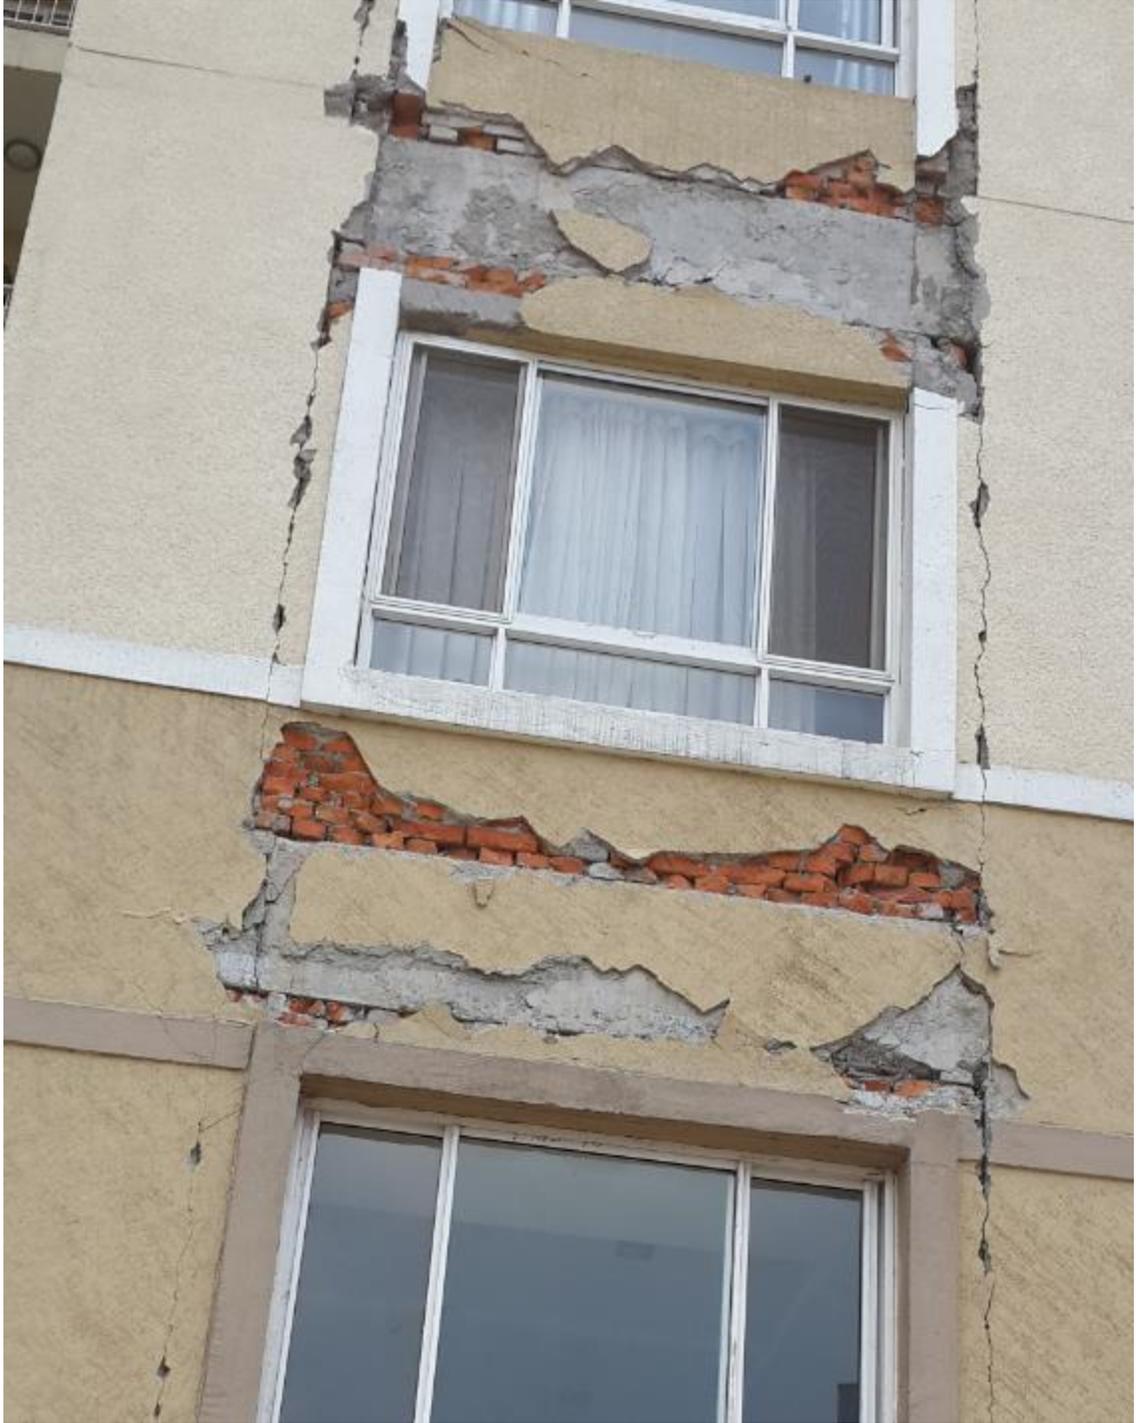
Damage in beam on left face of the building

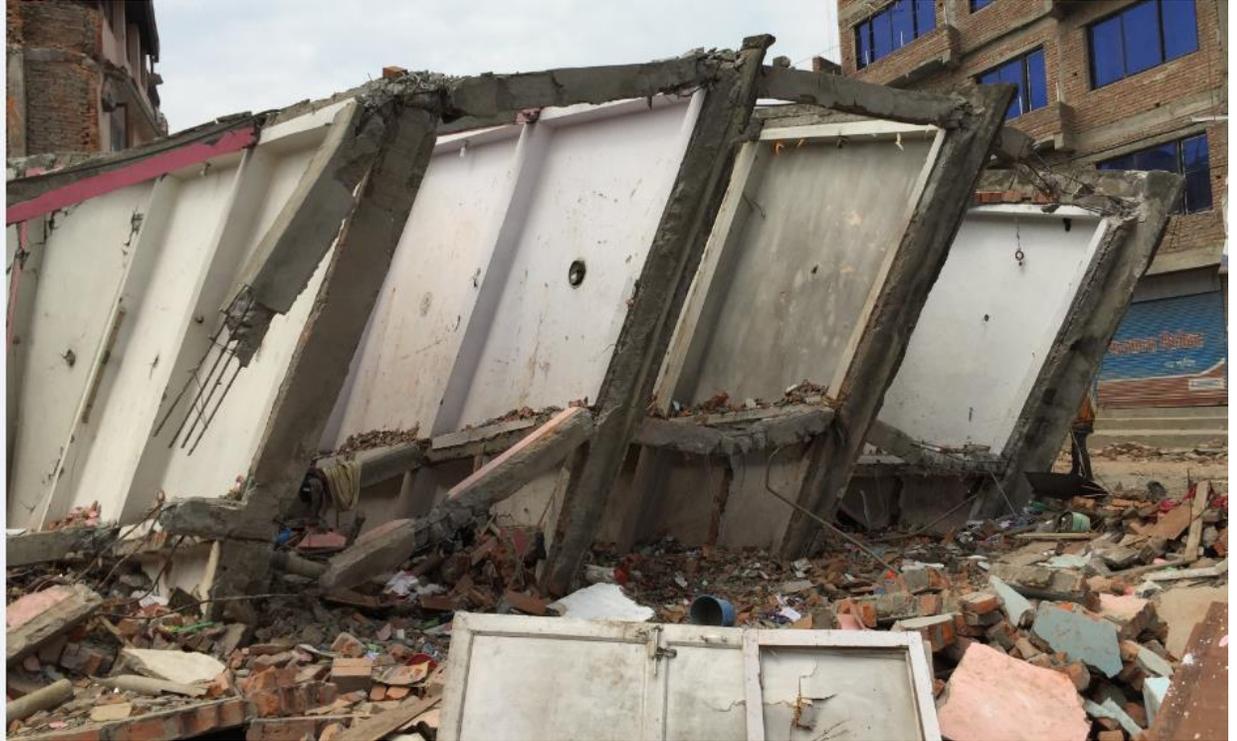
Overturning of a 7 storey tall building in Kapan area, Kathmandu

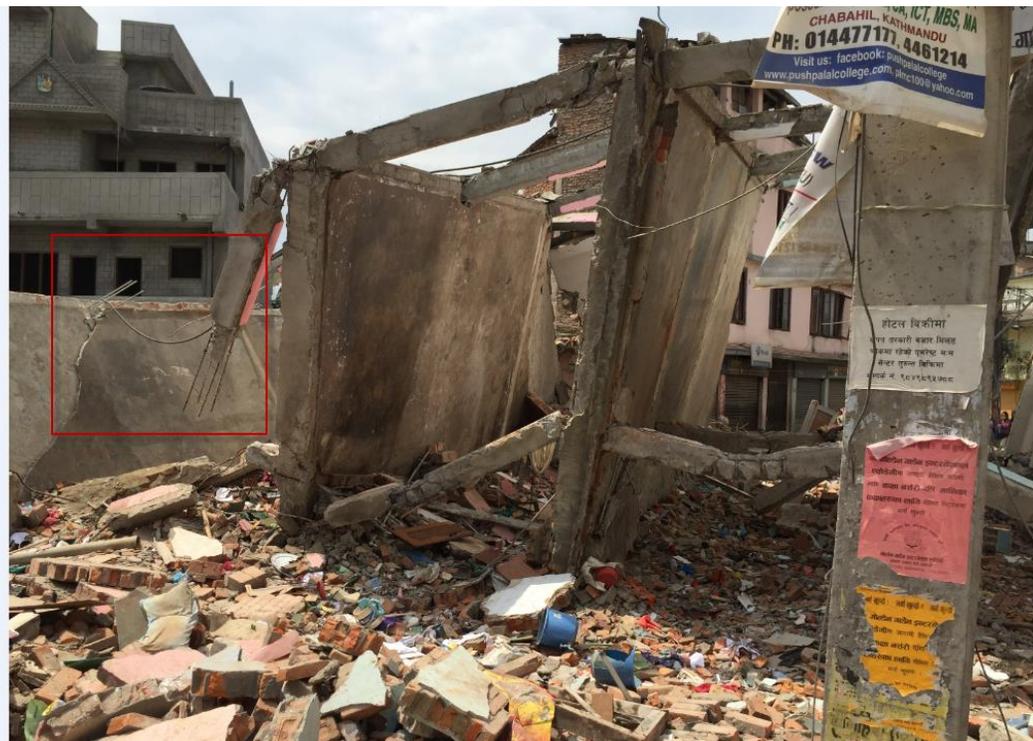
Longitudinal reinforcements were spliced at same location in the column and building overturned by lap splice failure at tension location

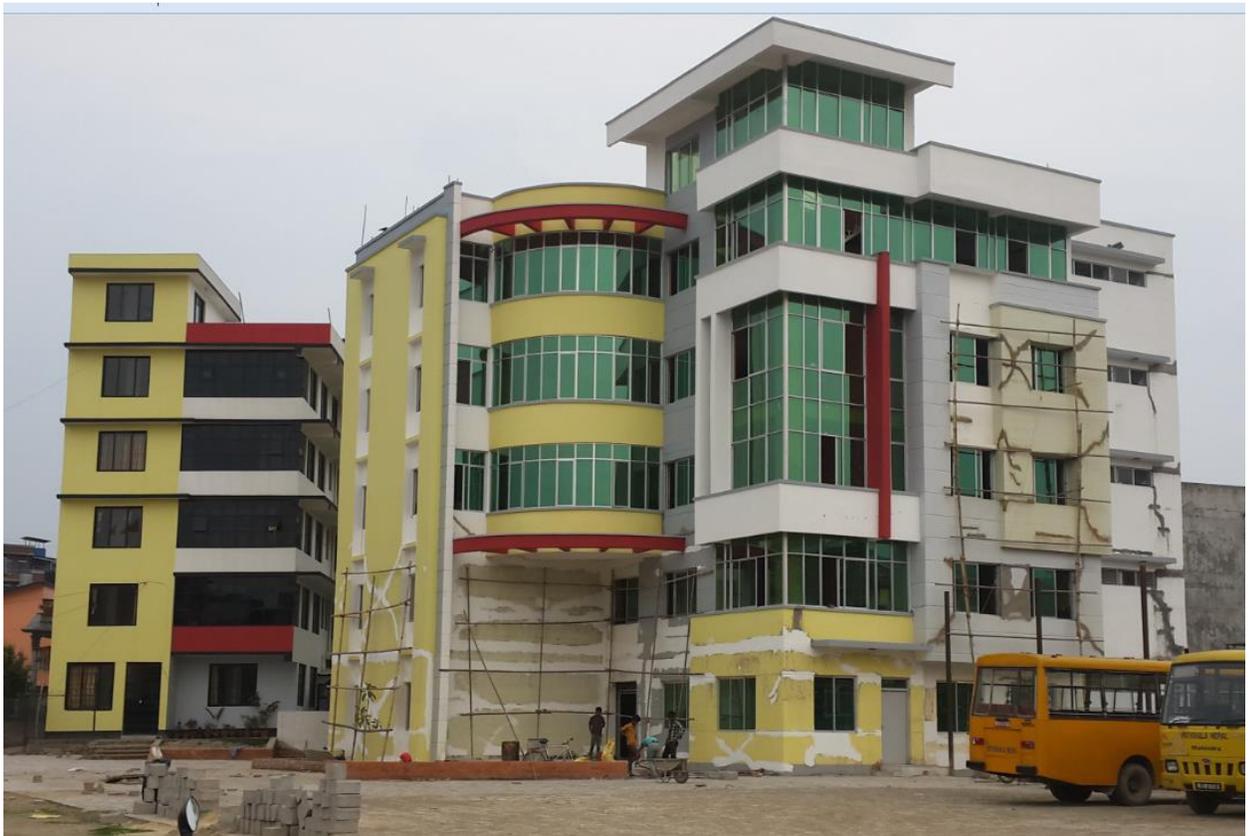
Repaired diagonal shear cracks in a school building in Imadol area, Lalitpur
