Rehabilitation and maintenance planning of Burapawithi's approach ramp, Bangkok-Chonburi expressway

Abstract : Burapawithi is the 55 km elevated expressway which connects between Bangkok and eastern seaboard. After almost 9 years of service, some highway ramps suffered the large deformation that caused the rotation of the transition boxes and question about its safety. Extensive investigation and analyses have been done including 26 soil borings, structure damage investigations, installation of instrumentations, analysis of structure and foundation safety and prediction of the affect of future settlement. It's found that only the ramps that located over the thick soft clay show the serious condition from the excessive of ground settlement. Most of the damages are not critical to the structural and foundation safety. However, the analyses show that the unappropriate repair and maintenance such as resurfacing of the pavement, might cause the failure of the transition piles. Furthermore, it's also found that the large deformation occurred in the middle of the transition zone where the pile tip of transition piles are above the stiff clay layer and float in the medium stiff and soft c

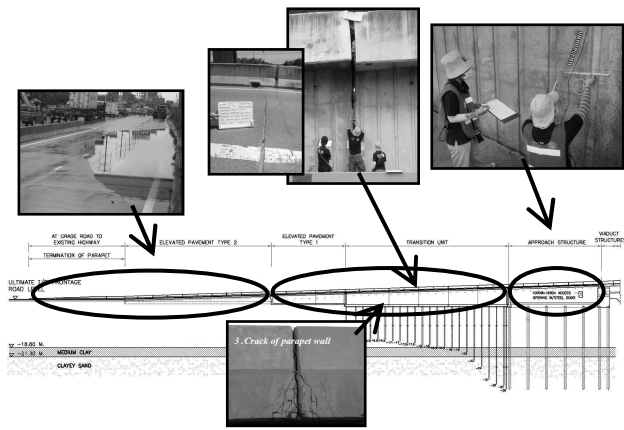
Fig. 4 Damage scenario of ramp structure

In 2008, Geotechnical research and development center (GERD) under civil engineering department, Kasetsart University is appointed by Expressway Authority of Thailand(EXAT) to investigate the problem and propose maintenance and repair plan for the highway ramps and the connecting stairs to the toll booths. The investigation found several flaws which are 1. Series of vertical cracks on the wall of approach structure, the crack width is mostly less than 0.2 mm. 2. Rotation of transition box causing the separation of contraction vertical joint and crack of ramp pavement 3. Cracking of parapet wall caused by the rotation of transition boxes 4. Flooding of elevated pavement type two from excessive settlement of this section. Figure 4 summarized the problems as described. As for the problem of the connecting stairs to the toll booths, since the stairs structure is supported by the shorter pile comparing to the supporting pile of the elevated highway, therefore the differential settlement between these two structures causing the simple span of connecting bridge section to move out of its support (Figure 5). The support have to be extended to accommodate the movement, the largest movement is about 20 cm. It also found that the ramps and staircases that have serious problem as explained are all located over the deepest area of soft clay layer which is between KM 24 to 37.

From the damage investigation it's clearly shown that the settlement of the ramp is sudden increased at 2 areas 1. at the joint between approach structure and transition unit and at the middle of transition unit where pile tip of transition system is above the stiff clay layer and tip on the medium stiff or soft clay. This can be confirmed by Figure 9 to 11 where detail movements have been collected. Questions has arisen that whether the consolidation has been finished or what is the current degree of consolidation of soft clay due to the structure load. One dimensional consolidation analysis based on

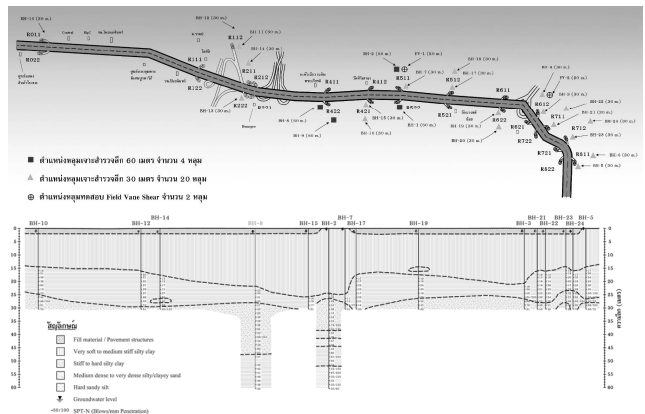
Fig.6 Subsoil layers along the elevated highway

In order to understand the subsoil condition, 20 of 30m deep boreholes and 2 vane shear tests were done. 4 of 60m deep boreholes were also done in the most critical ramps. Figure 6 shows the subsoil layers from bore holes data. It can be seen that the ramp and staircase structures that found to be in serious condition are located where the soft clay later is the thickest. Also the compression index(C_c) between KM 24 to 37 is found to be in a high value of 1.2-3.0 and the coefficient of consolidation(C_v) value is found to be 10^{-6} to 10^{-4} cm^2/sec where other section C_c is found to be about 0.2-1.0 and C_v is about 10^{-4} to 10^{-2} cm^2/sec (Figure 7). Furthermore, to see the effect of consolidation from the elevated pavement and at grade section, boreholes were drilled near the elevated pavement and outside the highway where undisturbed soil shall be found. Figure 8 clearly shows the consolidation effect in the upper soft clay layer where water content of the soil under elevated pavement is squeezed out causing lower in water content and higher in undrained shear strength comparing to the undisturbed zone.

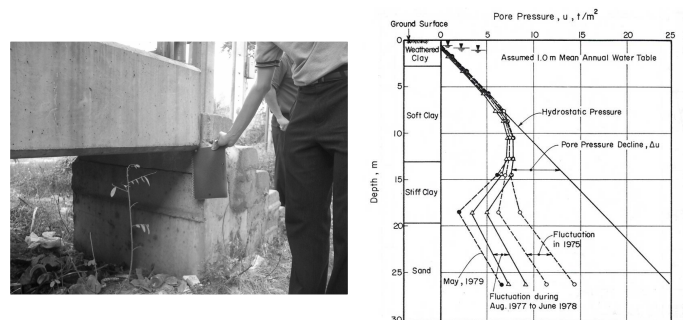
Fig.12 Evidence of ground subsidence near the staircase and record of piezometric drawdown in Suwanaphom airport (AIT, 1978)

conventional Terzaghi's theory has been used to calculate the settlement behavior along the transition unit and elevated pavements. Piezometric drawdown effect due to ground water pumping was also considered for calculating the applied effective stresses for consolidation settlement. The evidence of ground subsidence due to ground water pumping can be seen everywhere along the highway as shown in Figure 12. The rate of average ground subsidence estimated from the previous figure is about 4.5 cm per year. Piezometric drawdown recorded from Suwanaphom airport which located near by the studied site was used.

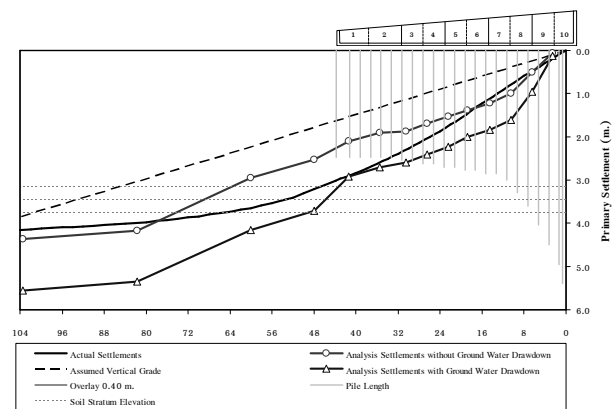
Fig.13 Calculated profile grading considering with and without piezometric drawdown effect comparing with present profile grading

The calculated profile grading of the most critical ramp, with and without considering the effect of piezometric drawdown is shown comparing with the current profile grading in Figure 13. The calculated profile grading is analyzed based on end of primary settlement. It can be seen that piezometric drawdown has less effect on the ramp section where longer pile which tip on the stiff clay or dense sand are used and also has less effect on the elevated pavement as well. However, it has a great effect on the ramp section where pile tip is in the medium stiff and soft clay. As for the rate of consolidation it's found from the analyses that at the present time, when the highway has been using for 9 years, the settlement has approached the end of primary consolidation stage (Figure 14).
