Investigation of Slope Instability of a Concrete-Faced Slope in Chiangrai

Keywords: slope stability, fill, concrete face, piezometer, pore water pressure

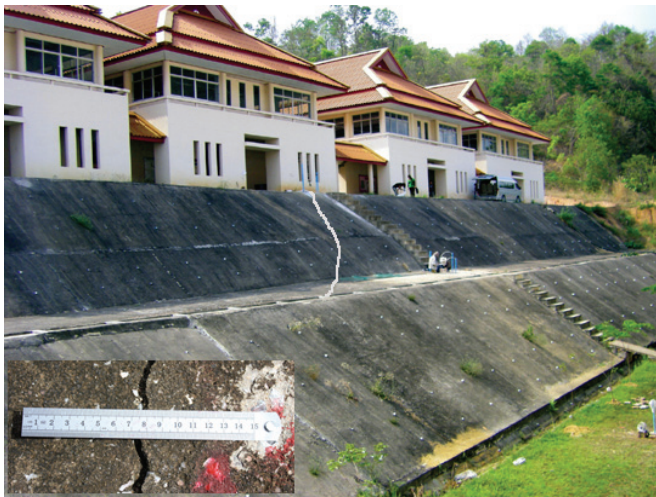
In particular, signs of distress and movement have been observed on the concrete-faced slope where the laboratory building of civil engineering department was located (Figure 2). The fill slope was constructed in 2002 and faced with concrete slab (5 cm thick) on beam (25cm thick). The concrete face was seated on the slope without internal drainage. Only short weep holes (5cm in length) were provided on the concrete

slab at about 2 metre spacing. Nevertheless, majority of these holes appear to be clogged only a few years after their construction.

Figure 2: Studied slope and crack observed on concrete face.

The proposed stabilization technique of the slope is the installation of perforated pipe as drainage which could increase the factor of safety by about 16%. Further investigation is required on the effectiveness of this method as well as the possibility of the dispersivity of the material involved.

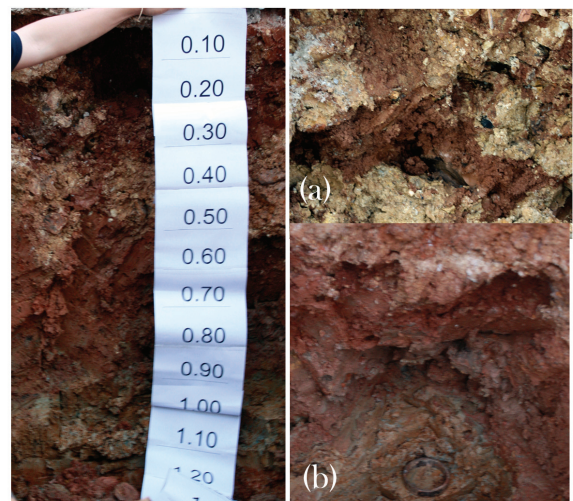
As shown in Figure 4, the soil under the concrete slab on the upper slope, especially near the ground surface, appeared loose with a high water content. The material near upper slope (Figure 4a) is classified as poorly graded gravel with low plasticity clay (CL) while those near the lower slope (Figure 4b) is classified as low plasticity clay (CL) with high moisture contents.

Figure 4: Soil profile under concrete slab.

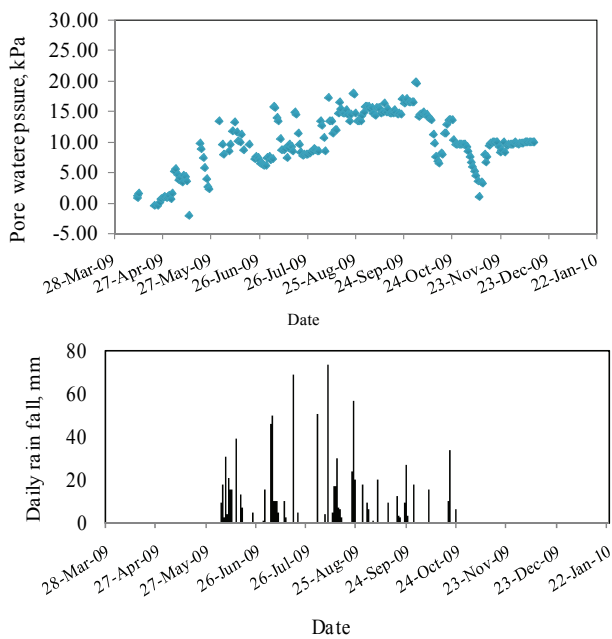
Typical results of pore water pressure and rainfall during the monitoring period from 10th April to 30th December are shown in Figure 11. During the rainy season, pore water pressure from P05 sensor increased gradually ranging from 0 to 15 kPa and then began to decrease slightly after the peak of rainfalls in the rainy season (around August). The inclinometer reading show some steady movement of the slope during the monitoring period as shown in Figure 12. The slope movement seems to be at a creeping rate, corresponding to the high ground water table. This observation is similar to the pattern of creeping slopes in Doi-Tung development project as described by Jotisankasa & Soralump (2008).

Figure 11: Pore water pressure and daily rainfall.

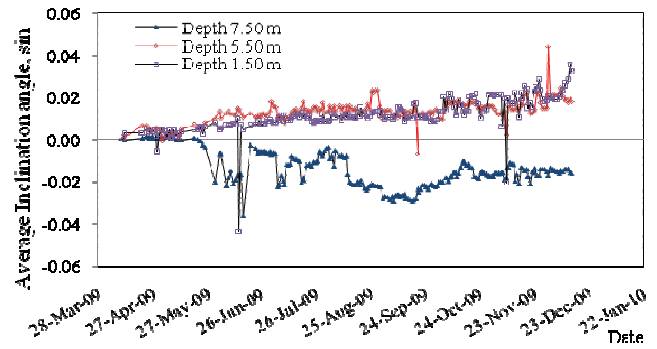
Figure 12: Inclination at various depths and time.

show some steady movement of the slope during the monitoring period corresponding to high ground water table.

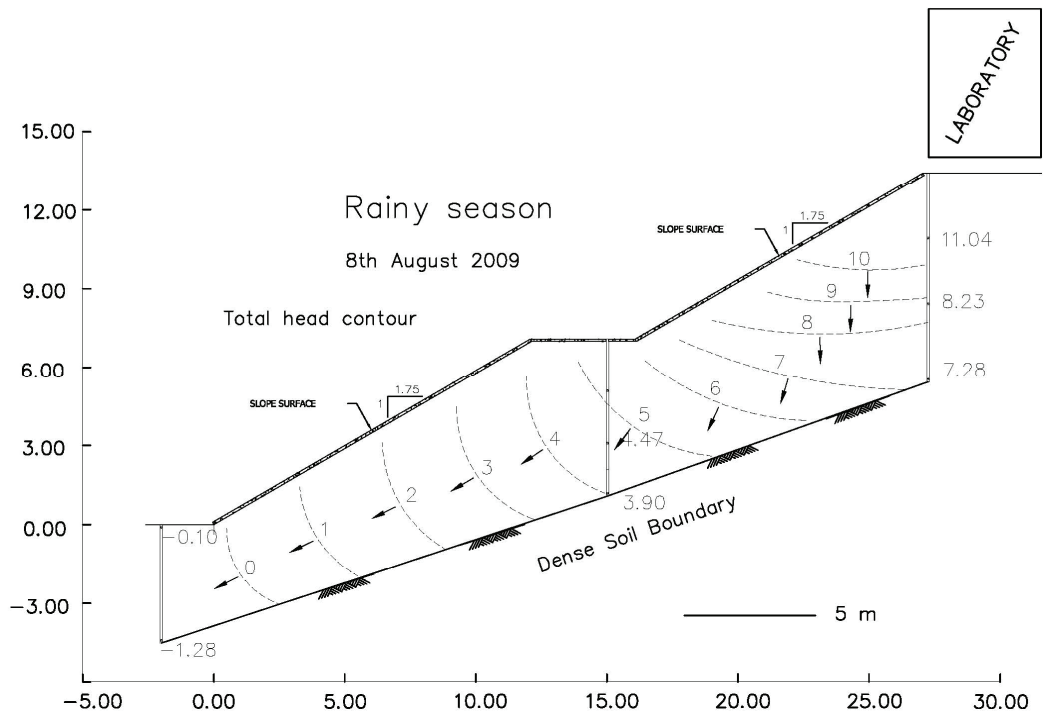
Based on the readings of piezometers and tensiometer at section 2 during rainy season (8th August 2009) and before dry season (8th December 2009), the total head contours were plotted in order to indicate the approximate flow line or the seepage directions (which is normal to equipotential line) as shown in Figure 13 and 14. It is clearly shown that the total head contours and seepage direction did not differ much between 8th August and 8th December 2009, suggesting the steady ground water level in the slope under the cover of concrete slab.

Figure 13: Total head contour (metre) and seepage direction during rainy season.

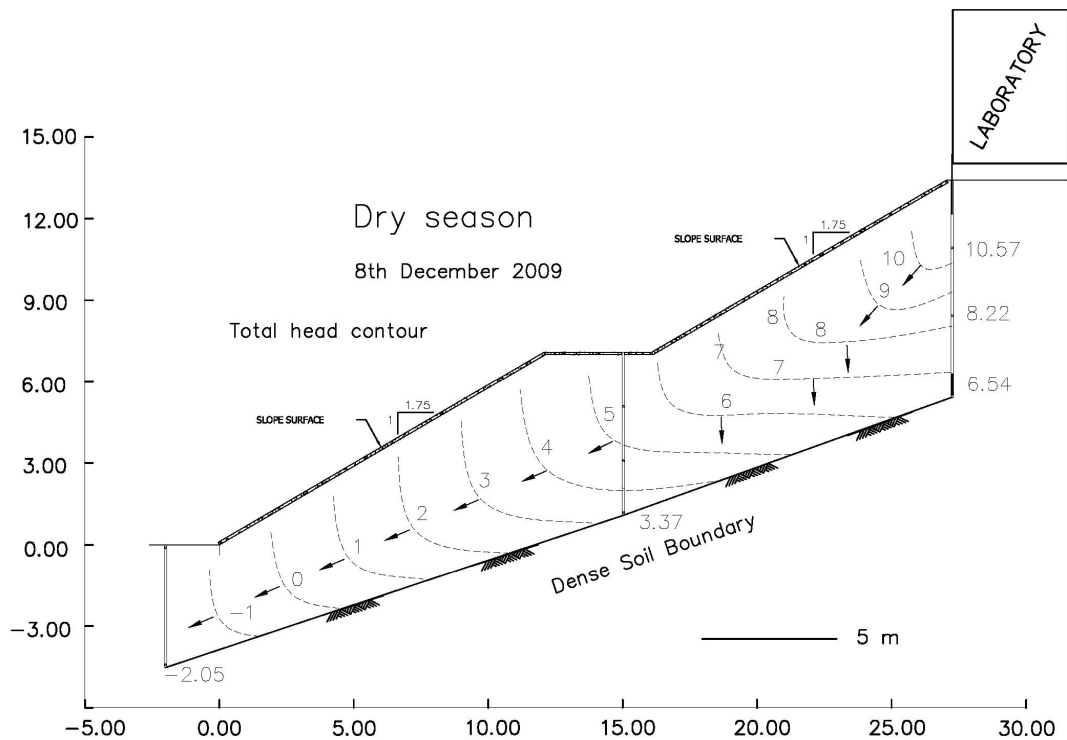
Figure 14: Total head contour (metre) and seepage direction before dry season.

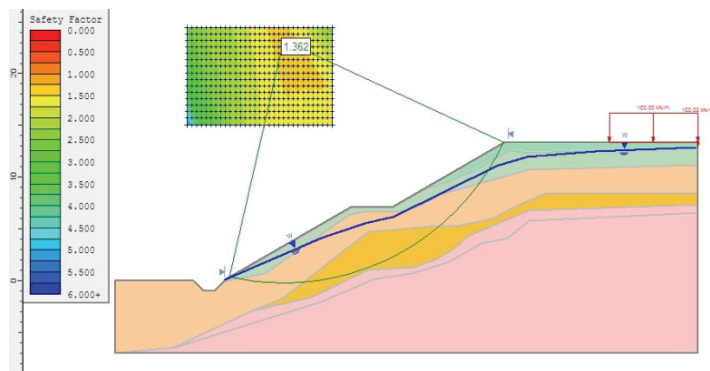
The analysis results for case (i) shows that the global factor of safety is 1.362 (Figure 16). With the ground water level lowered as in case (ii) the factor of safety is increased to 1.582 (Figure 17). The results show that the drainage system proposed could increase the factor of safety by about 16% as a result of increase in effective stress and shear strength. Whether this increase in Factor of safety could lead to cessation of the bulging and cracking of the slope is yet to be confirmed. Nevertheless, the dispersivity of the fill materials (Sherard et al., 1976) should also further investigated in order to ensure that the drainage principle will stabilize the slope and not causing further dislodging of fine particle or internal erosion from the slope.

Figure 16: Slope stability analysis – slope without stabilization.

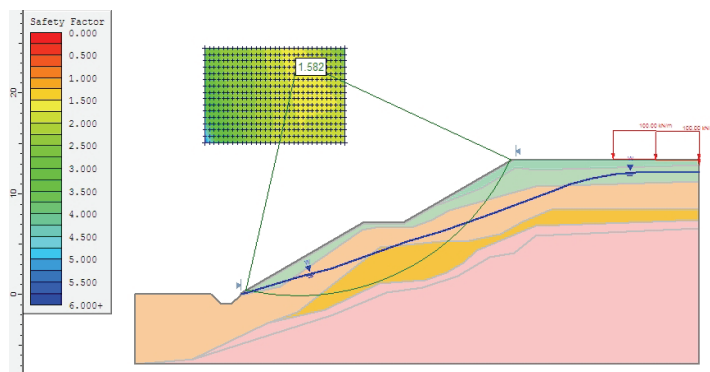
Figure 17: Slope stability analysis – slope with stabilization.
