Research Paper

Damages and causative factors of 2015 strong Nepal Earthquake and directional movements of infrastructures in the Kathmandu Basin and along the Araniko Highway

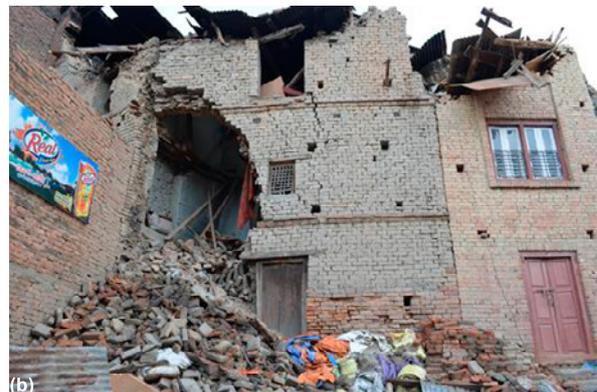
Fig. 2. April 25 main shock and May 12, 2015 aftershock contributed to intensive damages on old aged buildings. Photograph represents areas from (a) Bhatkpur and (b) Sankhu.

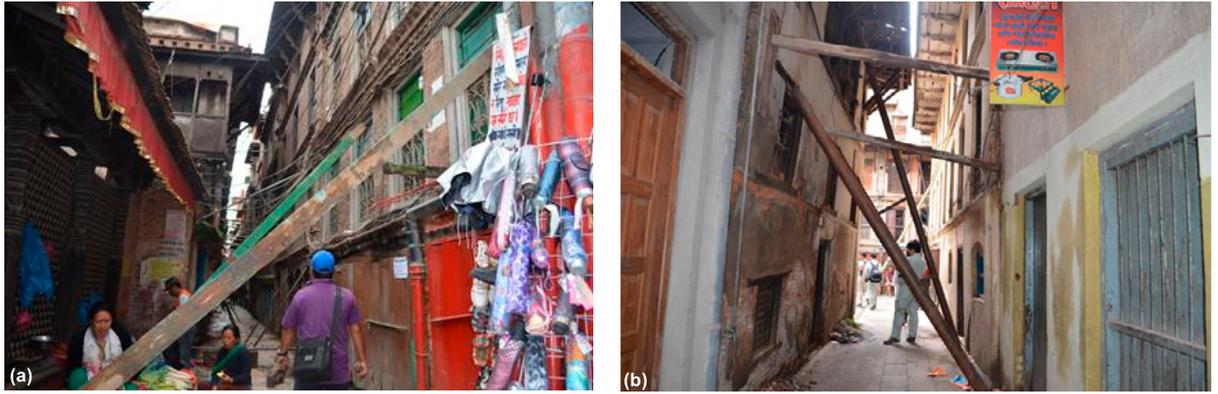
Fig. 3. Iron and wooden frames are used to give support on the narrow streets of south Durbar square. Clusters of old aged, renovated buildings combined with RCC buildings are distributed along this narrow streets. Most of the houses remain intact from support interconnected with each other.

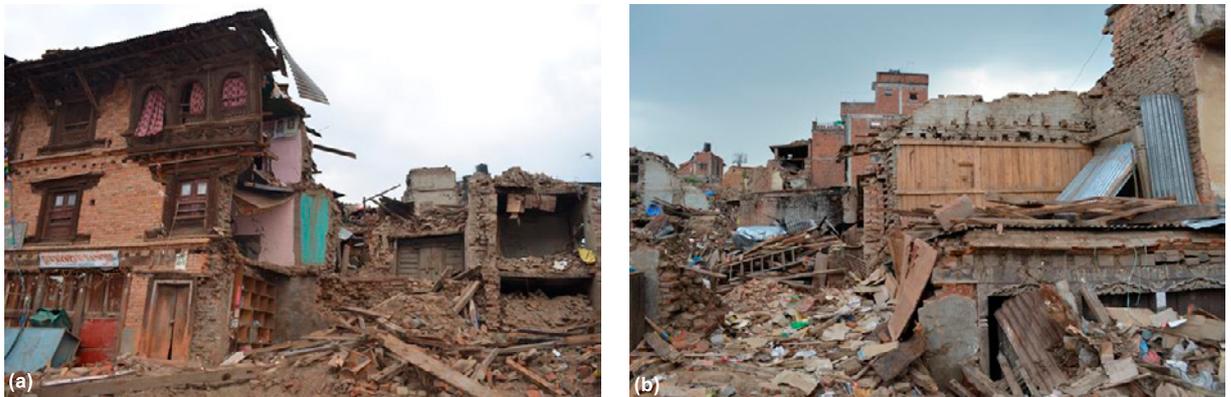
A section of Kathmandu extending 17 km along north-east corner contains an ancient city believed to be 3147 years old and the first developed town, long before Kathmandu city according to local people we surveyed. The city lies within the Kathmandu district of Shankharapur Municipality. Like Kathmandu Durbar Square, this is another typical Newar town developed with a long chain of inter connected row houses with typical history (<https://en.wikipedia.org/wiki/Sankhu>). Similar damage conditions can be clearly observed throughout the section (**Fig. 4**).

Fig. 4. Damages on ancient Newar town of Sankhu area.

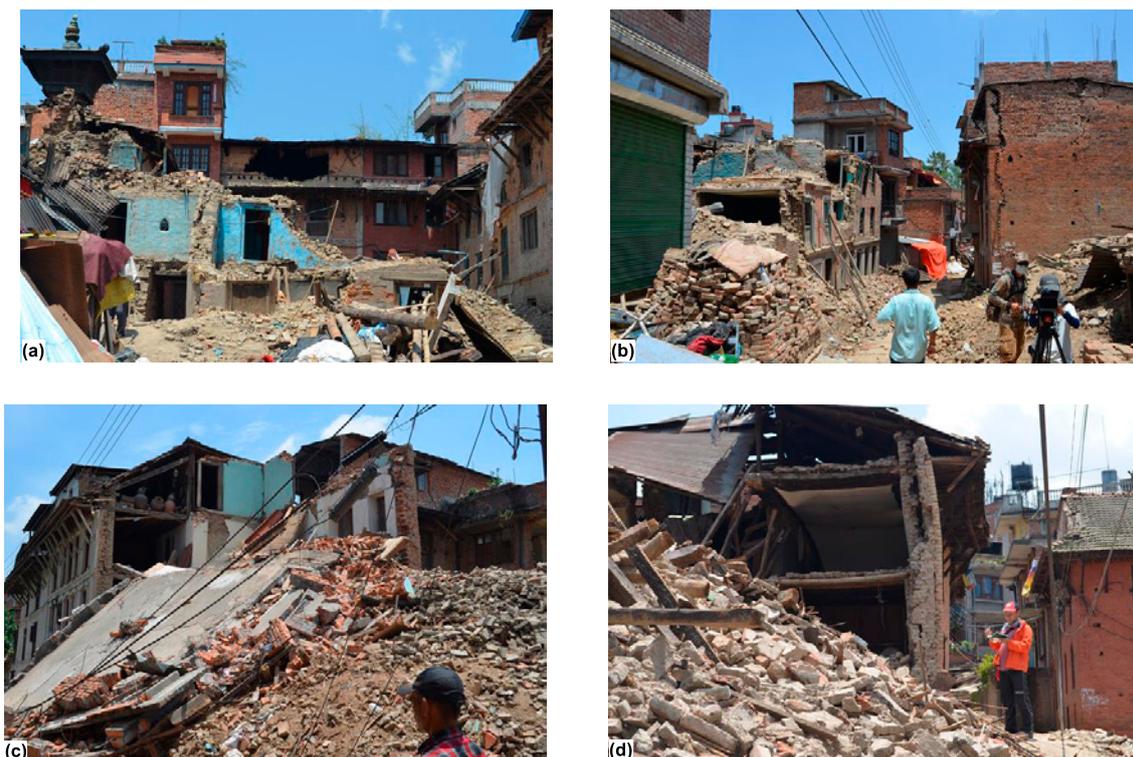
Fig. 6. Entire Newar ethnic town of Bungamati was damaged due to main shock and aftershock. This place is enriched in wooden handicraft business and UNESCO announced the area as the World Heritage sector.

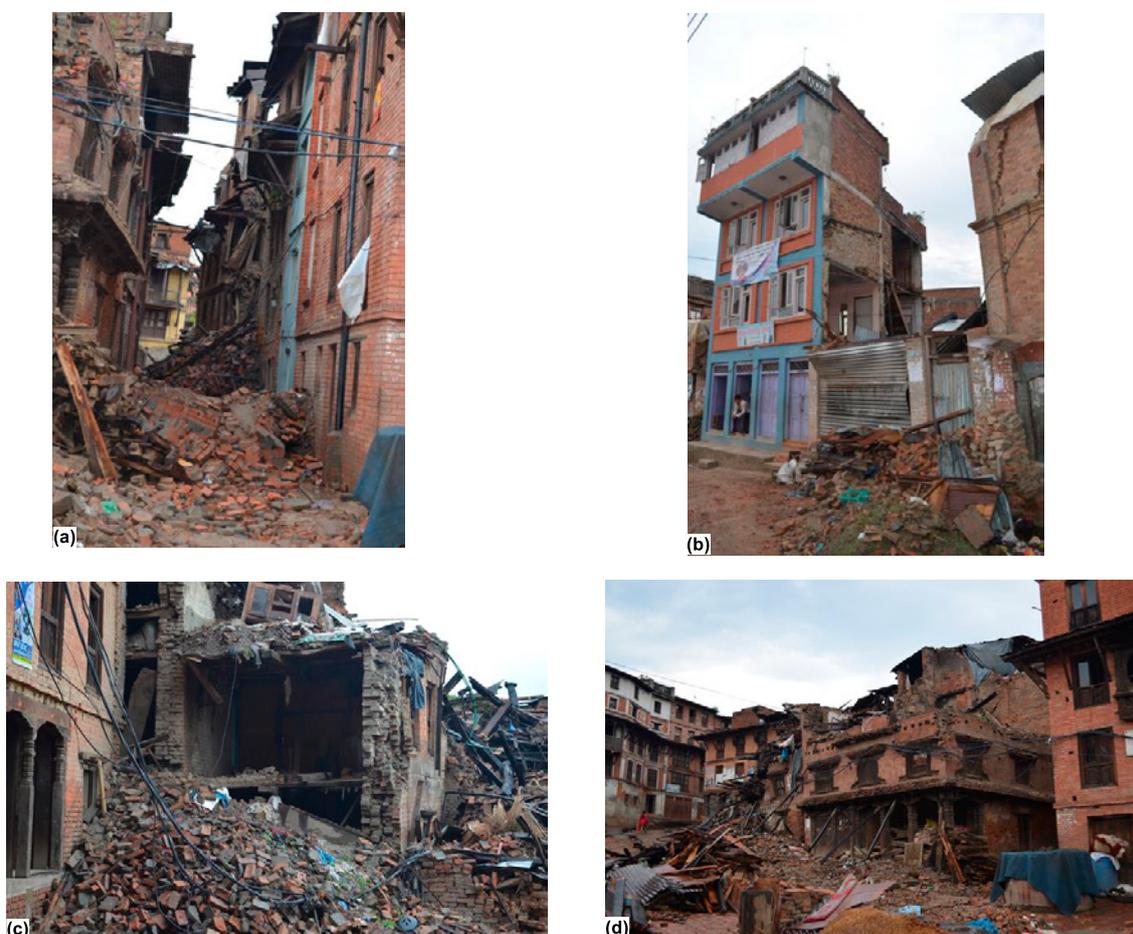
Bhaktapur District belongs to the most attractive traditional city for domestic and international tourists due to well preserved traditional architecture and cleanliness in comparison to other towns. Throughout the section several interconnected old row houses and renovated houses were partially to fully damaged. The foundation and origins of the most of the houses are more than 82 years old (**Fig. 7**).

Fig. 7. Damages around Naag Pokhari and Khala of Bhaktapur Durbar square. Many old-aged buildings were severely damaged together with occasional new buildings due to inadequate construction.

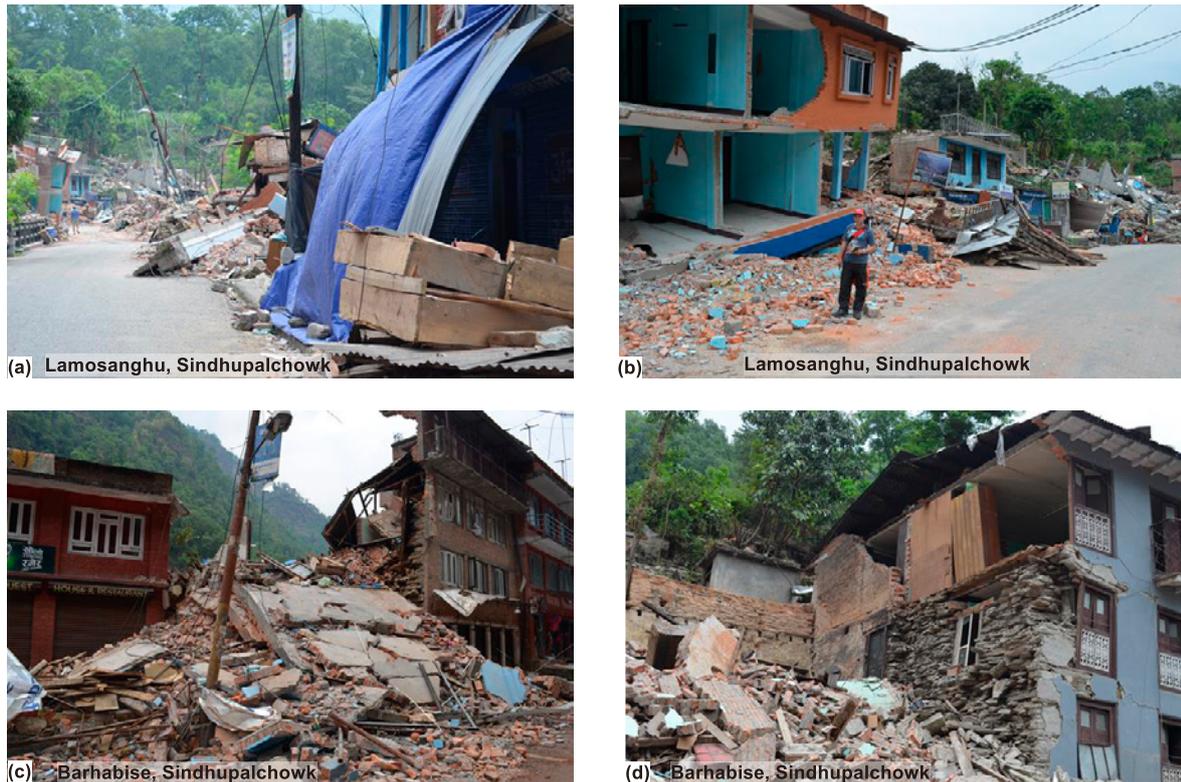
Fig. 8. Damages appeared along the Araniko Highway in Sindhupalchowk district: (a) Tilted poles and rubbles of houses can be seen at Lamosanghu area (b) Soft-story failure in RCC building at Lamosanghu, (c) Total collapse of concrete building at Barhabise, and (d) Debris of houses and severely damaged stone wall house at Barhabise.

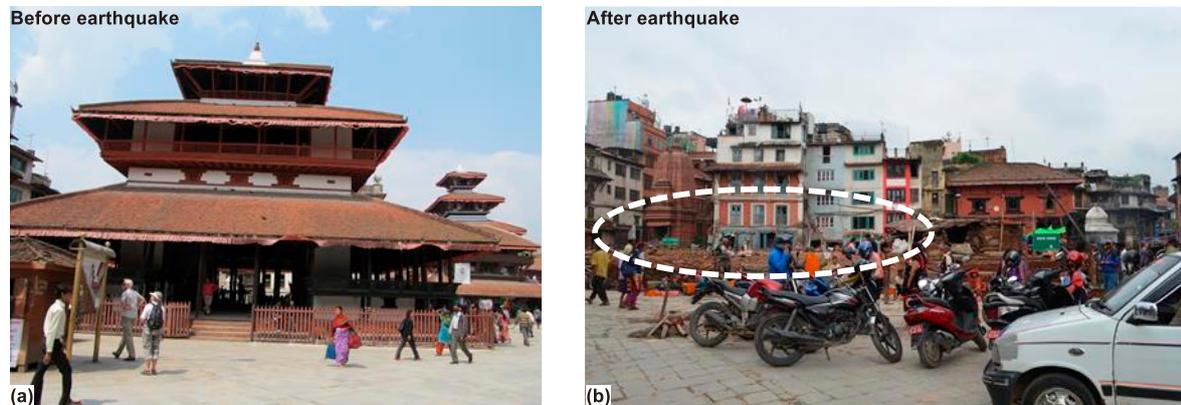
Fig. 9. Photograph representing Kasthamandap (Maru Satah): (a) Before earthquake (Courtesy: Wikipedia) and (b) After the earthquake. The name of the Capital Kathmandu is originated from this historical shrine.

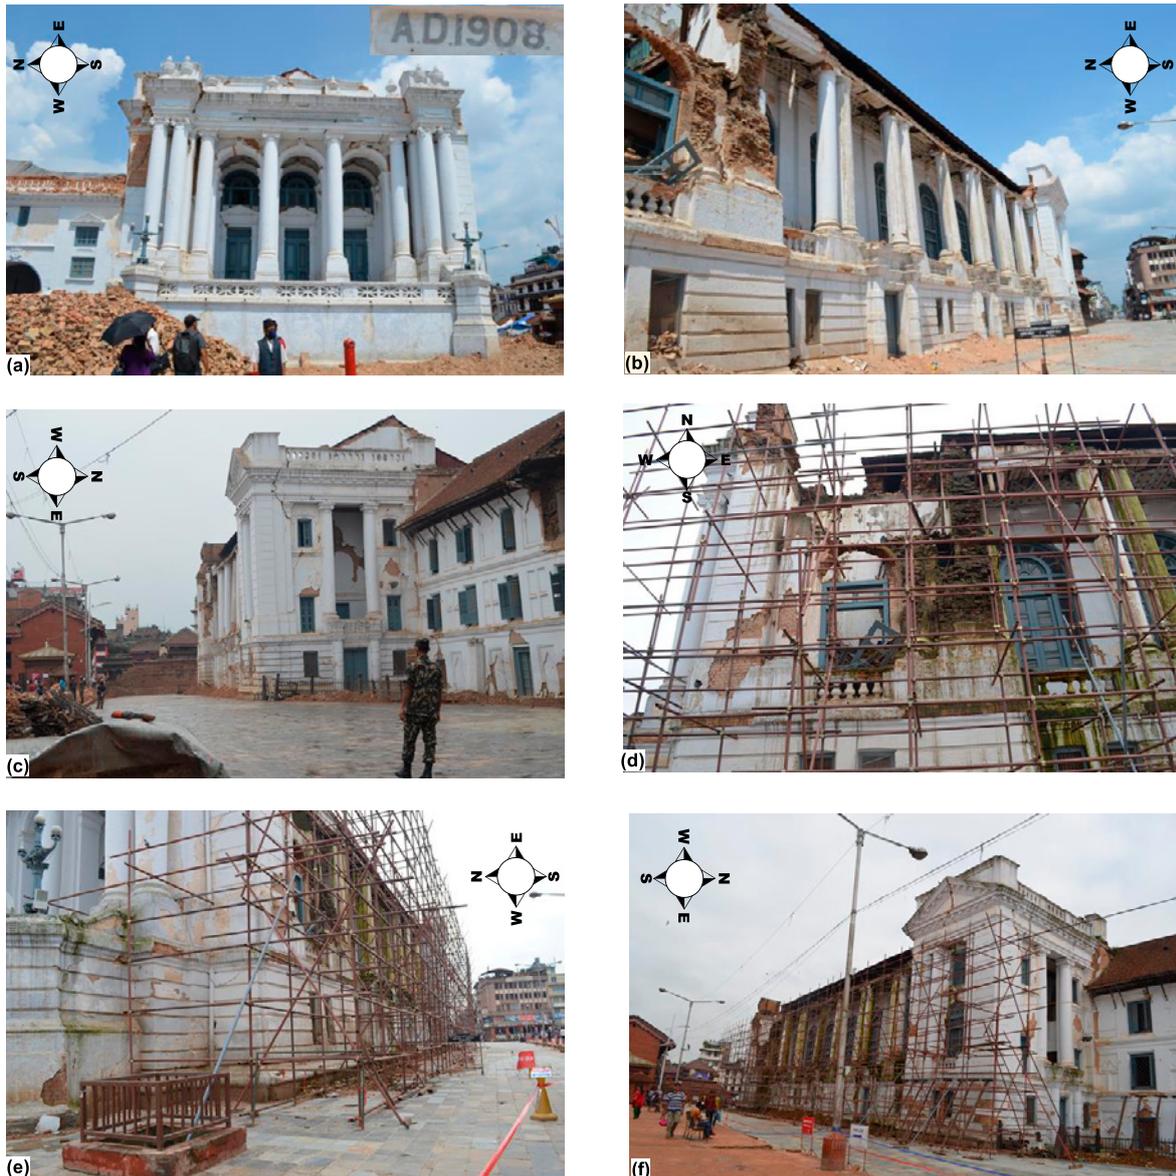
Furthermore, the White Palace (Lal Baithak) built by British Government on 1908 AD. during Rana regime was severely damaged (**Fig. 10**). The Northern and northeastern side contains the former royal palace. Not only the Nautale Durbar (also known as Basantapur tower) and Hanuman Dhoka but also most of temples and monuments of Malla Dynasty have been severely affected through earthquakes (**Figs.11, 12, 13 and 14**).

Fig. 10. British Government constructed this White Palace in 1908 AD. It was extensively damaged during the quake. Photographs (a), (b) and (c) represent the survey immediate after the main shock and aftershock in the month of May, 2015 while photographs (d), (e) and (f) show the rod framework supports on both sides of the palace to protect from immediate collapse. The photographs were snapped during the second survey on July 21, 2015.

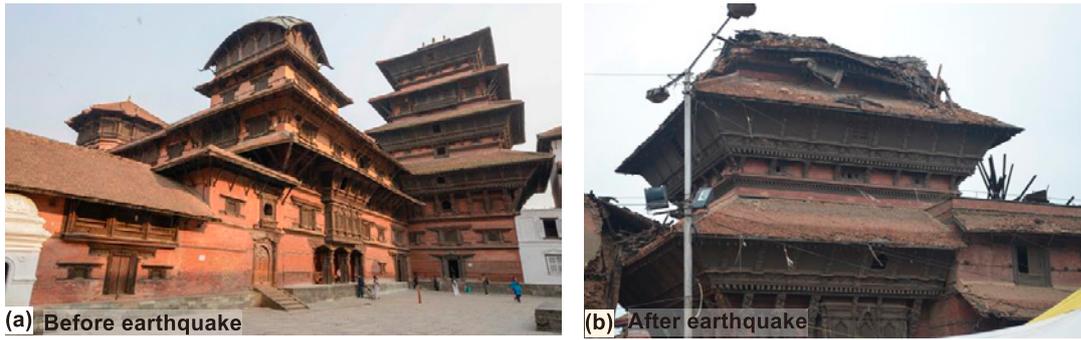
Fig. 11. Nyatapola (Basantapur tower) (a) inner premises of the former royal palace, a recent museum (Courtesy: Wikipedia) and (b) damages occurred at the roof and adjacent parts.

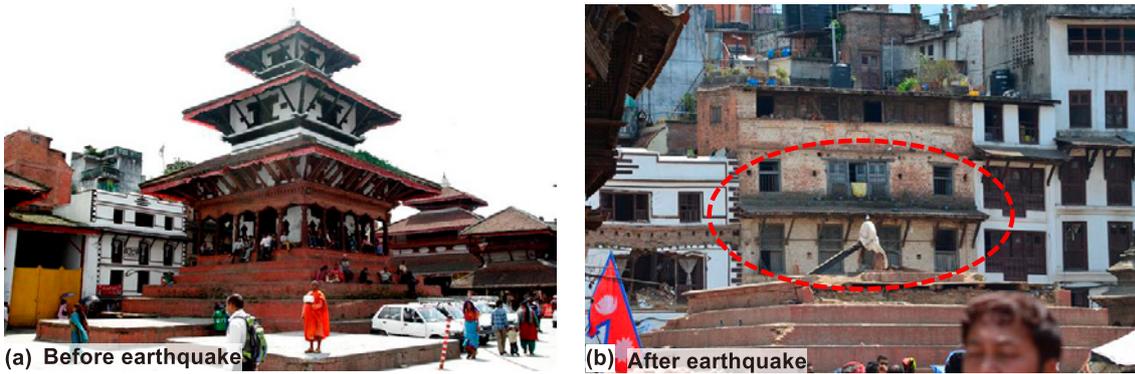
Fig. 12. Trailokya Narayan Mohan temple (a) before the quake (Courtesy: <http://hanumandhoka.gov.np/>) and (b) collapsed all three-stories after the quake.

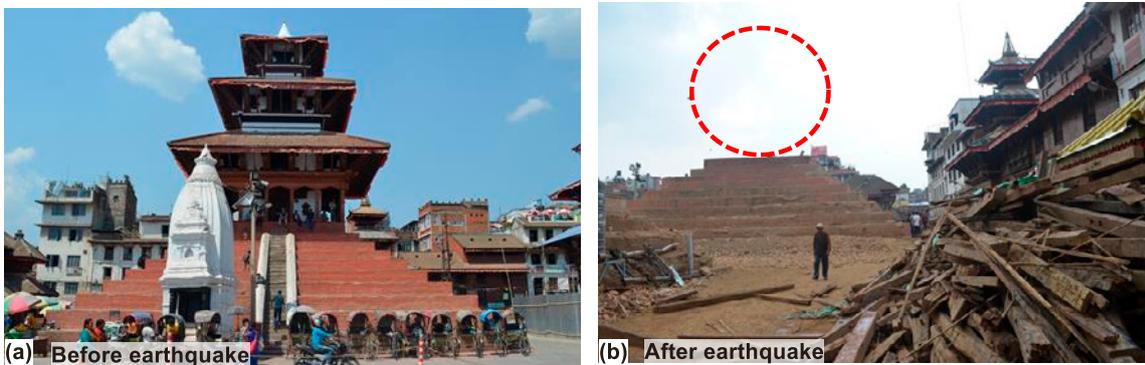
Fig. 13. Maju Deval temple built in 1690 A.D. (a) before the quake (Courtesy: <http://hanumandhoka.gov.np/>) and (b) collapsed all three-stories after the quake.

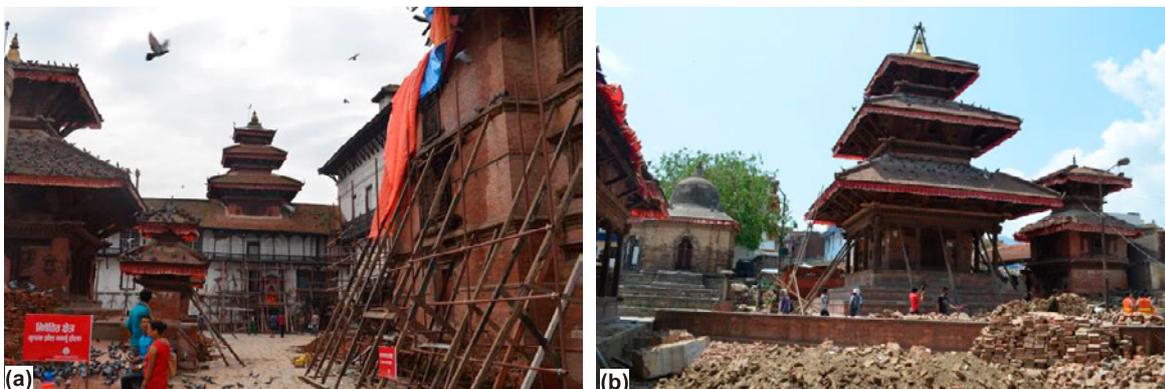
Fig. 14. Damages at (a) Hanumandhoka and (b) around Hanumandhoka.

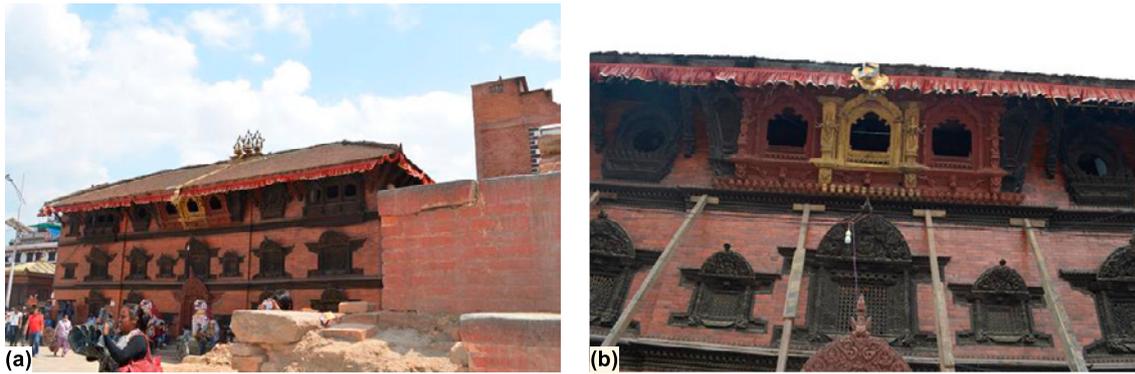
Besides, the Kumari Ghar, the House of the Living Goddess which was first built in 1757 by King Jaya Prakash Malla has been partially damaged during the seismic shaking (**Fig. 15**). The Kumari is a young girl who is believed to be the incarnation the Hindu goddess Durga, aged in between three to five from the Buddhist Shakya clan. The cult of the Kumari is popular in both Hindus and Nepalese Buddhists (Reed, 1999).

Fig. 15. Kumari House (a) first survey in the month of May 2015 without support and (b) the survey of July 2015 after wooden bracing support was added.

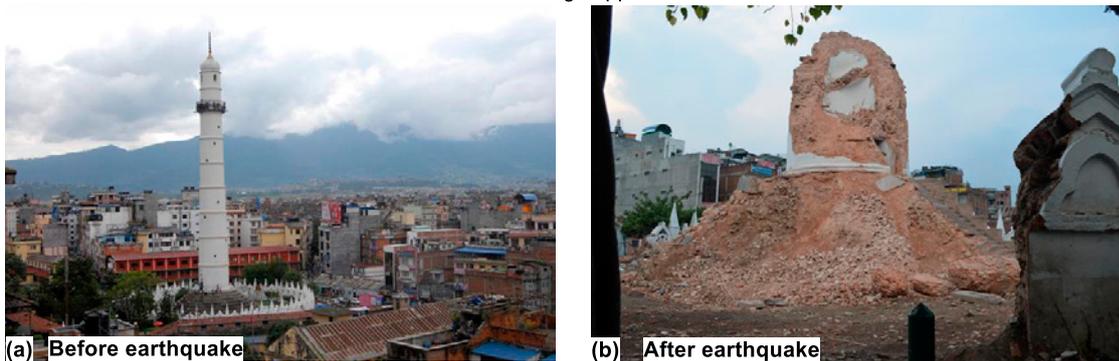
Fig. 16. Bhimsen Tower also called Dharahara (a) before the quake (Courtesy: <http://www.nytimes.com/>) and (b) collapsed after the quake.

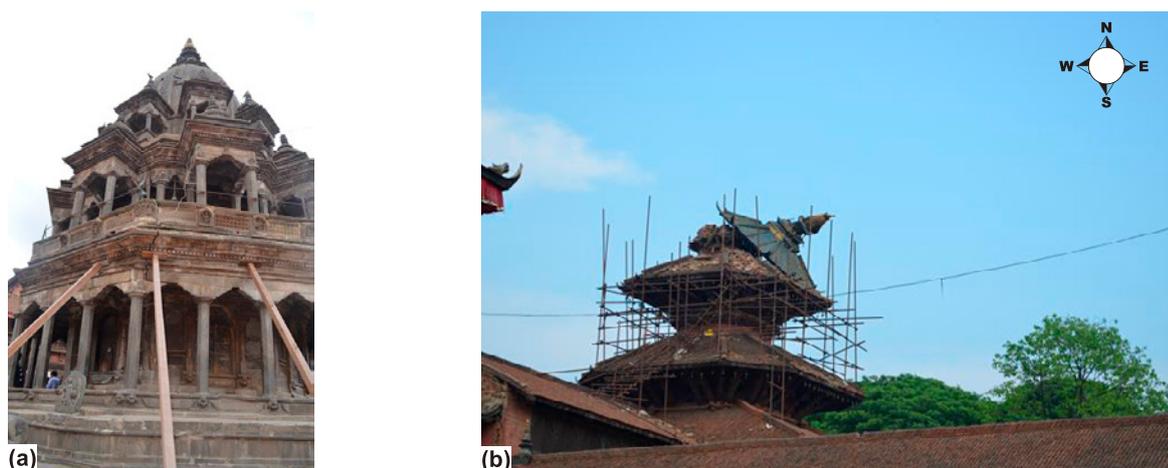
Fig. 17. Damages in Patan Durbar Square (a) Chyasim Deval Krishna Mandir and (b) toppling of the temple top in the east direction.

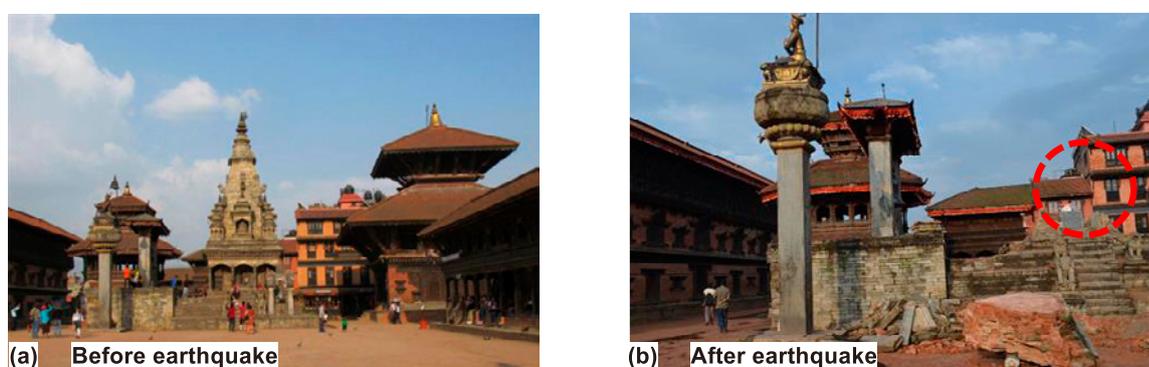
Fig. 18. Bhaktapur Durbar Square premises (a) Vastala temple, before the quake (Courtesy: <http://www.nytimes.com/>) and (b) collapsed after the quake.

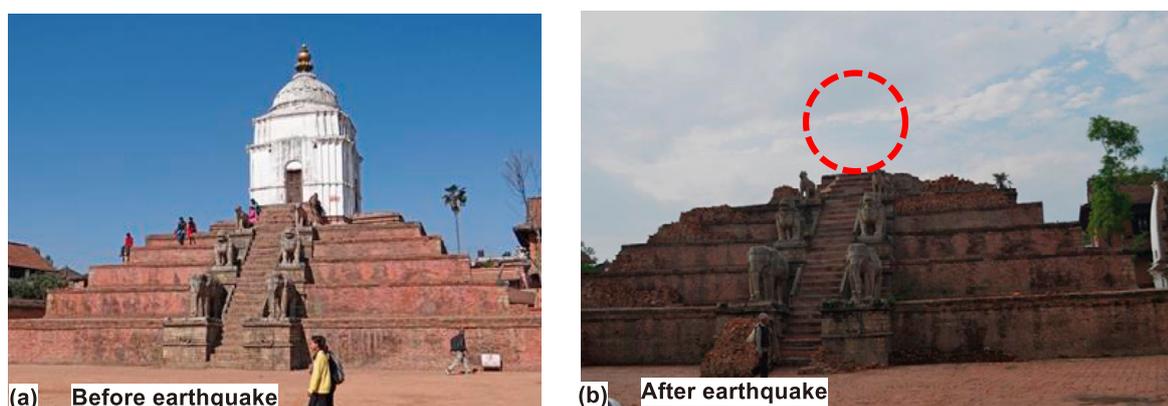
Fig. 19. Fasidega Temple in Square (a) before the quake (Courtesy: <https://commons.wikimedia.org>) and (b) collapsed after the quake.

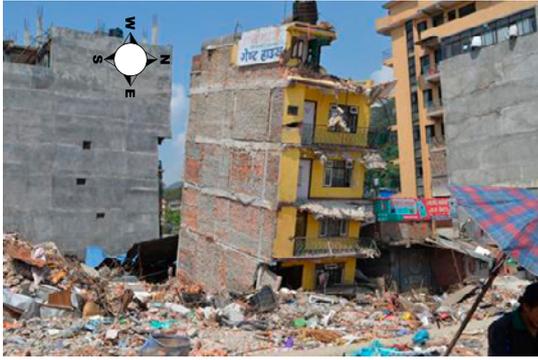
Fig. 20. Tilted RCC building at Machhapokhari, Ringroad, Kathmandu. Tilted towards the east direction.

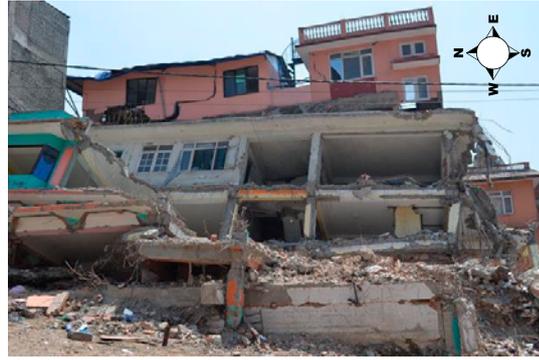
Fig. 21. Topped RCC building at Anand Nagar, Sitapailai, Ringroad, Kathmandu. Tilted towards the east direction.

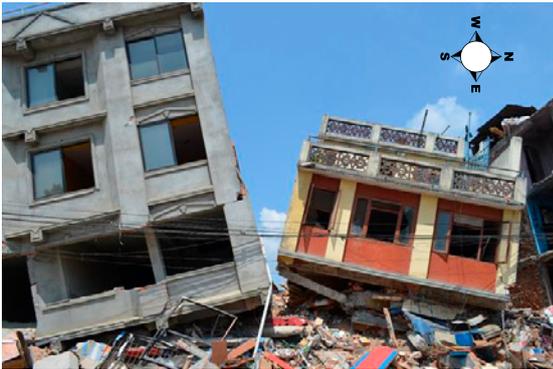
Fig. 22. Tilted RCC building near Sitapaila, Ringroad, Kathmandu. Tilted towards N-S directions.

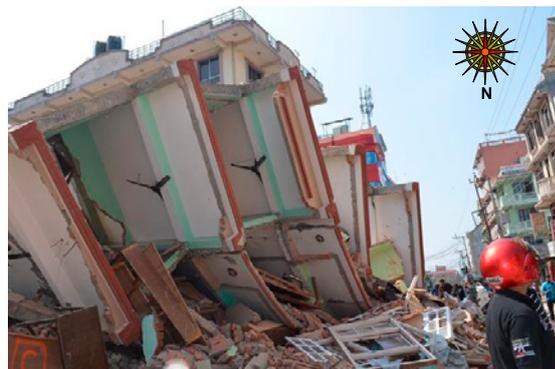
Fig. 23. Topped RCC building in Gongabu area, Kathmandu. Tilted towards the south direction.

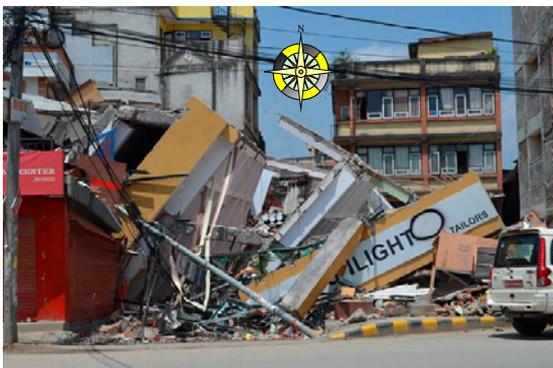
Fig. 24. Topped RCC building at Balkhu, Kathmandu. Tilted towards the east direction.

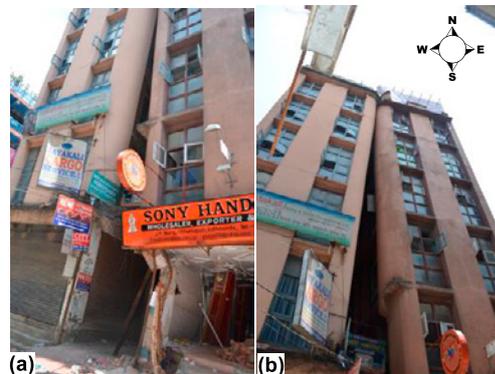
Fig. 25. Tilted RCC building at J.P. Marg, Kathmandu. Tilted towards the east direction

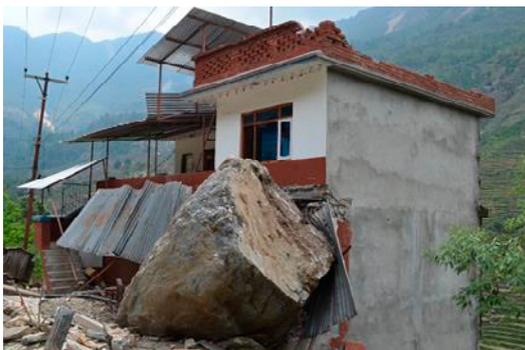
Fig. 26. Intact house shattered by earthquake triggered landslides along the Araniko Highway.

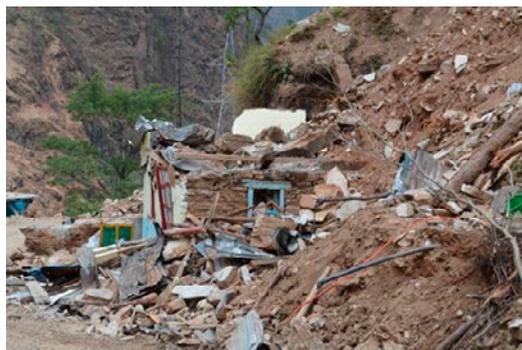
Fig. 27. Houses were at the toe of the slope was demolished completely by earthquake induced landslides along the Araniko Highway.

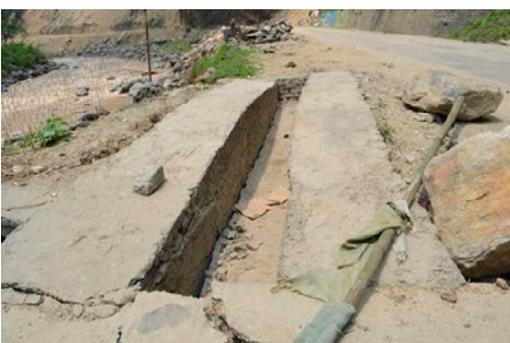
Fig. 28. Culvert and retaining structure on the bank of the of the river along the highway was severely affected.

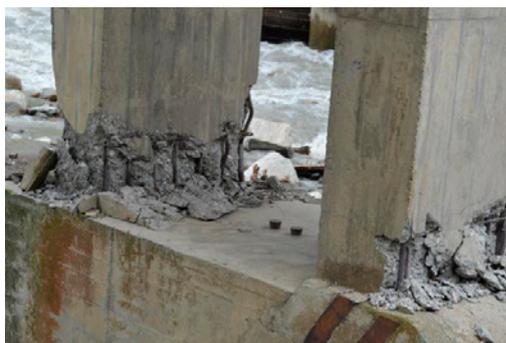
Fig. 29. Damages on column of the Sunkoshi Hydropower due to release of sudden landslide dam triggered by the earthquake.

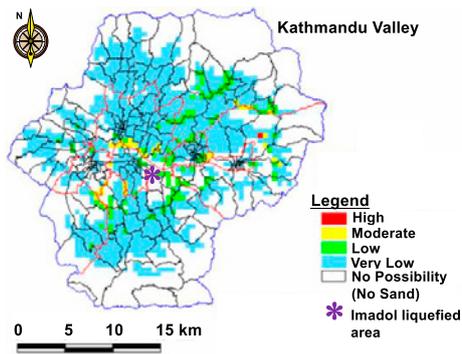
Fig. 32. Liquefaction potential map of the Kathmandu Valley (Source: JICA, 2002) and liquefaction observed area at Imadol, Lalitpur district.

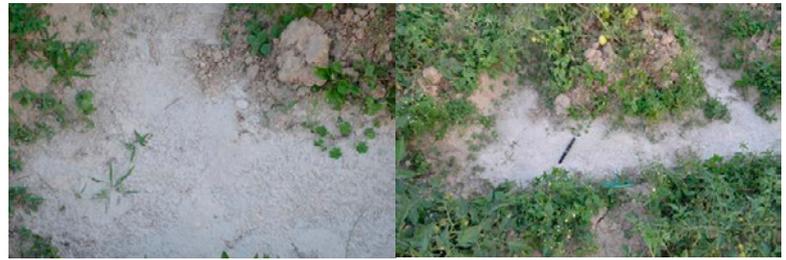
Fig. 33. Observed local scale liquefied white colored fine silty sand at the agricultural field in Imadol area.

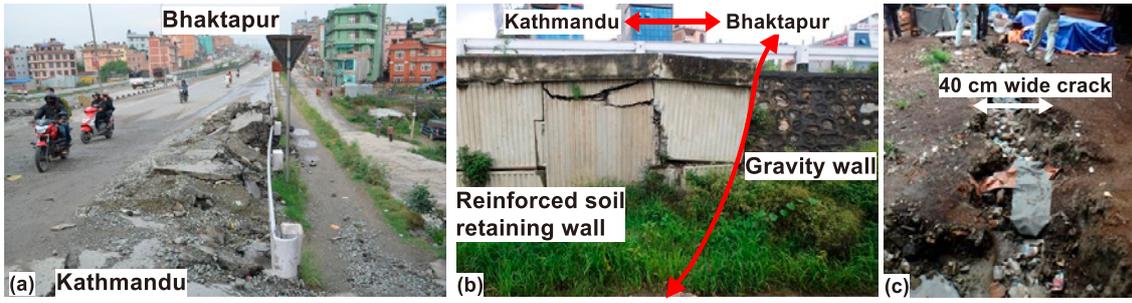
A longitudinal crack appeared at the Lokanthali intersection where the built embankment was damaged due to differential settlement. Several buildings along the highway were tilted with an apparent longitudinal crack of about 40 cm which passed through the bridge towards the direction of Bhaktapur. Several houses and garages were tilted. Moreover, the pedestrian foot bridge was severely settled and police checkpoint was tilted due to slope failure. A depression about 1 m deep appeared to be due to differential settlement. As a result, cracks

extended up the retaining walls. The joint between two types of reinforced soil retaining wall and gravity wall experience significant damaged. Ground fissures also passed through the gravity wall and continued to the opposite side of the bridge towards a residential area. **Figure 34** shows ground fissures, cracks on the wall, heaving and settlement of the area.

Fig. 34. Nepal-JICA road (a) road subsidence (b) cracks appeared on reinforced soil retaining wall and (c) 40 cm wide crack appeared. A longitudinal crack appeared at the joint of two embankment walls and runs along the another side of the bridge. Photos of (b) and (c) are adopted from Dr. H. Nakazawa from NIED, Japan.

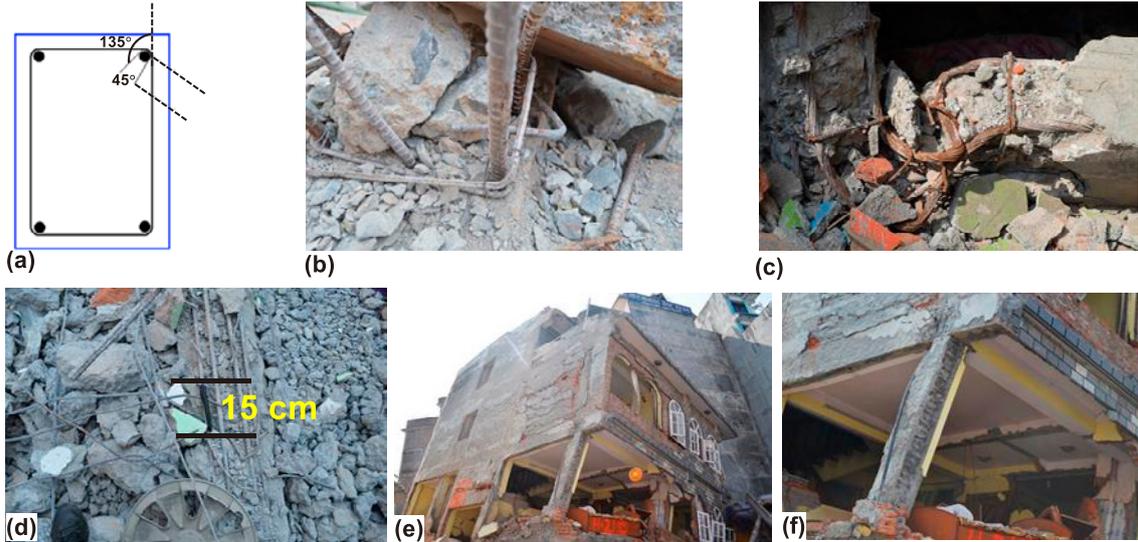
Furthermore, shorter development lengths were observed on failed columns and beams. The lap lengths were insufficient for reinforced bars. The shear stirrups spacing were measured to be around 15 cm which do not follow the Nepal design code limitation of 10 cm (**Fig. 35**).

reinforcing bend easily and collapsed. In some cases failures between pillar and beam can be easily observed. As an engineering practice, rods extended from the upper section of the beam should be bent at 90° and inserted into the pillar maintaining the development length. Conversely, rods at the bottom section of beam should also be bent at the similar pattern. In the failure region, rods of beam were not inserted far enough inside the pillar and left at the joint only with shorter development of length. As a result, during the 2015 strong shaking column edges of the pillars easily yielded, spalled and released.

Fig. 35. (a) Indian standard of stirrup, (b) in appropriate anchorage bend, (c) column joint failure, (d) stirrup spacing is approached 15 cm or greater and (e and f) soft-storey failure due to undersized column.

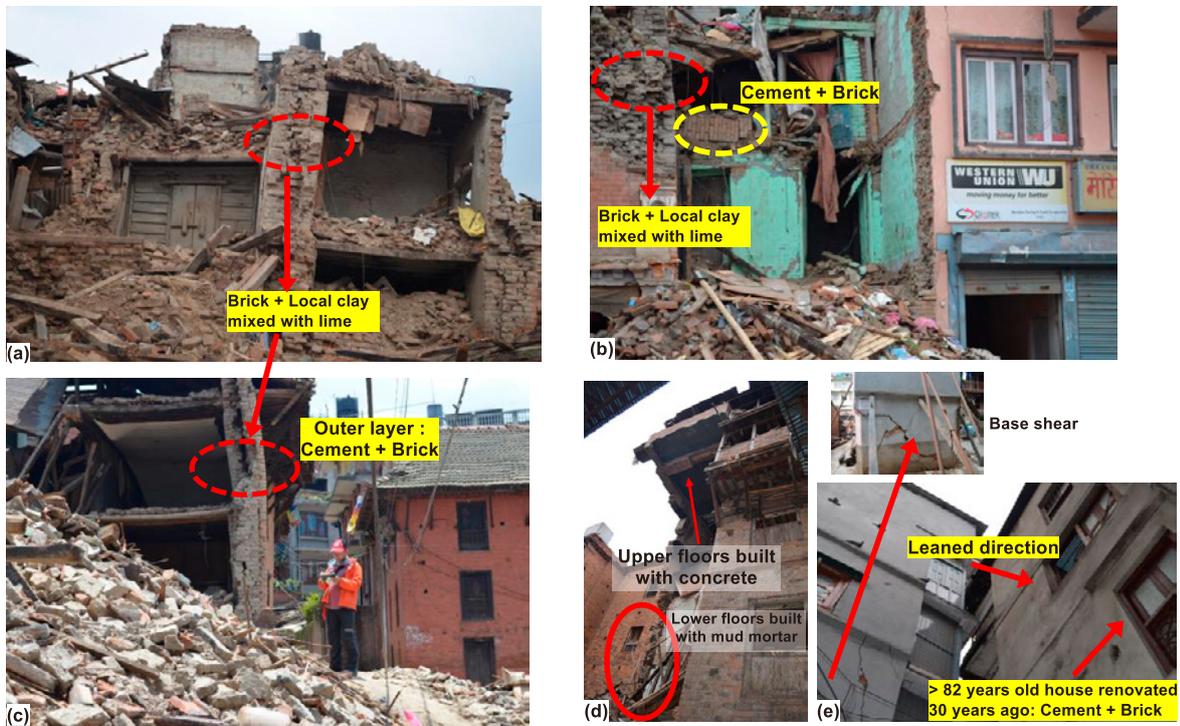
Old structures, especially houses built with the combinations of brick and local clay mixed with lime are remnants of 1934 AD earthquake (8.1 Magnitude) or were renovated after being damaged in that historic event. Most of houses have walls made of sun-dried/fire bricks or local stones utilizing mud mortar, not only in rural areas but also in core areas of city. Most of the frames are made up of wood with flexible roofs and floors. Due to inadequate connections, many buildings could not bear the strength and damaged heavily during the strong quake. Also, renovations have been carried out with cement brick walls without considering proper engineering reinforcement. As a result, fissures and wide cracks often appeared between mud mortar wall and cemented walls (**Fig. 36**).

Furthermore, many renovations of old buildings were performed without considering even basic engineering designs. For example, reinforced concrete for one to three story additions were placed on top of old buildings with brick wall with mud mortar which overloaded the buildings producing severe damage. Similar phenomena were found along the Arniko Highway in Sindhupalchowk districts.

Fig. 36. Figures from (a to d) represent non-engineered practices of renovation and (e) left house renovated one year before the quake without considering engineering design, as a result base shear formed and leaned towards next house. Meanwhile, the right side of the house was also renovated 30 years ago with completely replaced mud + brick with cement + brick and withstood the main shock and aftershock with only minor cracks inside the house. This house is older than 82 year and existed during the 1934 EQ.
