Impacts of 2014 Chiangrai Earthquake from Geotechnical Perspectives

Suttisak Soralump¹, Jessada Feungaugorn², Sirisart yangsanphu³, Montri Jinagoolwipat⁴,
Chinoros Thongthamchart⁵, Rattatam Isaroranit⁶

¹ Director of Geotechnical Engineering Research and Development center (GERD)
^{2,3,4,5,6} Researcher, Geotechnical Earthquake Engineering Unit, GERD
Faculty of Engineering, Kasetsart University, Bangkok, Thailand

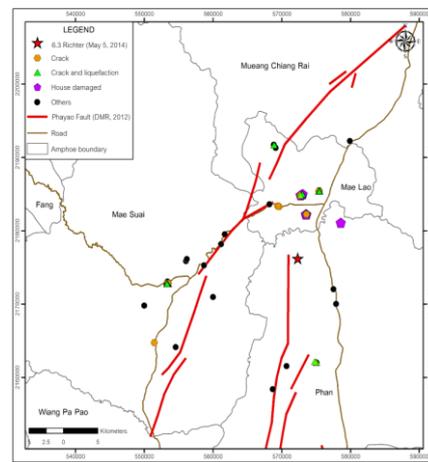
Figure 7 : Ground ruptures location

The ground ruptures have been observed. Their direction is either parallel or perpendicular to the Pha Yao fault lines (Fig 7). Most of the ruptures located over the

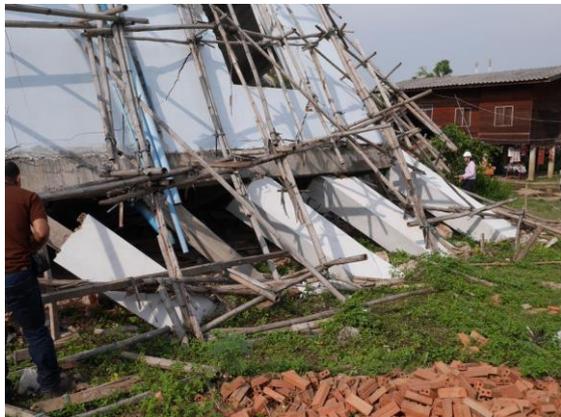
Figure 9 : The damaged of reinforced concrete structure (Picture taken by Dr. Pennung Warnitchai)

Most of the buildings were not designed to resist the earthquake force since the structure that below 15 m were not enforced by law to design for earthquake resistance. Wooden house is less damaged comparing to the reinforced concrete (RC) structure (Fig 9) since it's light and more flexible.

7.1 Most of the damage occurred to the structure that has not been designed to resist the earthquake force. Enforcement of small building for adequate seismic design may need to be reconsidered.

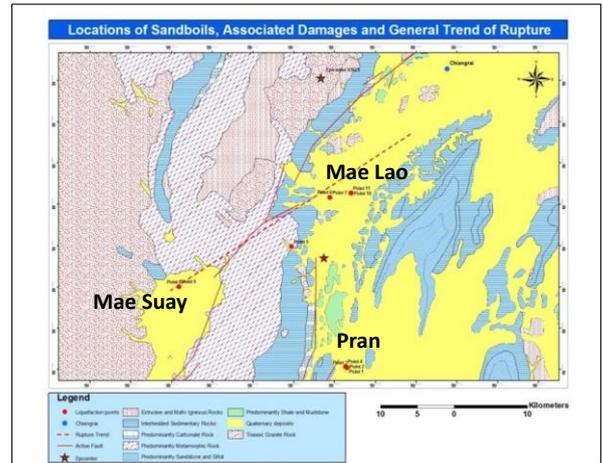
Figure 10 : Location of observed liquefied soil

Liquefaction was found within the radius of 20 km from epicenter and located in the quaternary deposit (Fig 10 and 11). It means that the peak acceleration should be over than 0.15g to cause liquefaction, according to the attenuation model discussed earlier. The subsoil investigation found the loose saturated sand in the shallow depth. Furthermore, the gradation of the soil particle found to be a uniform grade and fitted within the range of liquefiable material (Fig 12). The liquefaction potential analysis using Seed' method (Seed et al., 1971) also found that the soil will be liquefied if the peak acceleration is more than 0.15g (Fig 13).

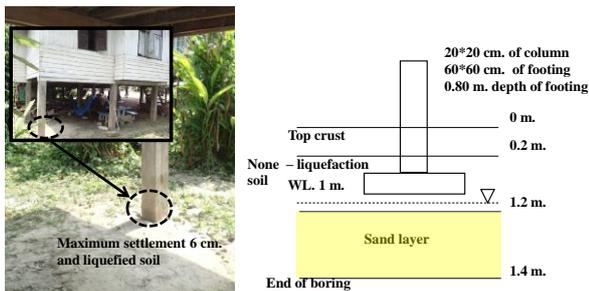
Figure 14 : Foundation settlement due to liquefied soil

Some foundation settlement was found due to liquefied soil underneath the shallow foundation. However, none of the cases were serious damage (Fig 14).

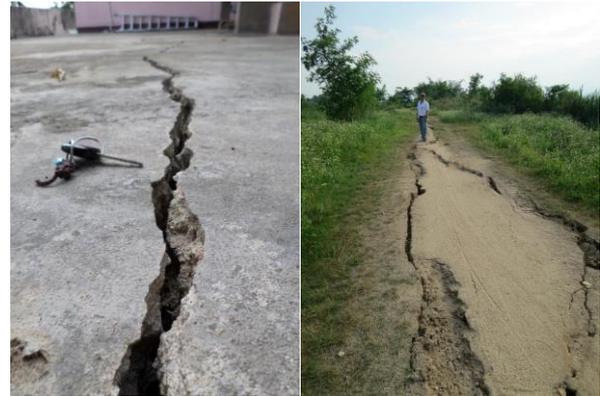
Figure 15 : Lateral spreading observed near the river or stream channel

Lateral spreading were observed near the river or stream channel (Fig 15) and also the new filled soil area (Fig 16). Landslide was not observed, even though the mountainous area located within 20 km from epicenter (Fig 17). Only some rock fall was seen.

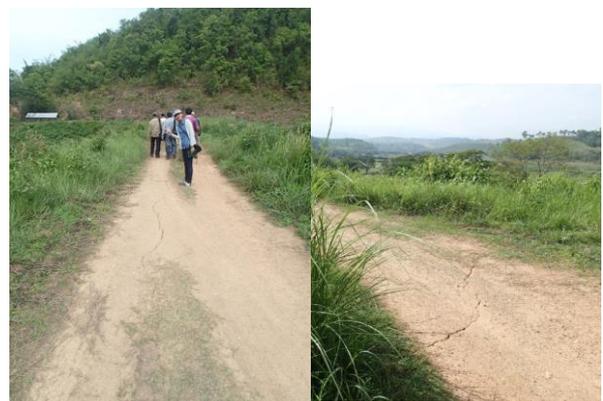
Figure 21 : Small longitudinal and transverse cracks

seismic force using pseudo static method. The previous work of Soralump and Kumma (2010) found that most of the small and medium sizes dams own by Royal Irrigation Department are quite safe to seismic force (Fig 20). Small longitudinal and transverse cracks were found but none of them leak (Fig 21). One large dam called Mea Suew get serious concerns from the public. It's a composite dam, consist of RCC spillway section at the center and side by earth dam. So far, no serious damage was observed.
