Weak Plane Failure of Phyllitic Sandstone: Back Analysis for Slope Stabilization and the Use of Probabilistic Approach for Design Optimization

Abstract The main access road of Mae Mao dam hydropower project, Chiang Mai province, Thailand, has failed during a sunny day. The question has been raised of what might have triggered the failure. At the day of failure, the precipitation amount was very small and the accumulated rainfall amount in the past days was also not significant to trigger the failure. Detail geotechnical investigations were carried out including the geological survey, seismic refraction survey, bore holes drilling and various laboratory testing. The rock found at site was Phyllitic and Quartzitic sandstone. It appears that the engineering properties of Phyllitic sandstone are more susceptible for slope failure. Rock and soil slope stability analysis have been done, however none of them was found to be the cause of failure. After carefully reexamining the geologic structure, it was found that there is a weak plane layer that resulted in the failure. A suitable stabilization method has been selected as the economical remedy of the slope failure. In this case, flatten

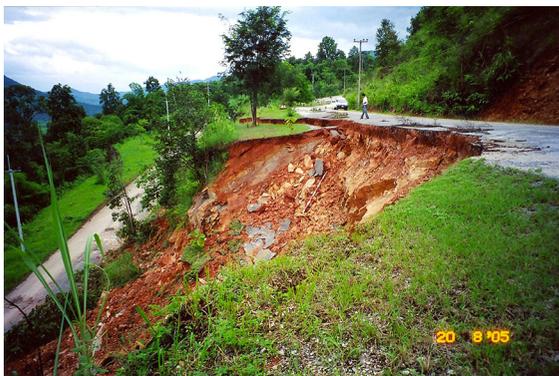
Mae Mao hydropower project is located at Fang district, Chiang Mai province. The general geology consists of Phyllitic sandstone and Quartzitic sandstone. After 24 years of construction (since 1986), the failure of the main access road to the dam has occurred (Figs. 1, 2). The factor causing the failure is unclear. Rainfall and seismic activity are the two possibilities suspected for the failure. However, the precipitation amount was just 2 mm at the day of failure and the accumulated rainfall amount for 4 days prior to the failure was just 59.2 mm (Fig. 3). The precipitation threshold for landslide in Thailand is much larger than the records. Another possibility might be credited to the seismic activities around the site which was quite active during the past service period of the dam (Fig. 4). The site is located in 2B seismic hazard zone based on UBC. With the evidence of the seismic activities in the area, the seismic slope displacement

Fig. 2 Failure of the back and filled slope

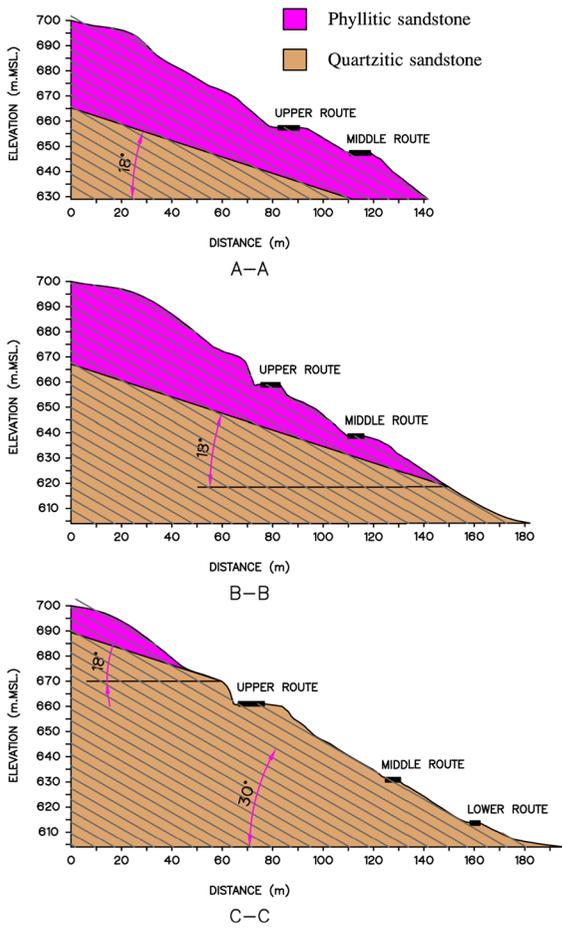
From the geological investigation, in the failure area it was found that the 15–35 m thick of Phyllitic sandstone is overlaying the Quartzitic sandstone. Figure 5 is the plan view showing the contact boundary between these two rocks. Combining with the boring log data, the schematic of geologic structure is shown in Fig. 6. The rock structures consist of fault, shear and foliation. It's the foliation plane that is firstly suspected to be the plane of failure. The orientation of this foliation plane consists of strike and dip angle of 330/30. Figures 7 and 8 show the photographs of fractures and planes. Figure 9 shows the fracture orientation data analysis on the stereonet (Markland 1972). It is found that the possible mode of rock failure is the combination of planar and wedge failure.

Fig. 6 Cross sections and geologic structure

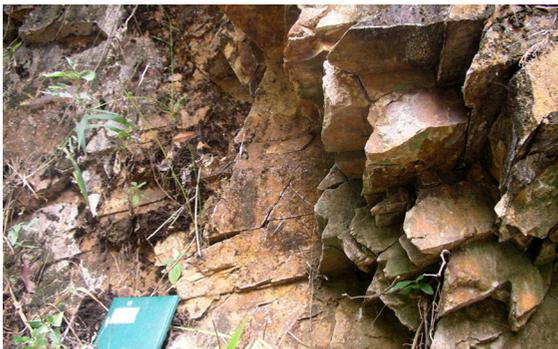
Fig. 7 Rock fractures

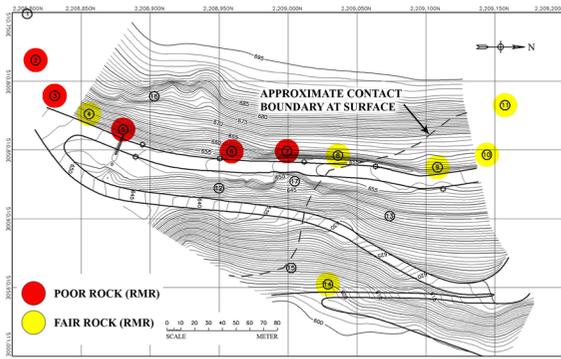
- a. RMR (Bieniawski 1973) and SMR (Romana 1985) determination of the rock mass was done in the area vicinity to the failure. The results are shown in Figs. 10 and 11. It was found that the Phyllitic sandstone is mostly classified as poor to bad rock while the Quartzitic sandstone is classified as normal to good and fair rock.
- b. Seismic refraction survey (Hagiwara and Omoto 1939) was done in order to investigate the thickness of weak strata. The result from seismic survey line 3 (lower slope) shows that the rock mass in this area is more solid compared to that of line 1 located in the upper slope (Figs. 12, 13).

Fig. 10 Rock mass quality determination by RMR

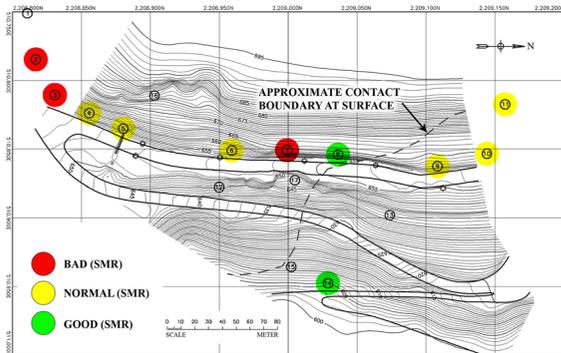
Fig. 11 Slope mass quality by SMR

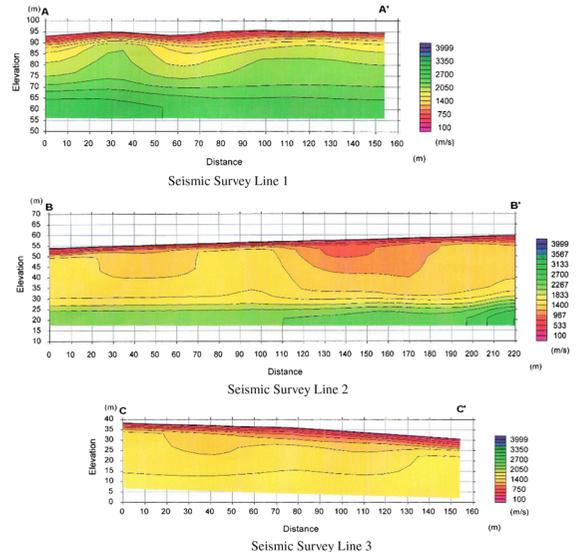
Fig. 13 Results of seismic refraction survey

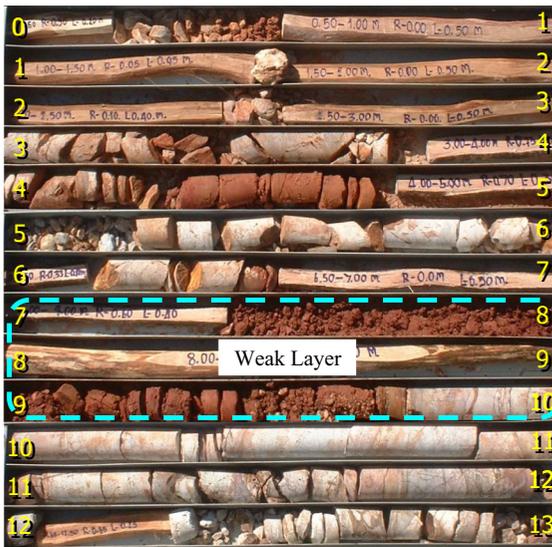
that there is a 3 m thick completely decomposed rock layer present in each bore hole column (Fig. 16). This weak layer has a dip angle that is quite similar to the dip angle of the foliation plane

Fig. 15 Core samples showing the weak zone

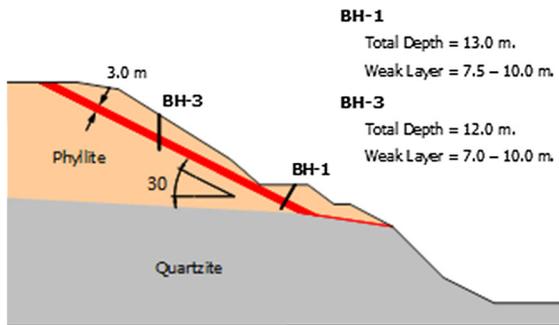
Fig. 16 Configuration and the properties of the different features of the slope for back analysis (Section A–A)

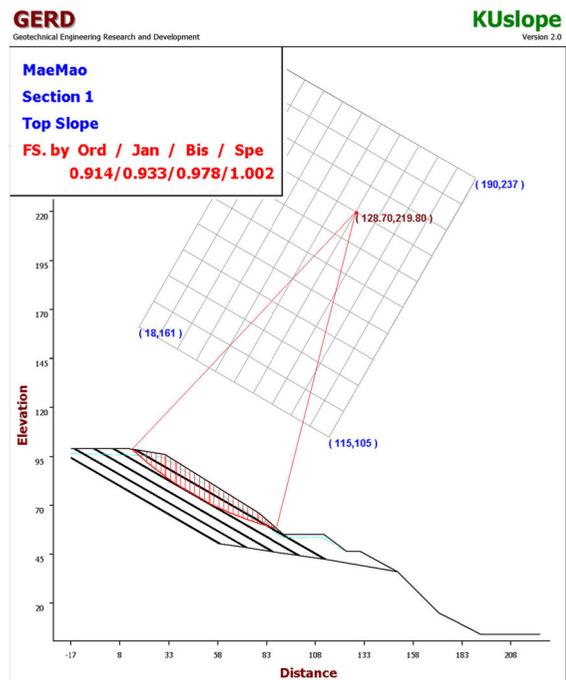
- a. Back analysis was done using the configuration as shown in Fig. 18. The 5 m thick layer of Phyllitic sandstone is modeled together with the 0.5 m thick of weak layer in which all layers have 30 degree of dip angle. The results of direct shear test explained earlier were used. The Phyllitic sandstone strength parameters are modeled based on its joint strength. The weak layer shear strength is modeled based on the direct shear test result of recompacted material. The result revealed that the thickness of the rock mass layer need to be at least 10 meters thick to make the factor of safety of the slope less than one (Fig. 19). This back analysis scheme is based on the assumption that the ground

Fig. 19 Result of slope stability analysis

water is located at the ground surface. The result of the back analysis corresponds with the actual condition where the weak layer is found at the depth of 10 meters with almost 30 degree of dip angle.

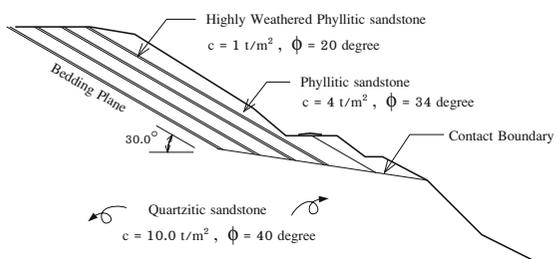
Fig. 18 Configuration and properties of slope for back analysis case (Section A–A)

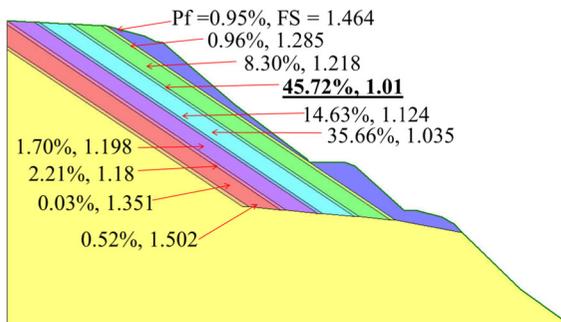
input parameters were expressed using the Coefficient of Variation (COV) values published by various researchers. Figure 20 shows the results of the probability of failure values for each potential slip plane. It is clear from the figure that the actual slip plane matches with the plane that has the highest probability of failure.

Fig. 20 Pof values for each potential slip surface

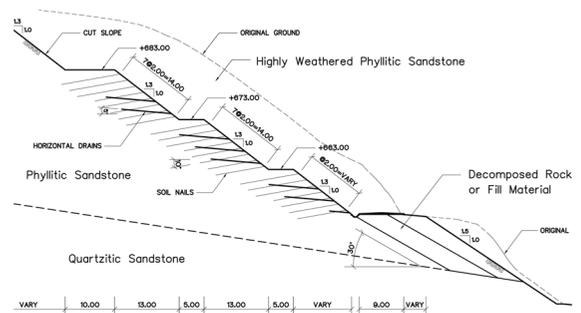
Fig. 21 Configuration of remedial work (Section A–A)

- b. Analysis for slope remedial design was done based on the design concept explained earlier. It is recommended to flatten the upper portion of the slope including 5 m wide benching steps, 10–12 m long rock nails and horizontal drains as shown in Fig. 21. The design cases are shown in Table 4.

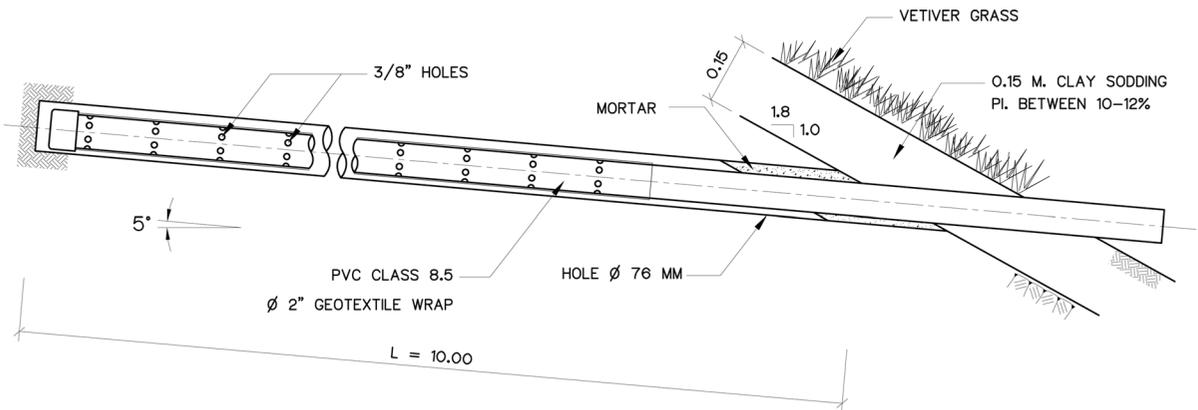
Fig. 23 Typical section of drainage and erosion control

Therefore, this scheme was selected for the remedial work. It can also be seen from Tables 5 and 6 that use of rock nails is not a quite cost effective solution since the gaining of factor of safety is small compared to the additional cost that will have to be invested. Figures 22 and 23 shows the typical section, and drainage system surface protection measures.

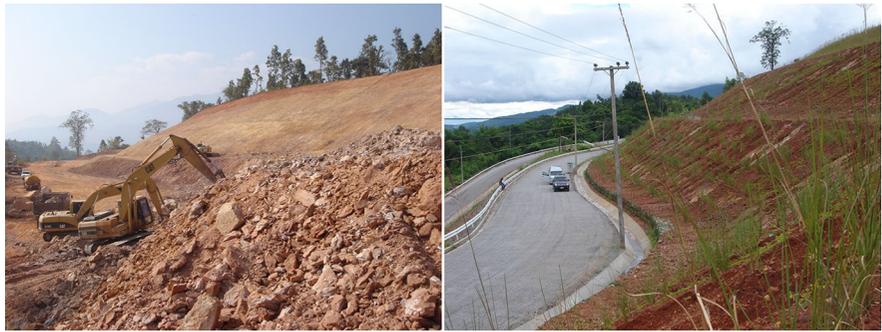
Fig. 26 Cut slope during construction and after its completion

Minimum design factor of 1.25 may be used for routing Highway (FHWA 2006). Furthermore, Santamarina et al. (1992) suggested that P_f between 1 and 2% may be used for existing large cut to low consequences of slope failure. Hence, a cut slope with factor of safety 1.3 and probability of failure of 3.69% was used for the stabilization of this slope. In order to understand the situation correctly, the results obtained were plotted in the curve proposed by Silva et al. (2008) and hence the project can be classified between category II and III (Fig. 25). The design of the project was carried out in category III considering the quality and efficiency of the contractor. The cut slope during its construction and after its completion is shown in Fig. 26.
