ความเสี่ยงแผ่นดินไหวของอาคารสูงใน

กรุงเทพมหานคร

ศ.ดร. เป็นหนึ่ง วนิชชัย

ภาควิชาวิศวกรรมโครงสร้าง
สถาบันเทคโนโลยีแห่งเอเชีย (AIT)

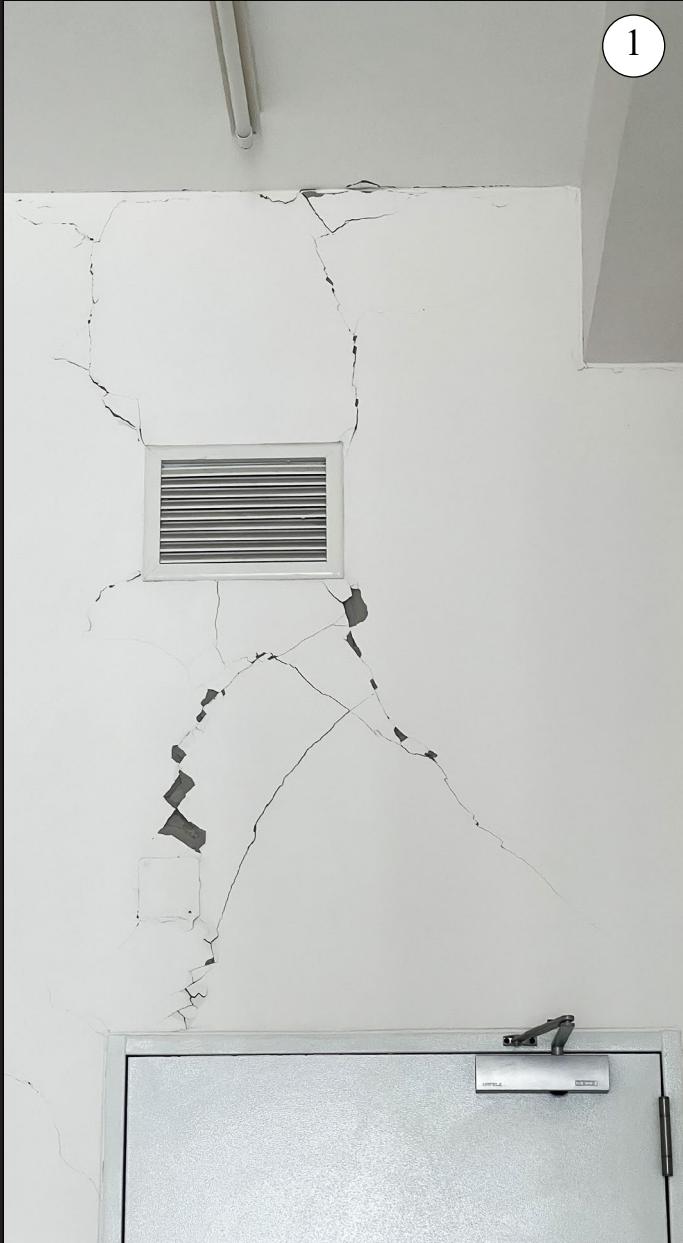
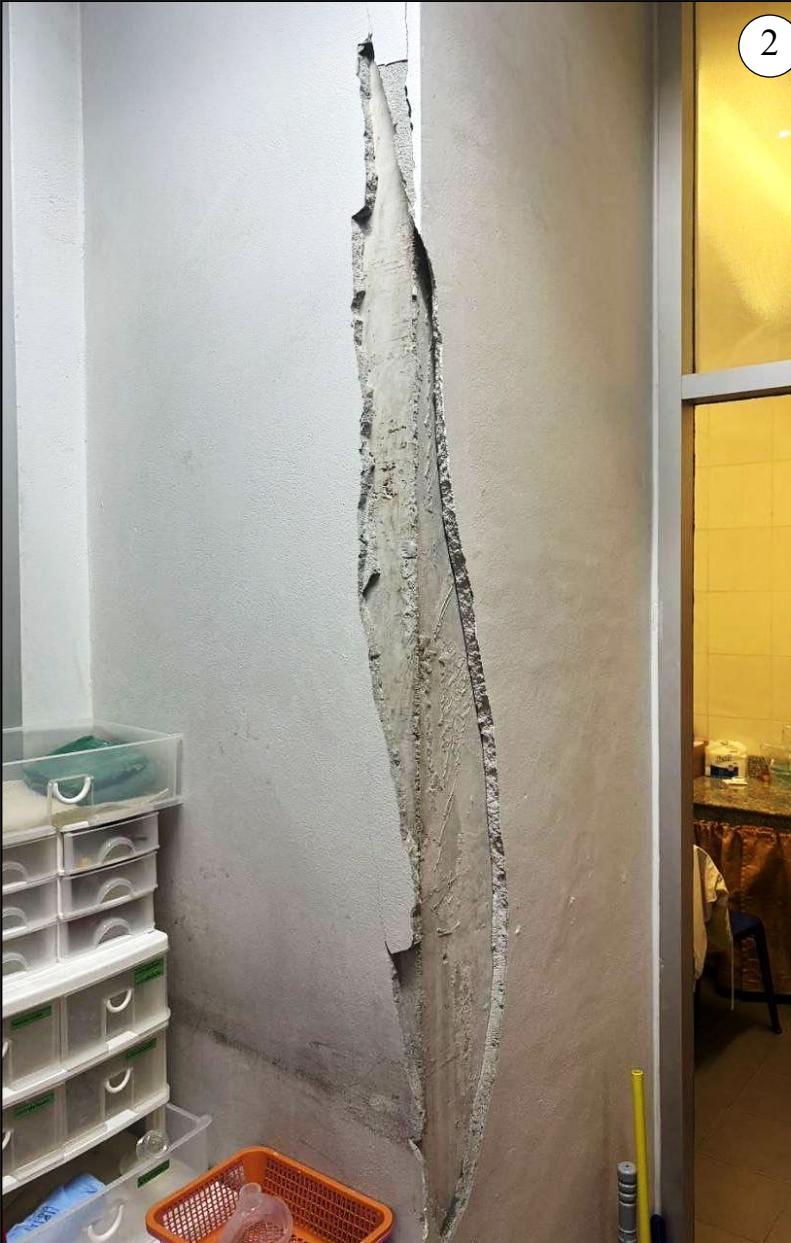
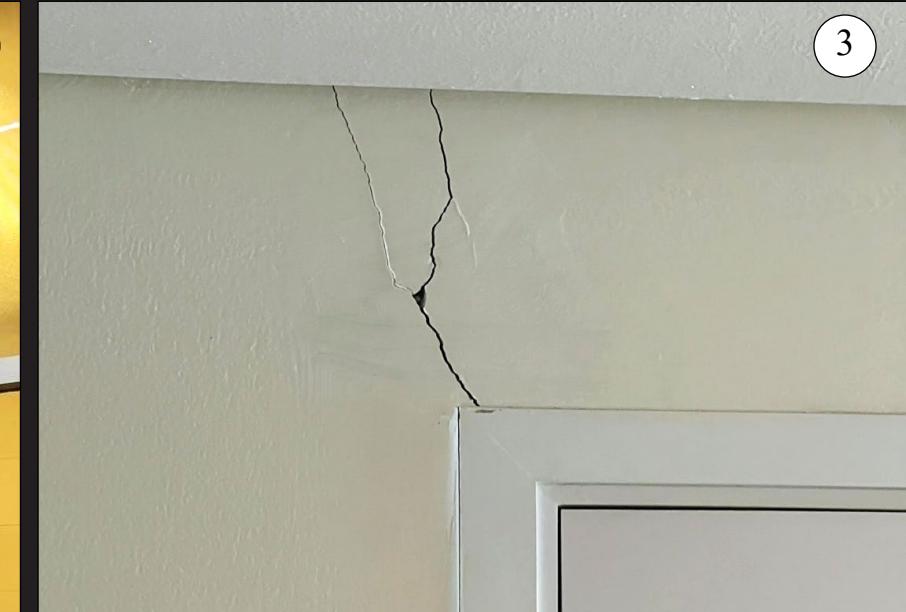
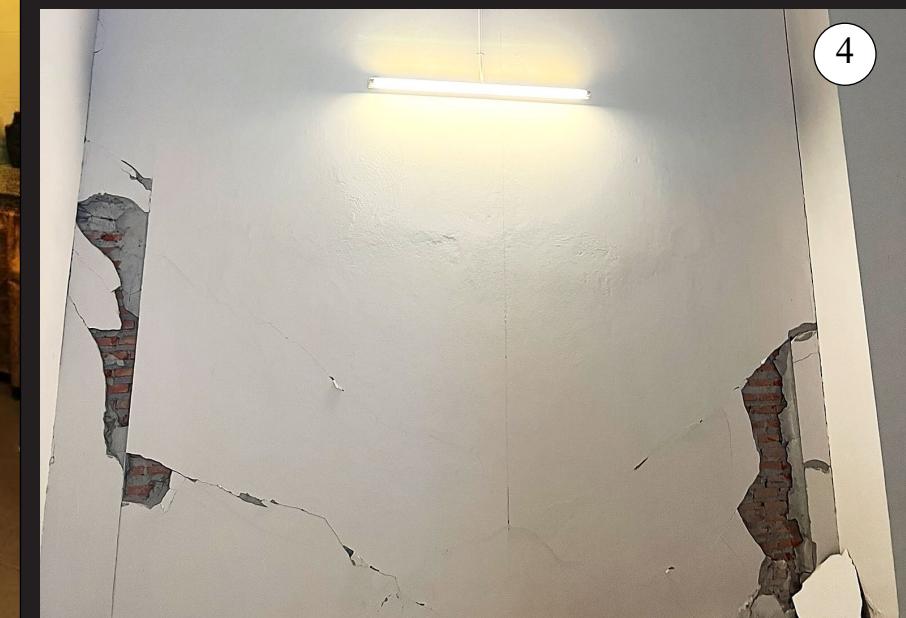
Slight to Moderate Damage to Non-Structural Masonry Walls

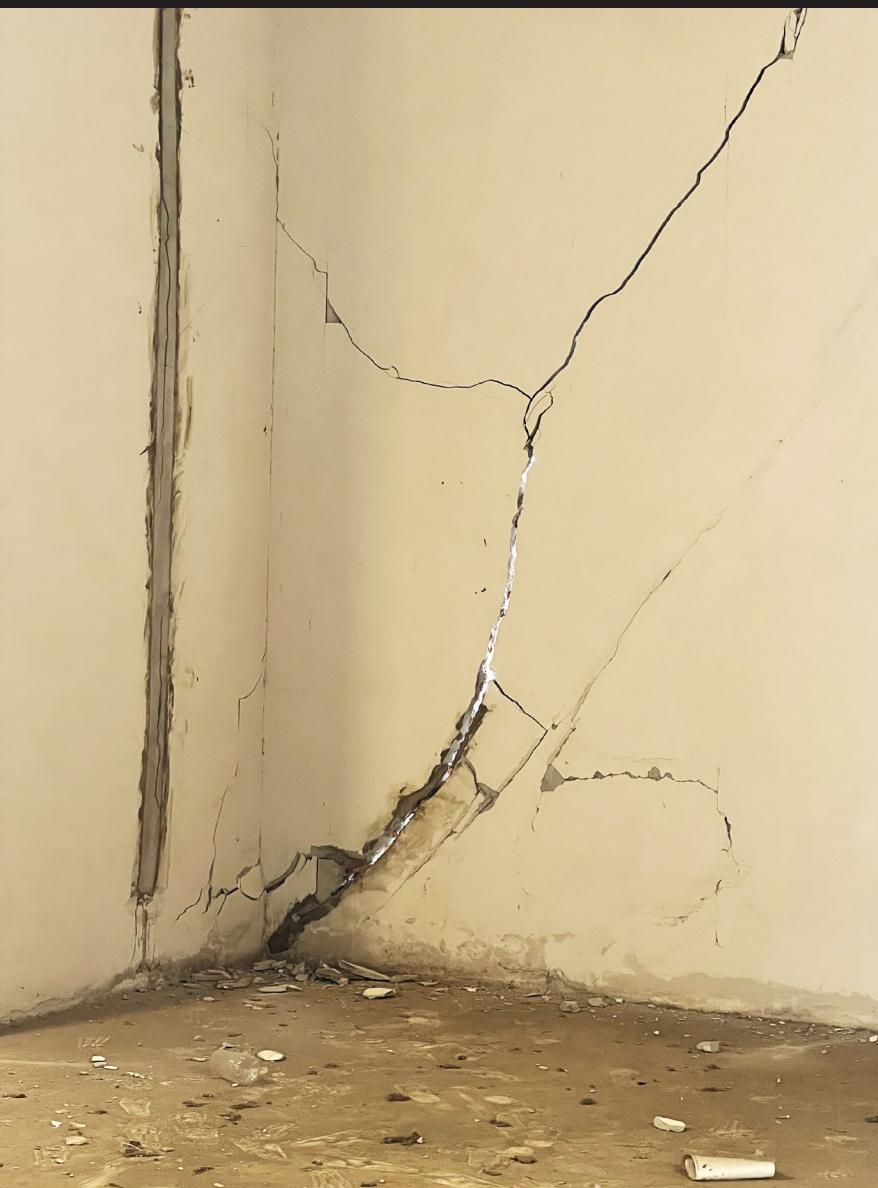
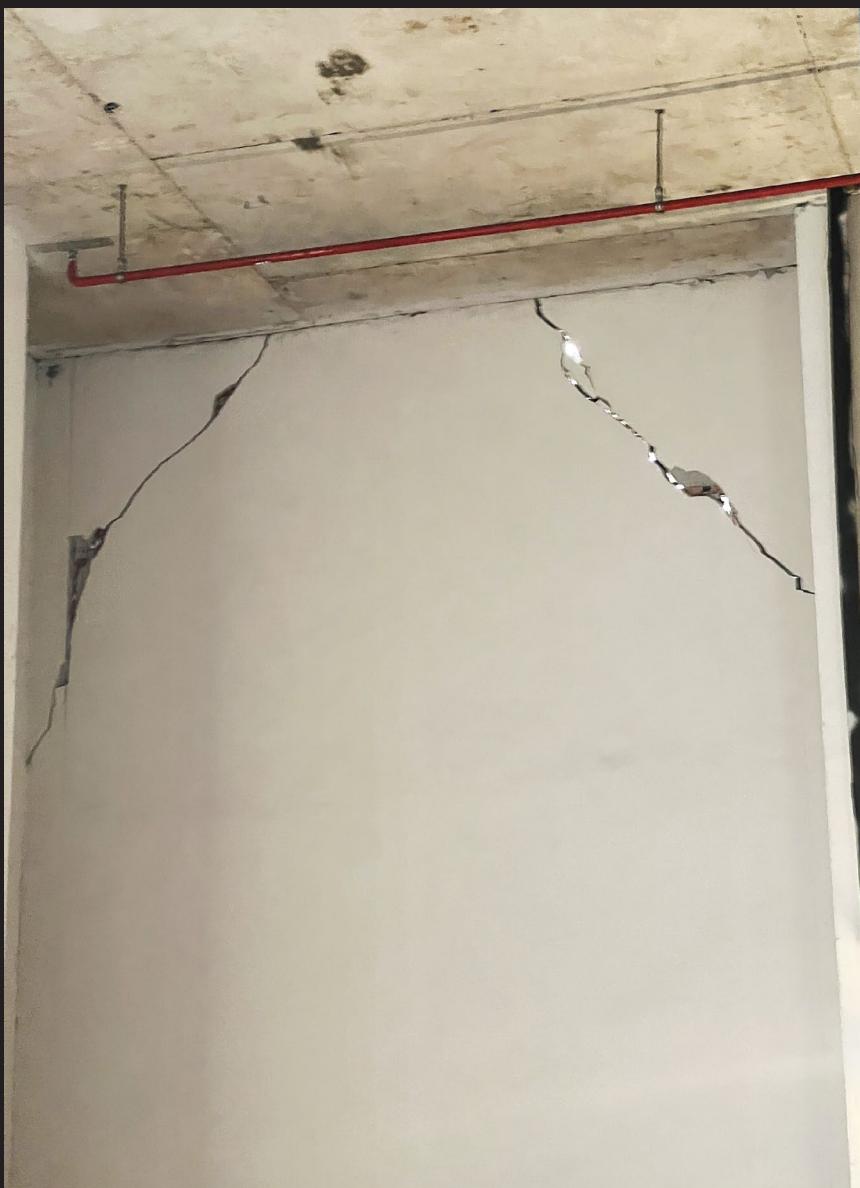
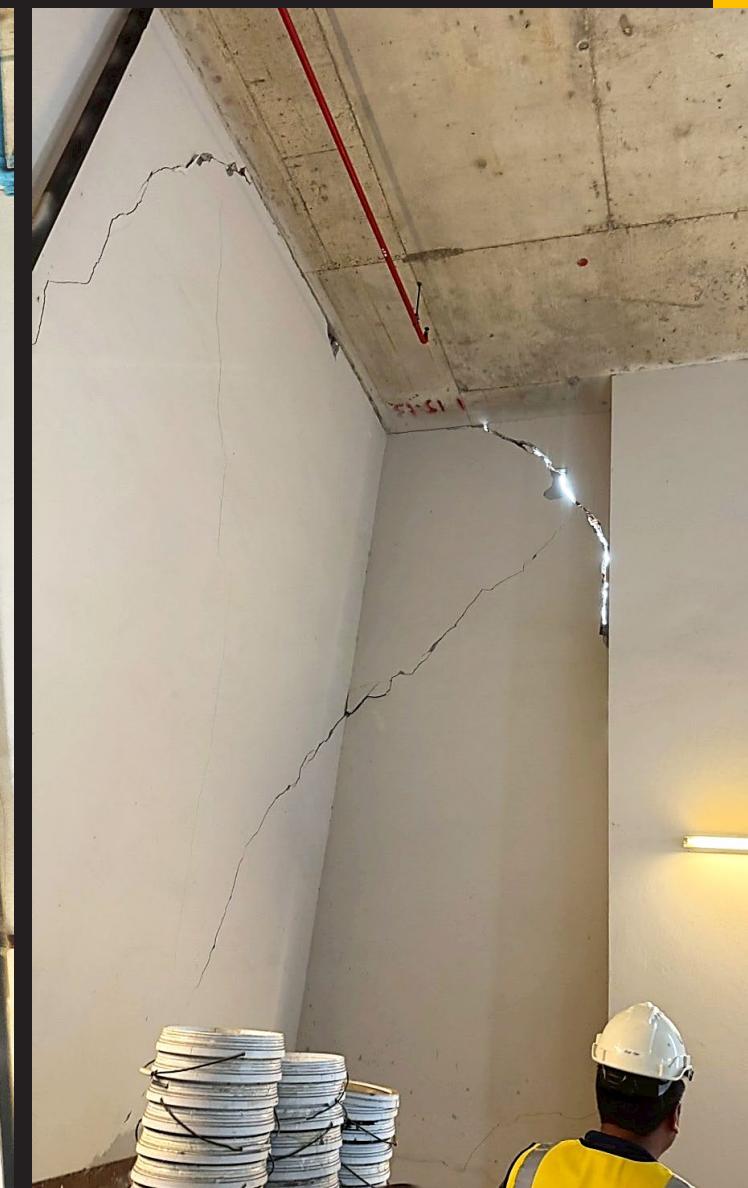
Severe Damage to Non-Structural Masonry Walls- ผนังอิฐก่อร้าวทะลุสองฝั่ง

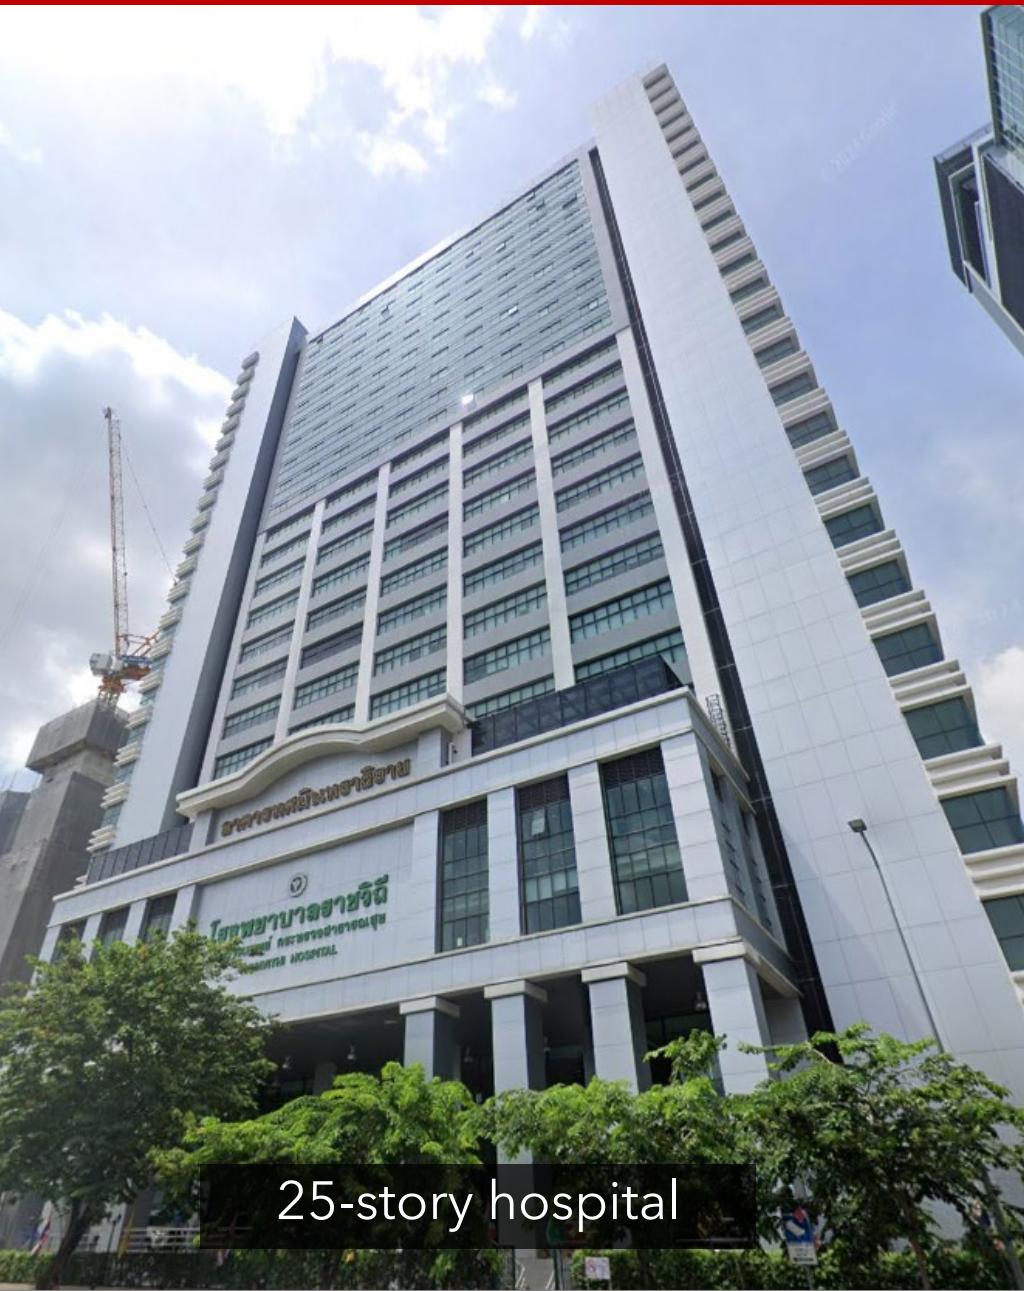
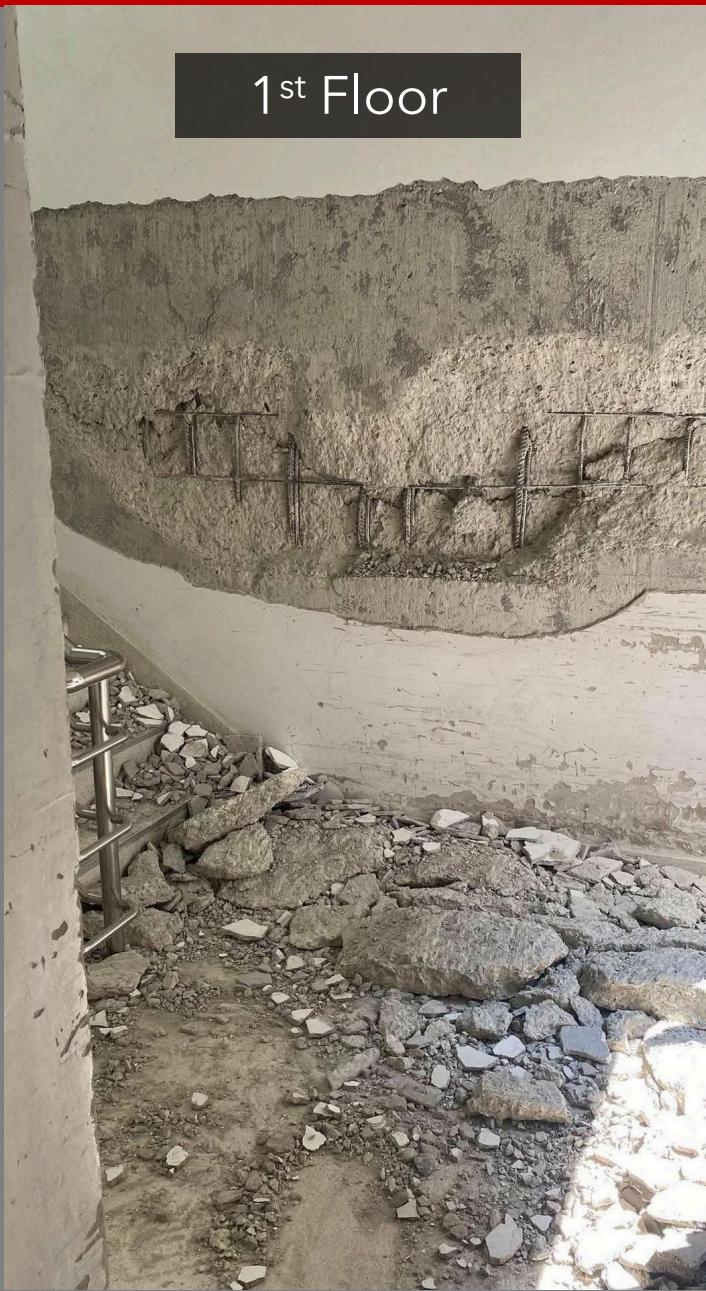
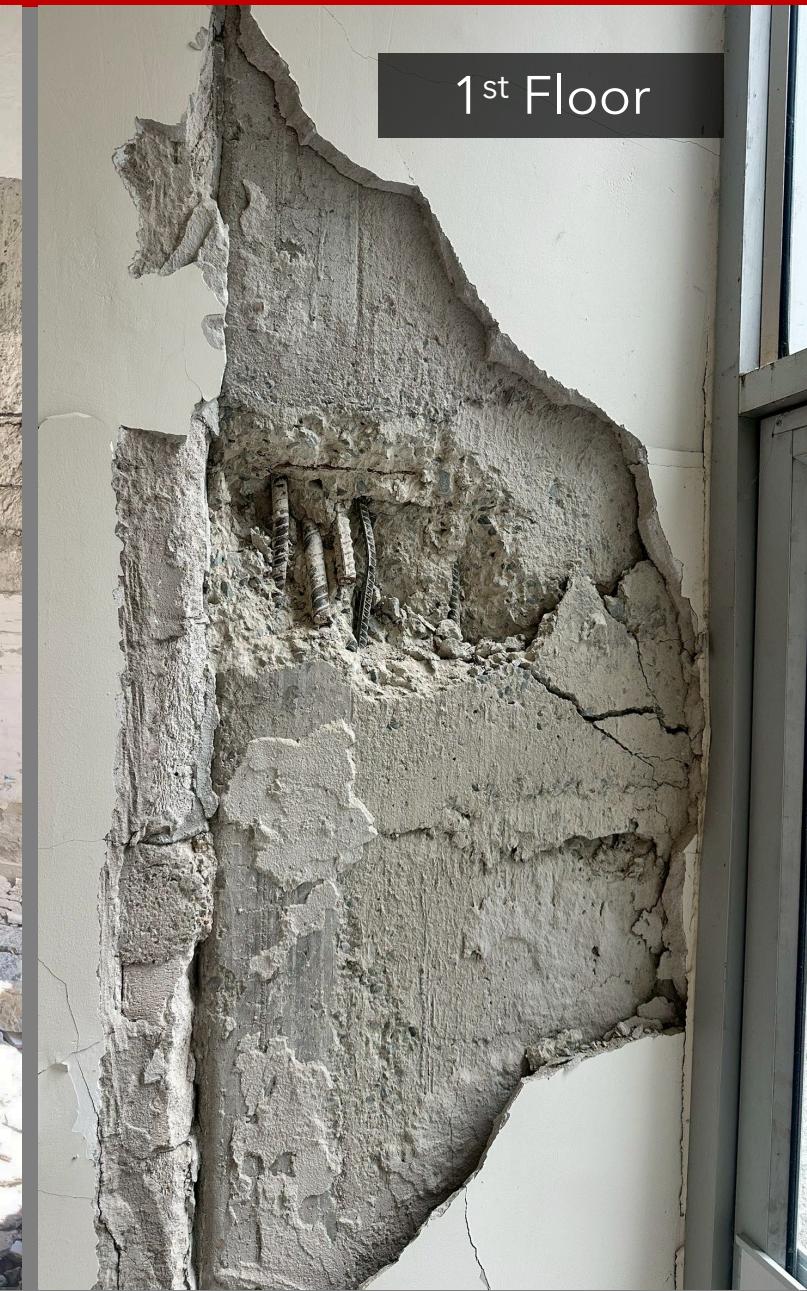
Significant Structural Damage (25-story, Rajavithi Hospital)

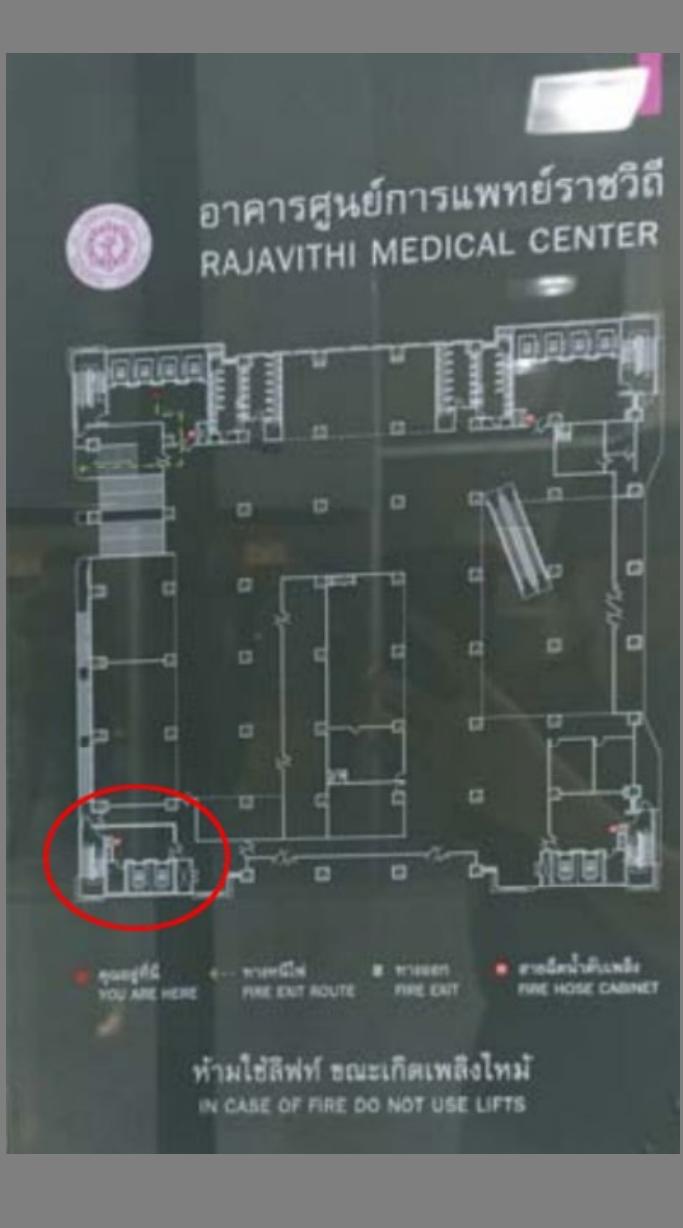
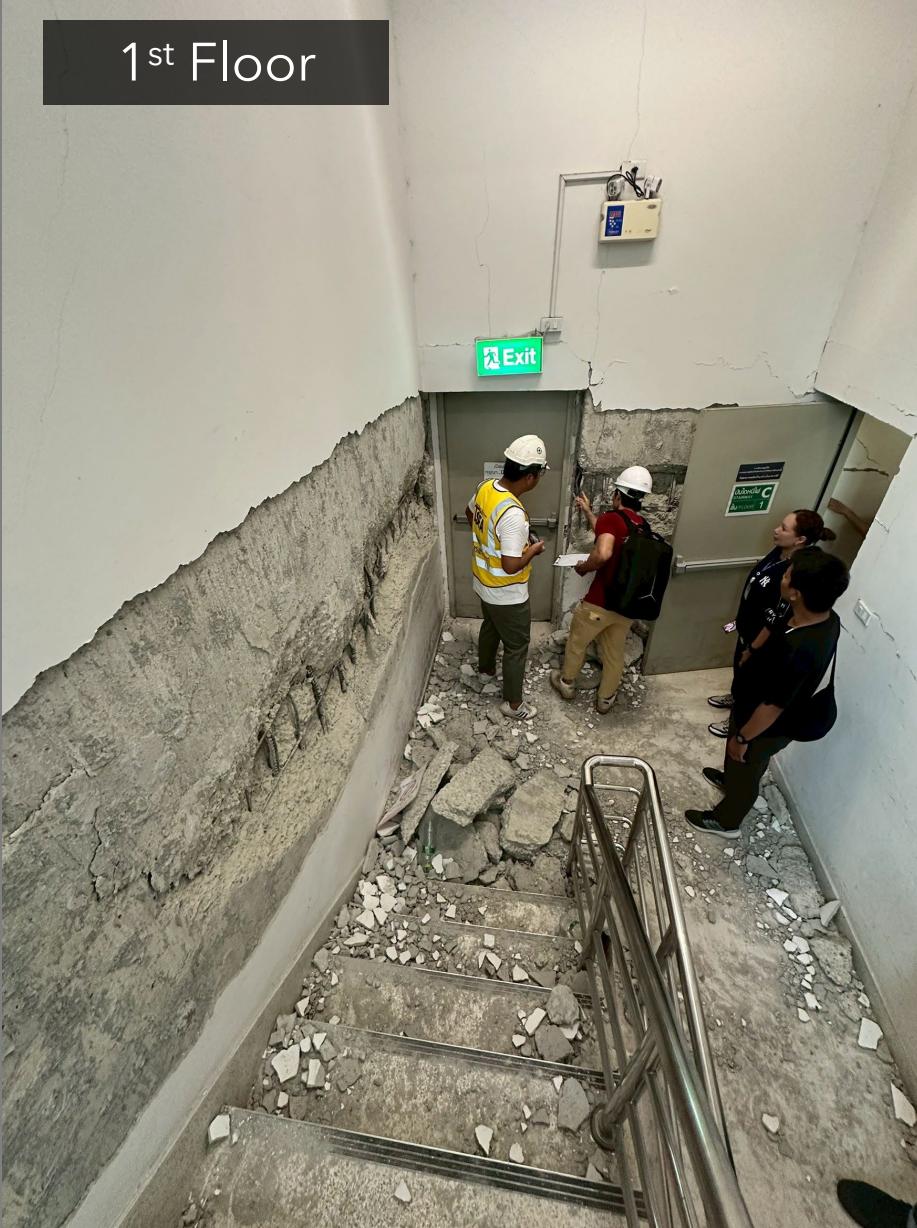
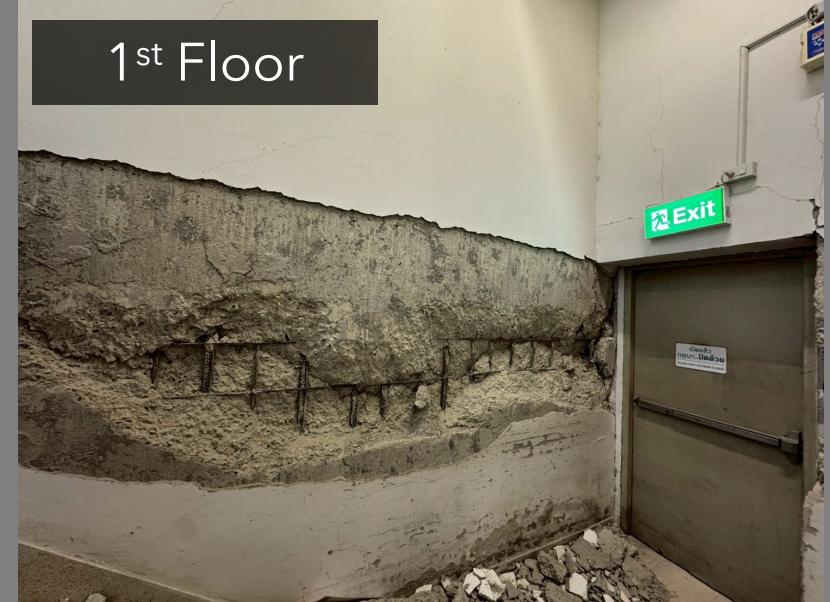
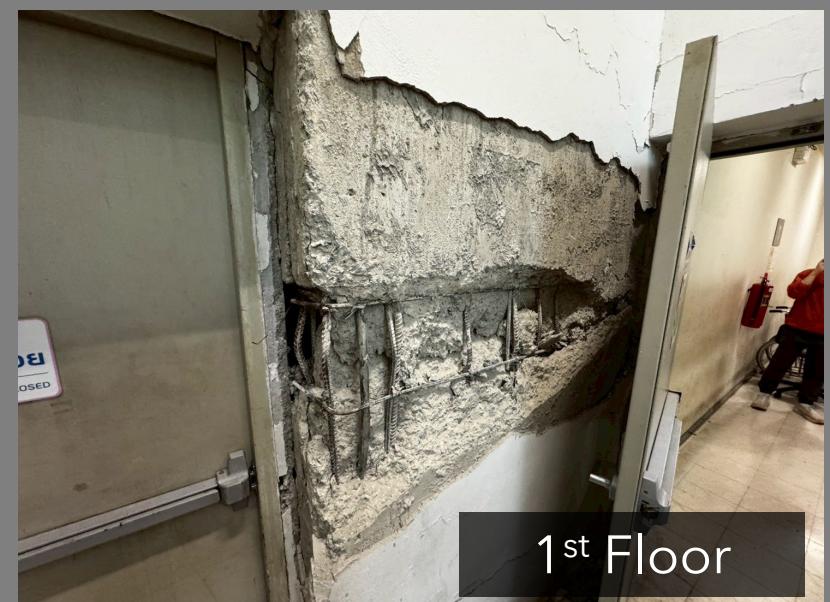
Significant Structural Damage (25-story, Rajavithi Hospital)

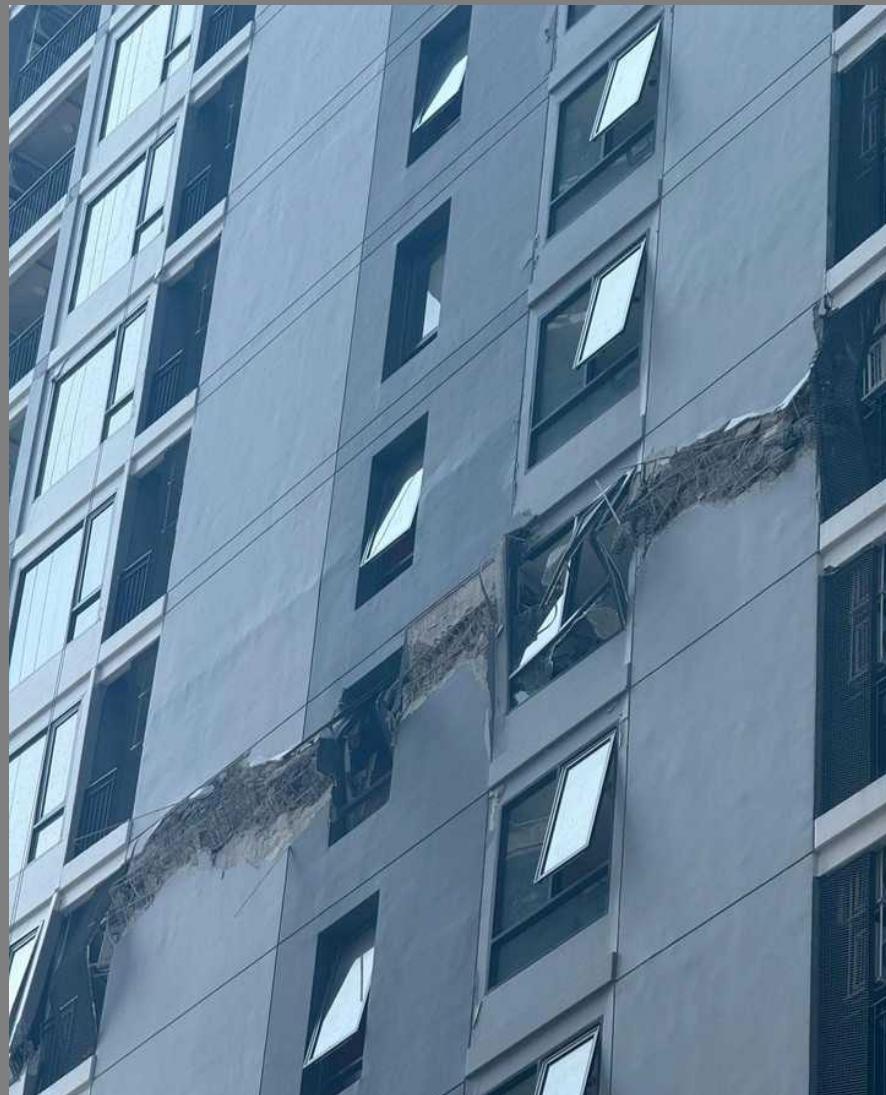
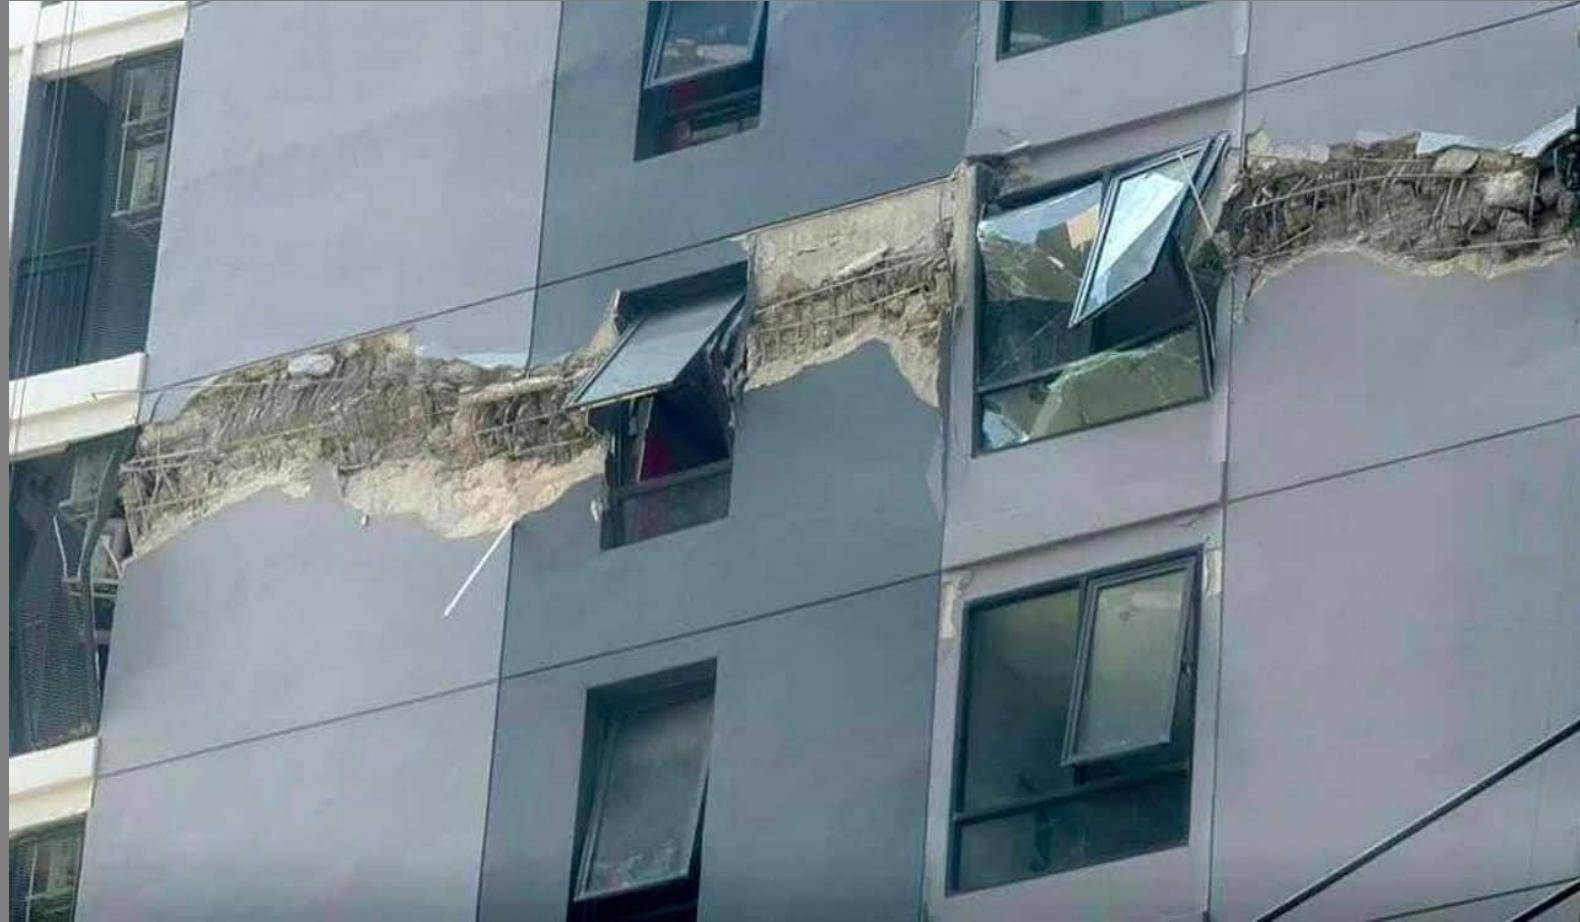
Significant Structural Damage (Building in Bangkok)
