## Ecological Mitigations Rain-Triggered Landslides Using Construction Methods with Geosynthetics

D.T. Bergado<sup>1\*</sup>, S. Soralump<sup>2</sup>, S. Duangkhaeb<sup>3</sup> and G. Manuel<sup>4</sup>

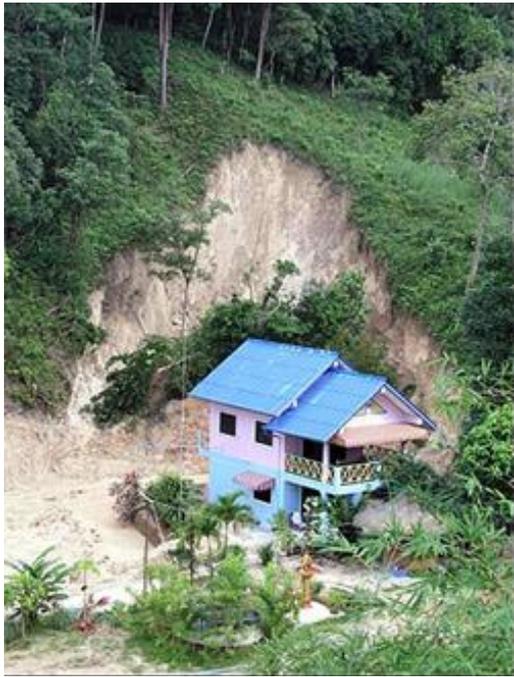
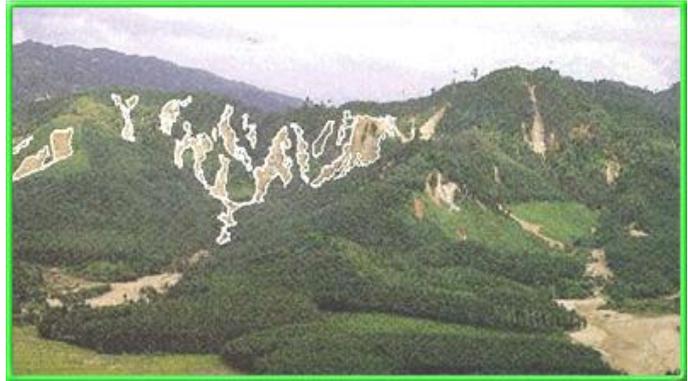
Fig. 1 Limited and large area landslide (Soralump, 2010)

caused by the disturbance due to human activities which change the landform or surface and underground water flow characteristics. On the other hand, large area landslide is natural and mainly caused by unusual large precipitation in the area. However, there are also many evidences that deforestation or agricultural process is the main cause of large area landslide. Figure 2 shows the location of recorded landslide events from the database. It can be seen that the landslide occurred mostly in the northern and southern parts of Thailand. The frequency of the landslide event is increasing sharply during the last decade starting from 1996. The assumptions for the cause of increasing number of landslides for the past decade are: 1) Landslides naturally occur more often which might be related to the climate change (2) Mismanagement of land use due to the increasing number of population and the needs of land for producing agricultural products, that force people to stay in the landslide hazard areas (3) Combination of first and second reasons. Figure 3 shows the statistic data of landslide events that caused economic loss of greater than 100 million Bahts (exchange rate: 1USD = 32 Bahts).

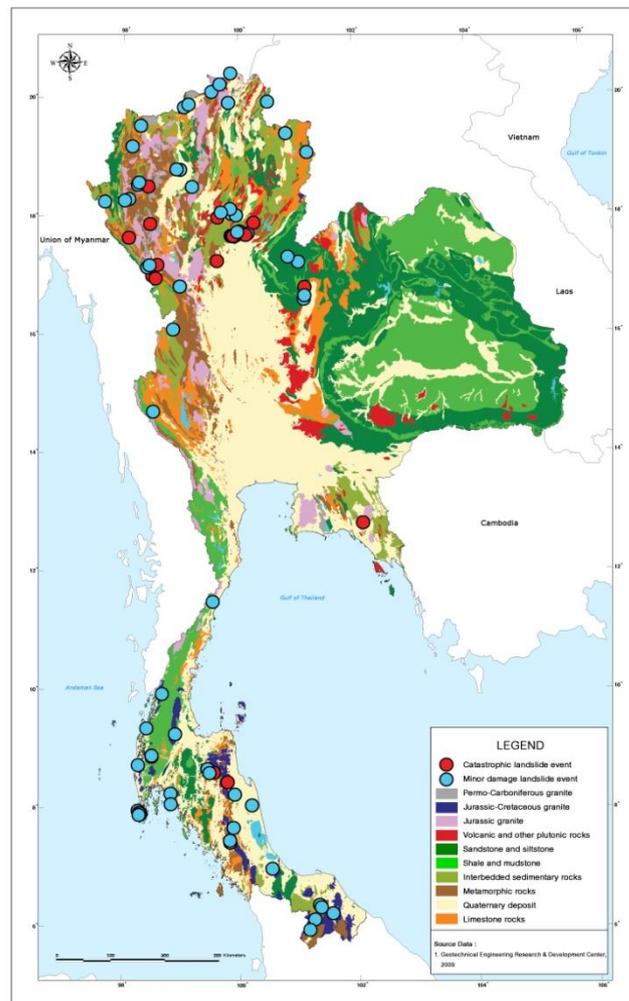
Fig. 2 Landslide events in Thailand from 1970-2006 (GERD, 2006)

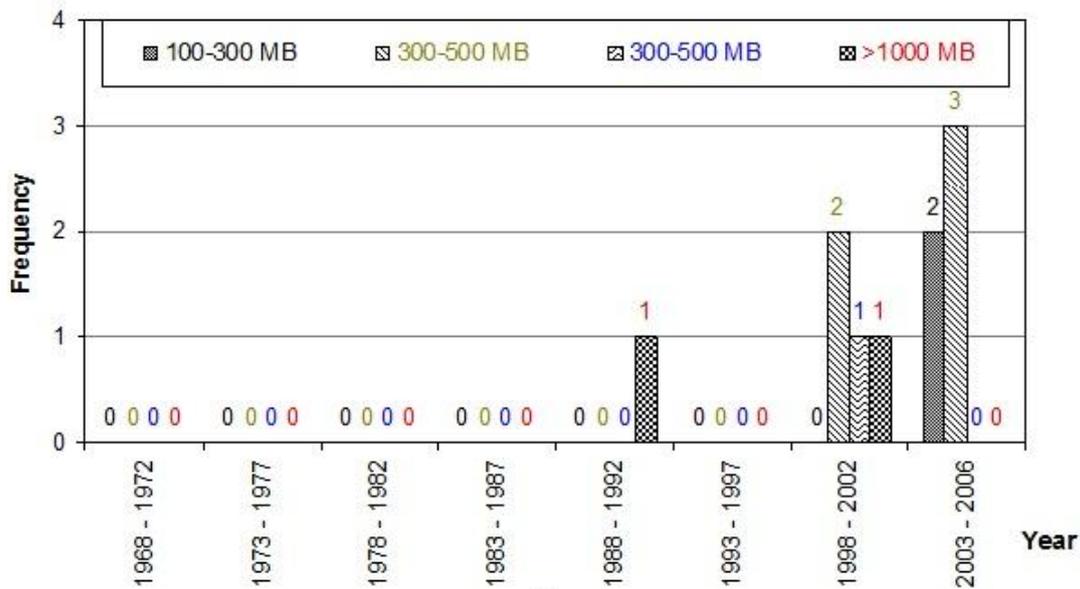
Fig. 3 Direct damage cost of greater than 100 million baht from landslide Events in Thailand (Soralump, 2007)  
(Exchange rate: 1 USD = 32 Bahts)

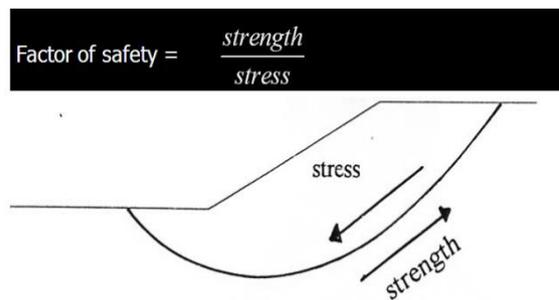
Fig. 4 Schematic illustration of factor of safety in slope stability analysis

Landslides occur due to unstable natural or artificial slopes when the shear stress (“Bad”) exceed the shear strength (“Good”) as indicated in Fig. 4. The factors leading to instability can generally be classified as follows:

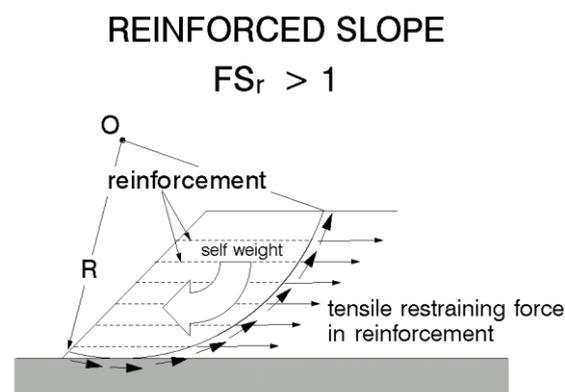
influence of reinforcement on global slope stability

Fig. 5 Geosynthetics soil reinforcement

geosynthetics is mainly utilized to provide tensile strength and added stiffness to the soil which is basically strong in compression (see Fig. 5).

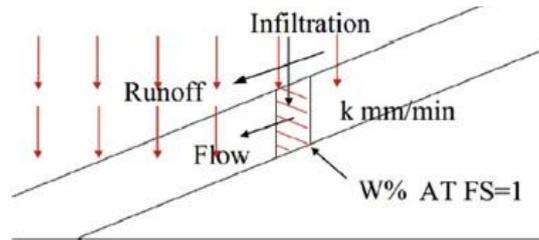
Fig. 6 The modeling of rainfall triggered slope failure (Kunsuwan, 2005)

Brand (1980) discussed the mechanism of rain-triggered landslides with reference to residual material acknowledging the fact that they are heterogeneous and, under dry conditions, exists as unsaturated. It was stated that the mechanism of rain-triggered landslides is that water infiltration causes a reduction in the matric suction in the unsaturated soils. This gives rise to a reduction in the effective stress on the potential failure surface, decreasing the soil strength to a state at which equilibrium can no longer be sustained in the slope (Fig. 6).

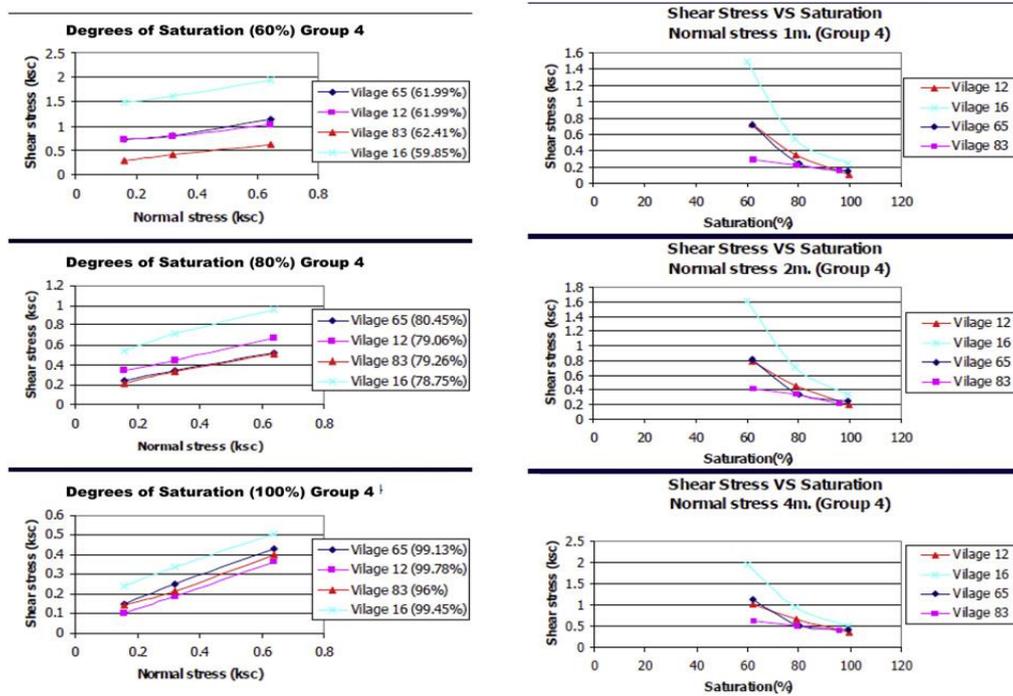
Fig. 7 Strength reduction characteristic from increasing of soil moisture content (Soralump and Torwiwat, 2009)

has been tested for their engineering properties and 307 undisturbed soil samples have been specially tested their shear strength reduction behavior by direct shear testing method (Soralump and Torwiwat, 2009). Figure 7 shows the example of strength reduction characteristics.

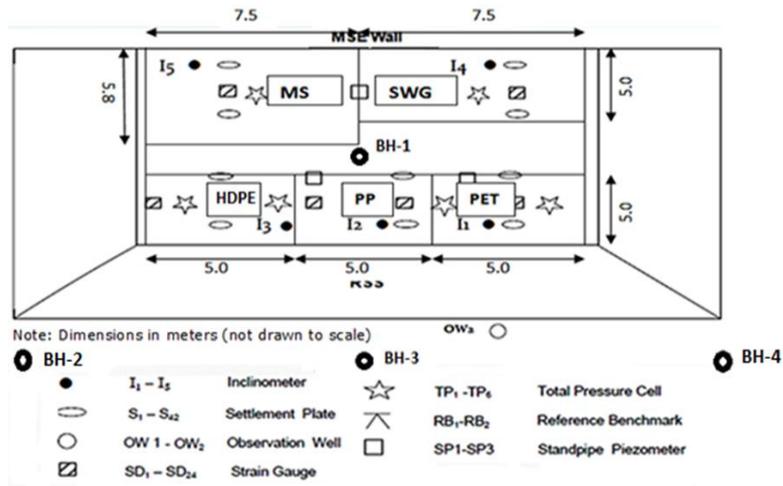
Fig. 8 Plan of MSE wall/embankment.

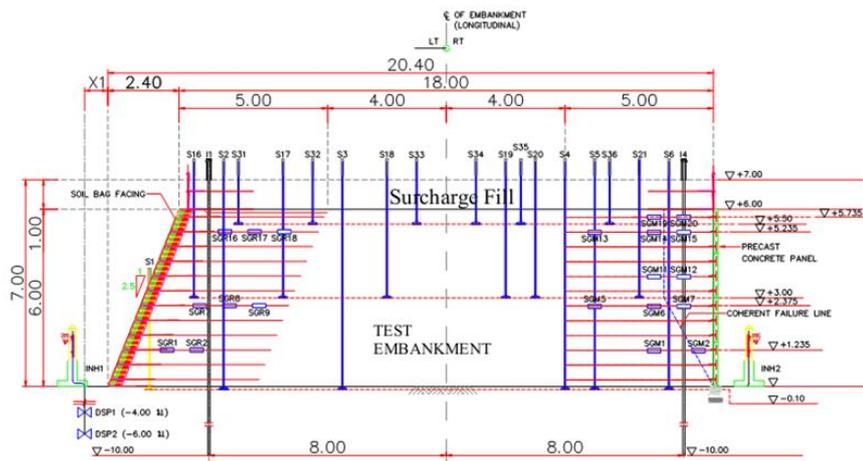
Fig. 9 Cross section of MSE wall/embankment indicating the location of the monitoring instrument.

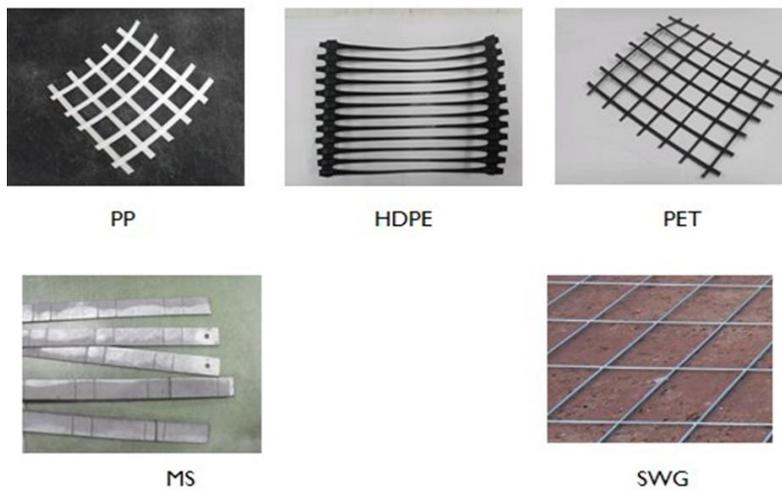
**Fig. 10** Reinforcing materials

Two types of reinforcement, namely: polymeric and metallic reinforcements, were used in the reinforced embankment. Details regarding the five different polymeric and metallic reinforcements are tabulated in Table 2. The reinforcing materials are shown in Fig. 10. The photographs of the vertical face and sloping face with metallic and polymeric reinforcements, respectively, are shown in Fig. 11.

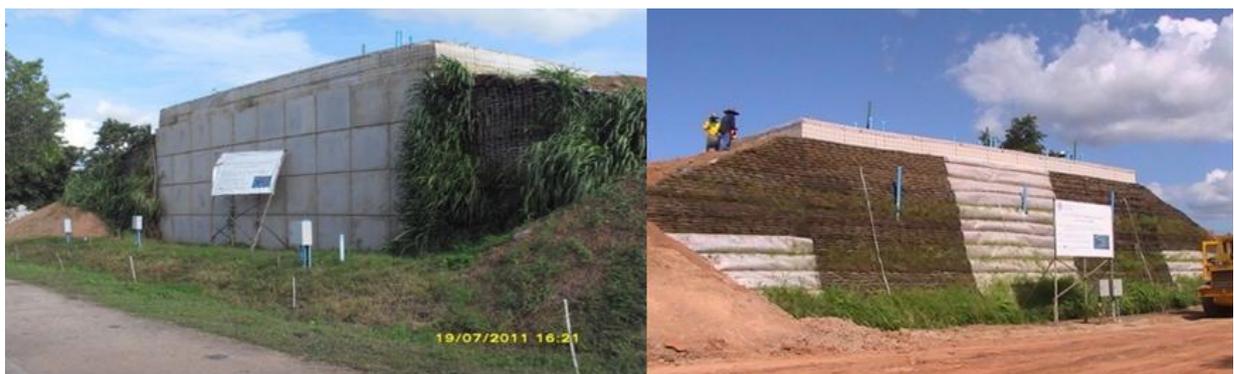
**Fig. 11** Photograph showing vertical face and sloping face with metallic and polymeric reinforcements, respectively.

The test embankment was constructed to 6 m height for 125 days. Subsequently, a surcharge of 20 kPa (1.2 m thick of fill) was added at the top of the embankment as shown in Fig. 11. The lateral deformations were monitored until 186 days after construction. The lateral deformation of each type of polymeric reinforcement (i.e., PET, PP and HDPE) on the RSS side and each type of metallic reinforcement (i.e., MS and SWG) on the MSEW side obtained from field measurements using inclinometers is compared with the numerical simulation results at 186 days after the end of the construction. The inclinometer readings and field measured values after 186 days for polyester (PET) and steel wire grid (SWG) are shown in Figs. 13 and 14, respectively. At the top of the embankment, larger deformation for PET (i.e. 21mm) and smaller deformation for SWG (i.e. 6mm) were observed. This is due to smaller value of stiffness of polymeric reinforcement. The 3 polymeric reinforcements had similar lateral deformations.

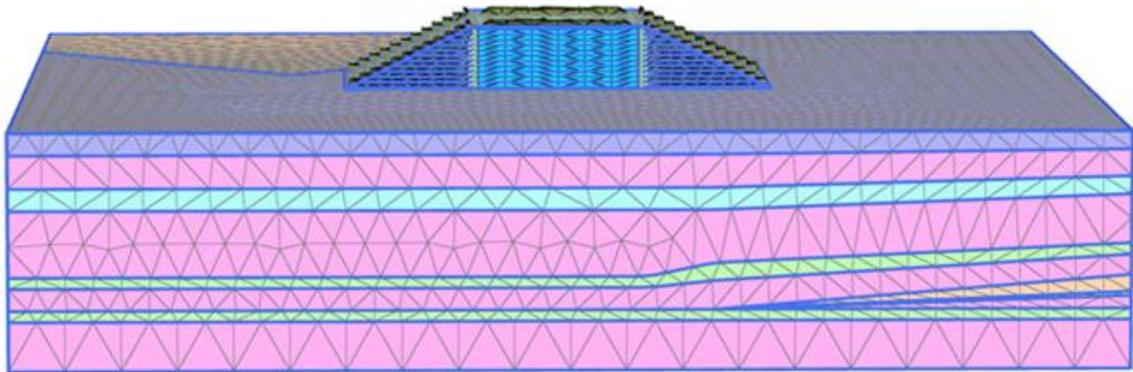
Fig. 12 3D Discretization model of MSE wall/embankment

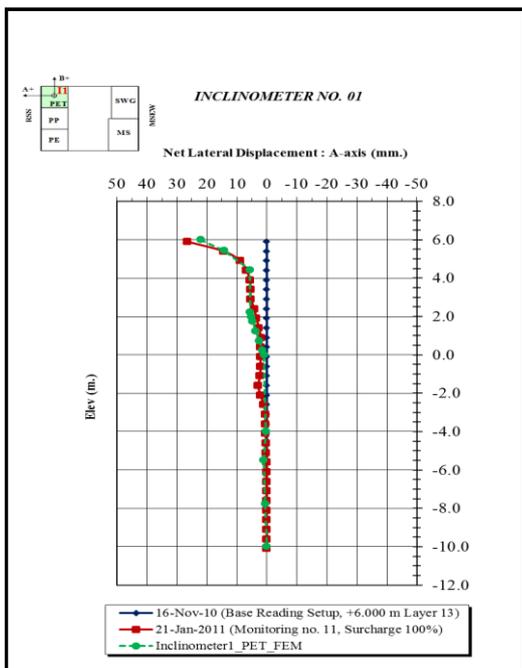
Fig. 13 Inclinometer readings at the facing of the polyester (PET) geogrid reinforcement

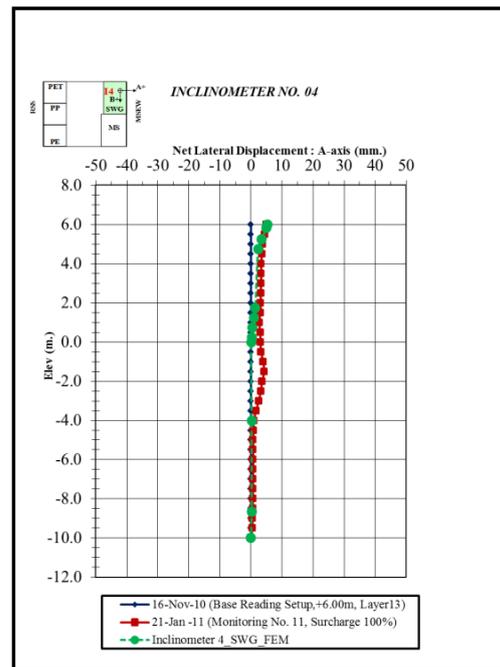
Fig. 14 Inclinometer reading at the facing of the steel wire grid (SWG) reinforcement

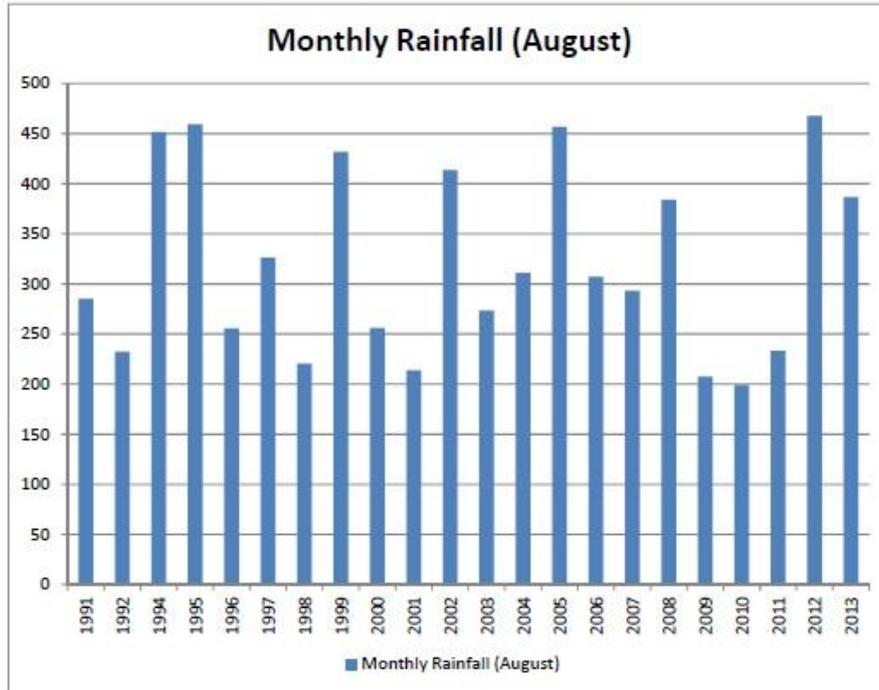
Fig. 15 Monthly rainfall for August near NR 1B, Laos

Weather has been extreme in 2013 which started early June and continued until December. Typhoon Trami brought heavy rainfall from 19-21 August 2013. The three days heavy rainfall was unusual. The monthly rainfall data in August and September from 1991 to 2013 are plotted in Figs. 15 and 16, respectively.

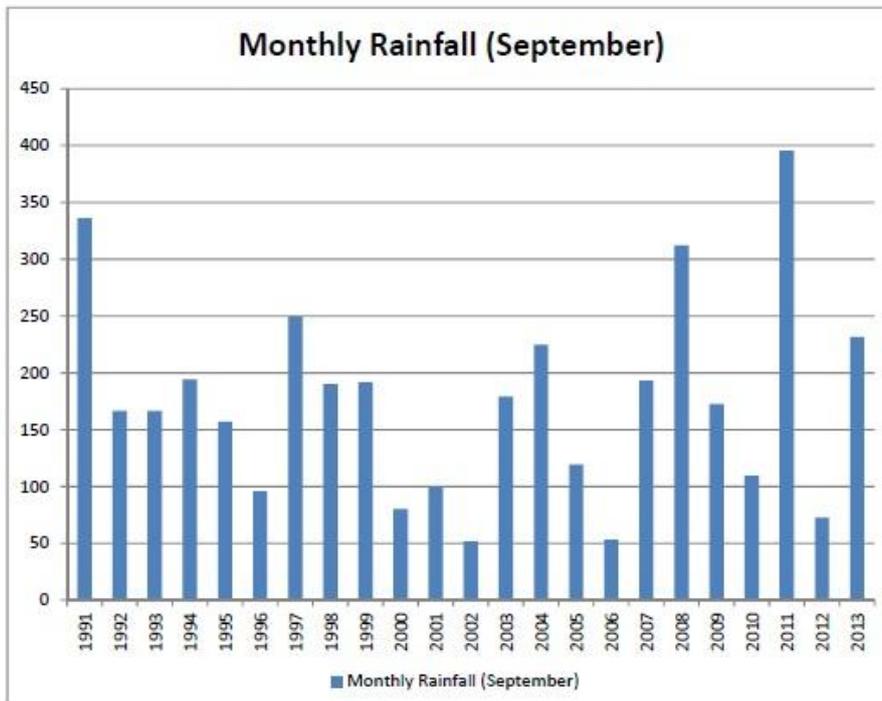
Fig. 16 Monthly rainfall for September near NR 1B, Laos

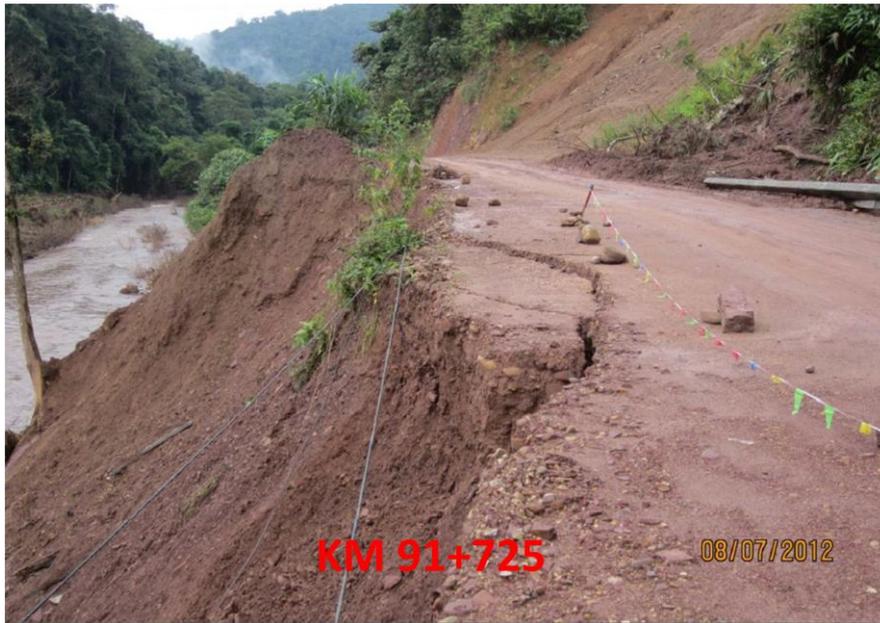
Fig. 18 Landslide at KM92

In Fig. 18 at KM 92, slope failures also occur in the lower slope adjacent to a river. Both external and internal slope stability were performed at the slope sections. The external slope stability analyses were done without reinforcements while the internal slope stability analyses were done with

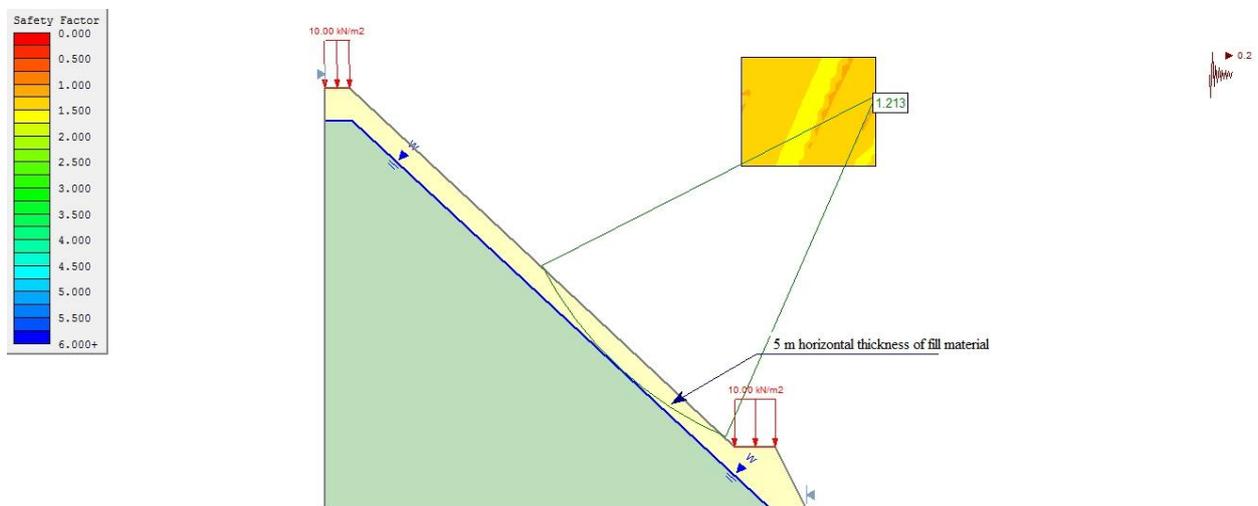
Fig. 19 External slope stability analysis at KM 92

geogrid reinforcements. Results of the external slope stability are shown in Fig. 19 which indicated safe values of the factor of safety. In addition, infinite slope stability analyses with reinforcement ( $T_{ult} = 150 \text{ kN/m}$ ) were done. The ultimate tensile capacity of the reinforcements was assumed to be 150 kN/m with vertical spacing of 0.5 m.

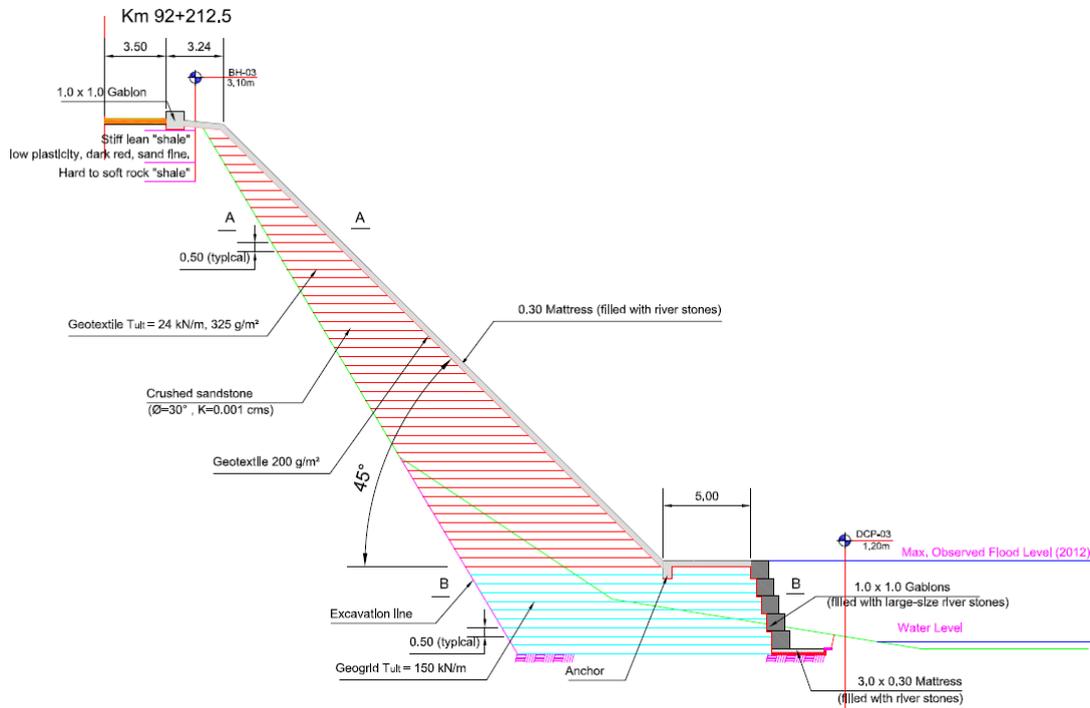
Fig. 20 Proposed mitigation using geosynthetics at KM 92

The recommended mitigation measures for this landslide is shown in Fig. 20. The lower sections of the soil erosion mitigation adjacent to the river bank consisted of gabions with 1.0 m by 1.0 m cross-section filled with large size river gravel. The gabions shall extend from 4 to 7 m in height to protect against the highest observed flood level of the river. Behind and underneath the gabions, geotextiles ( $200 \text{ g/m}^2$ ) were provided as separator, filter and drainage. Moreover, the

lower sections, were reinforced with polymer geogrids ( $T_{ult} = 150 \text{ kN/m}$ ) with vertical spacing of 0.5 m in combination with the gabions. The polymer geogrids consisted of polyester (PET) geogrids.

In the upper sections of the erosion mitigation measures, a combination of 0.30 m thick mattresses filled with large size river gravel and geotextile reinforcements ( $T_{ult} = 24 \text{ kN/m}$  and 325 grams/square m) with 0.5 m vertical spacing shall be

provided. Beneath the mattresses, geotextiles ( $200 \text{ g/m}^2$ ) shall be installed as separator, filter and drainage. Progress of construction and completed construction at KM 92 are shown in Figs. 21 and 22. The loose overburden layers were remarked and replaced with compacted crushed sandstone fill. The geotextile reinforcements also served as horizontal drainage.

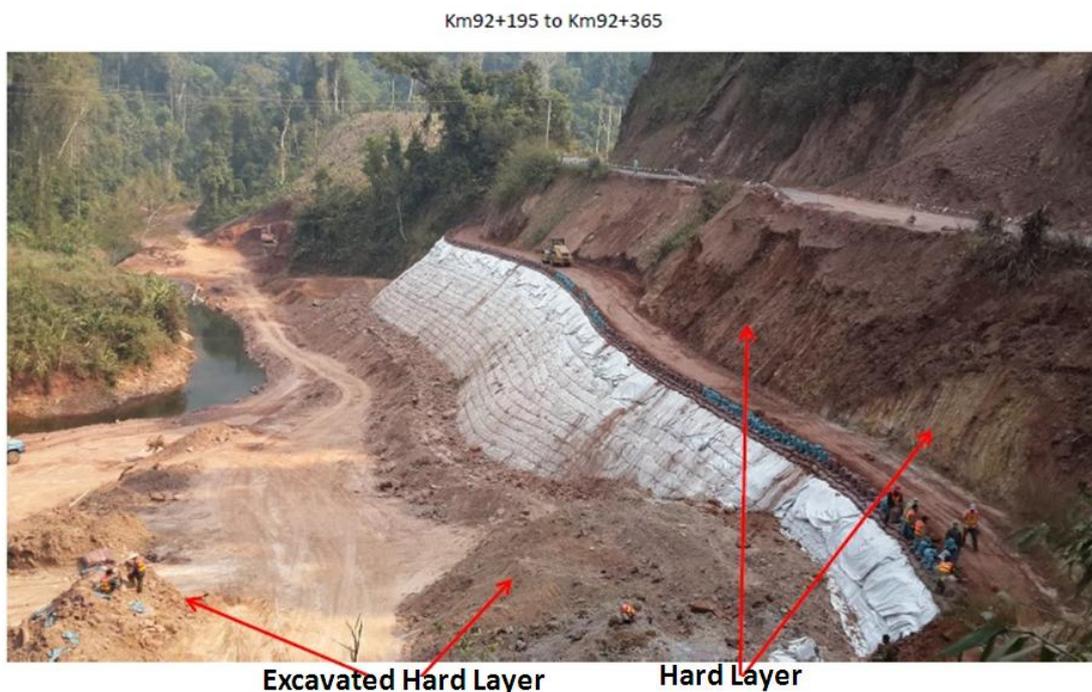
Fig. 21 Progress of construction for KM 92

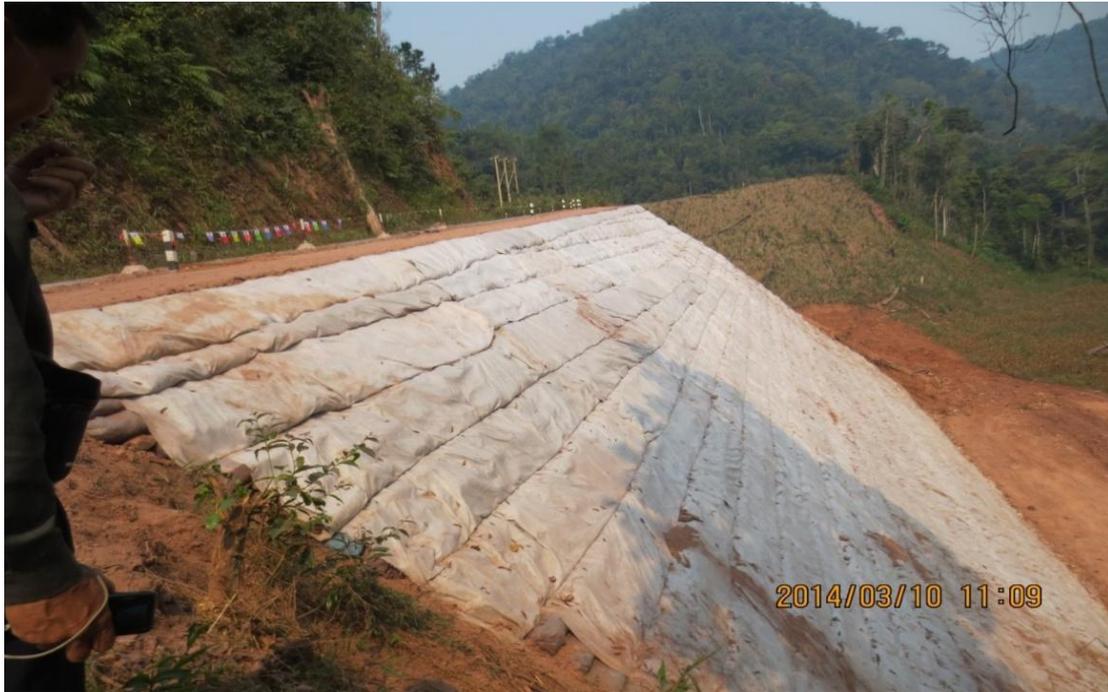
Fig. 22 Completed construction at KM 92

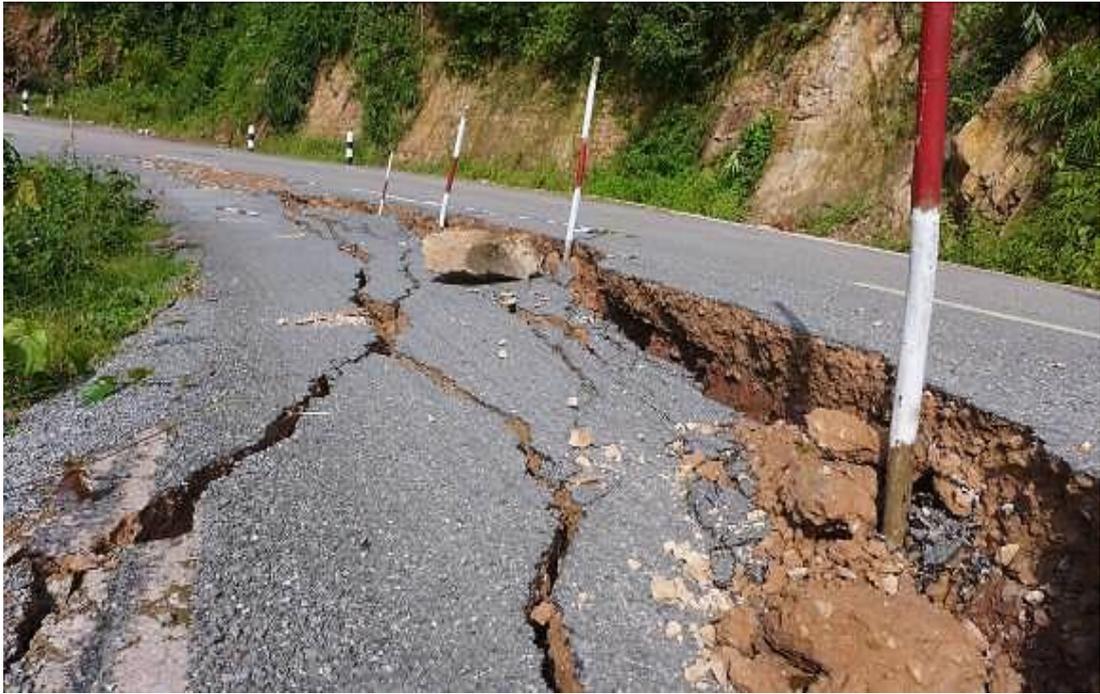
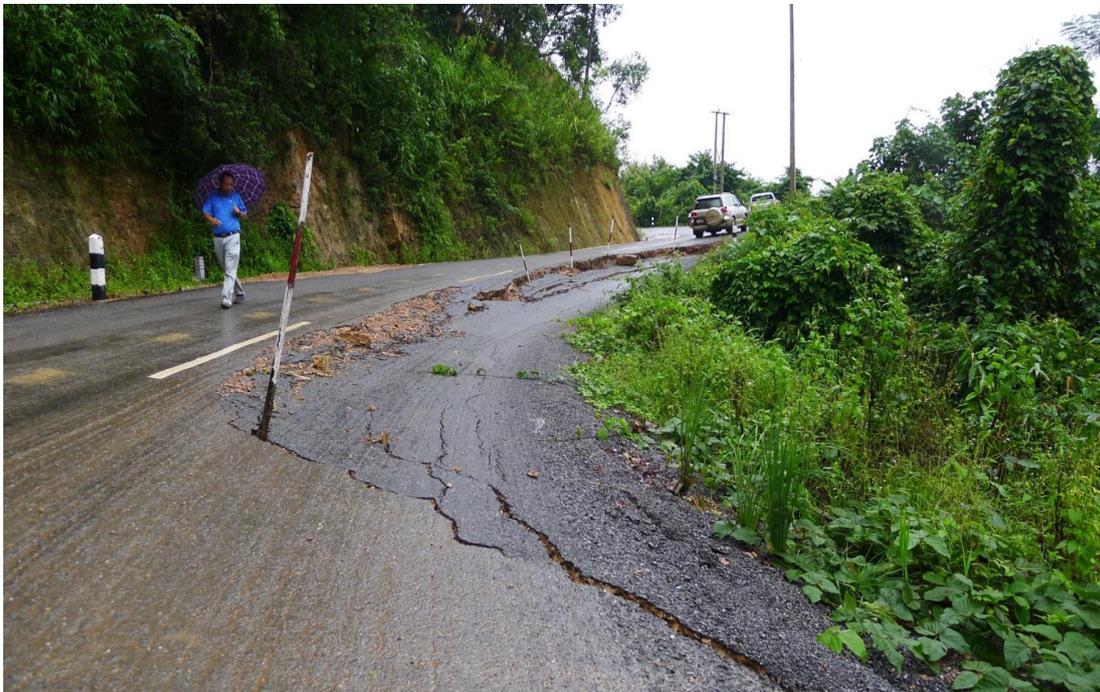
a. Deep slope failure at KM 27

b. Deep slope failure at KM 27

**Fig. 23** Deep slope failure at KM 27

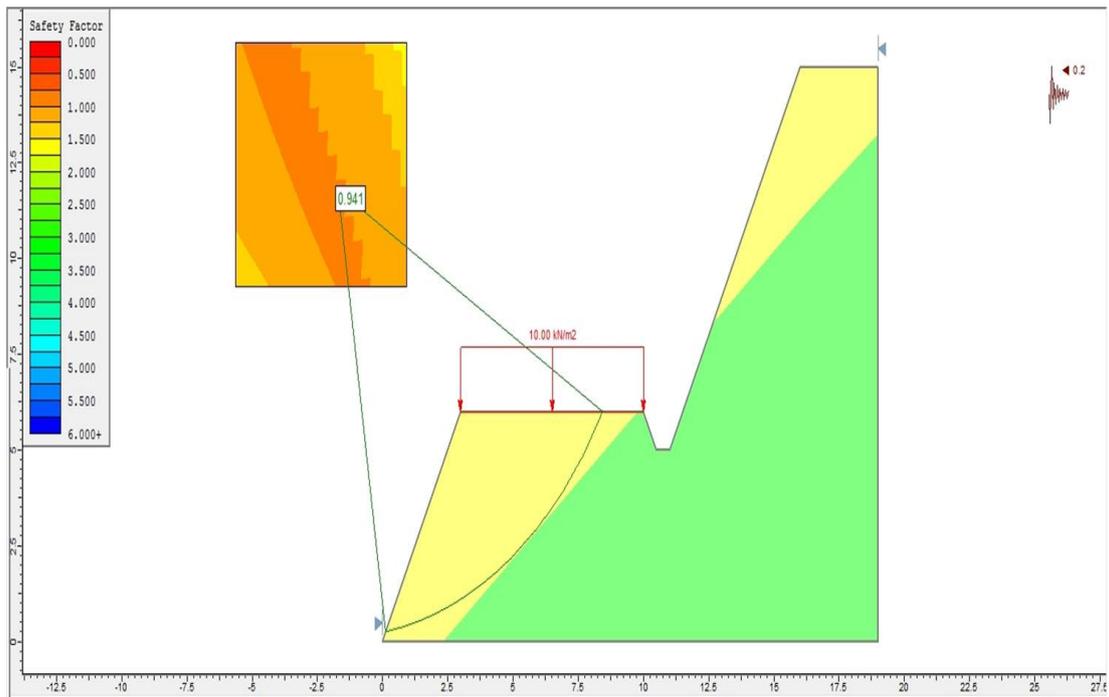
Fig. 24 External slope stability with surcharge load of 10kPa and 0.2 g of horizontal earthquake force

Both external and internal slope stability were performed at the slope sections corresponding to the locations of boreholes. The internal slope stability analyses were done with high strength geotextile reinforcements. The ultimate tensile capacity of the geotextile reinforcements consisted of PEC-150 was 150 kN/m with vertical spacing of 0.5 m. The external slope stability is illustrated in Fig. 24.

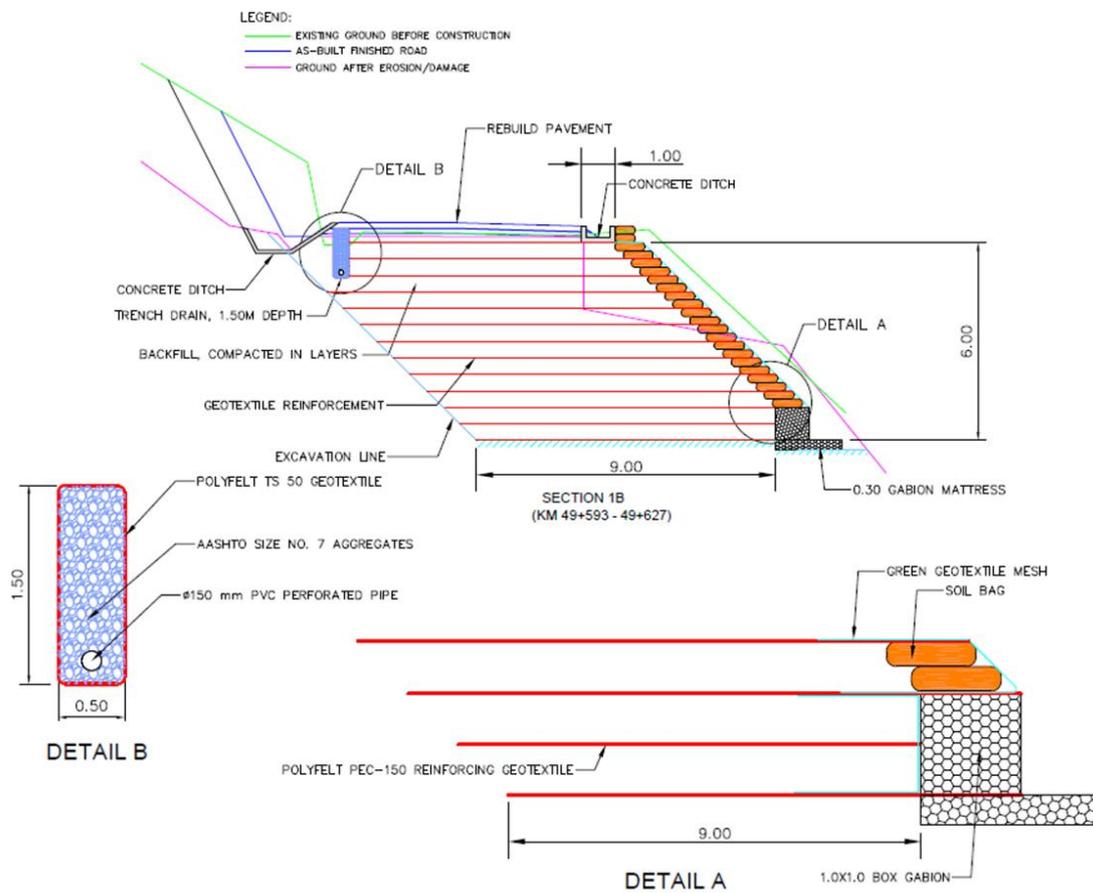
Fig. 25 Mitigation scheme combining trench drain and reinforcement with high strength geotextiles

The recommended mitigation measure is proposed for the slope sections as shown in Fig. 25 combination of 5 to 6m high geotextile reinforced lower slope and trench drain (1.5m deep and 0.5m wide) with TS50 ( $T_{ult} = 15 \text{ kN/m}$ ) geotextile as separator, filter and drainage. Moreover, the lower slope shall be reinforced with 6 to 9m long PEC150 polymer geotextile ( $T_{ult} = 150 \text{ kN/m}$ ) with vertical spacing of 0.5 m in combination with the gabion or jute bag facing. The geotextile reinforcement consisted of high strength polypropylene geotextiles. The high strength non-woven and needle-punched geotextile reinforcements can also serve as horizontal drainage.
