Landslide Hazard Mapping and Mitigation Measure in Pathong City

Suttisak Soralump¹, Mananya Chantasorn², Damrong Pungsuwan², Nuttawut Intamala³

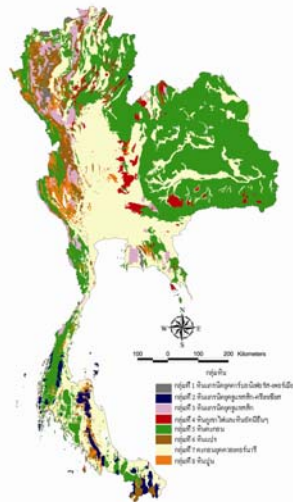
Fig. 1 Geologic map of Thailand classified by level of landslide hazard (Soralump, 2006)

Landslide is one of natural hazard that affected Thailand. The direct economic lost due to landslide is calculated to be equal to 60 million Baht per year and the return period of large area landslide is once in every 5 years (Soralump, 2006). Fig. 1 shows the geologic map of Thailand which group of rock related with the capability of producing landslide. From recorded data, Soralump (2006) found that Granitic rock in Jurassic era has highest rate of landslide (per unit area) (Fig. 2).

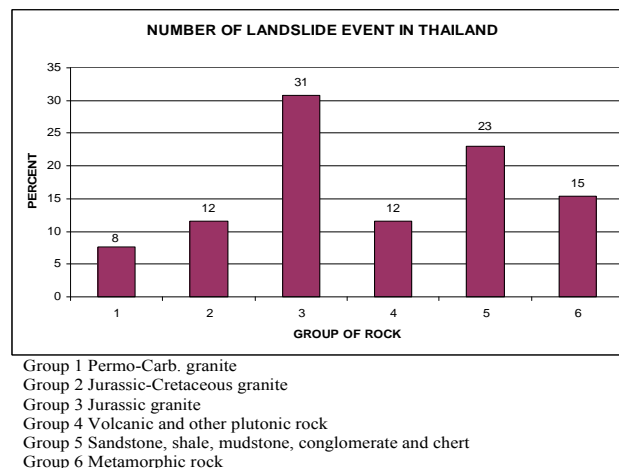
Fig 2 Number of landslide event per area of rock group in Thailand (Soralump, 2006)

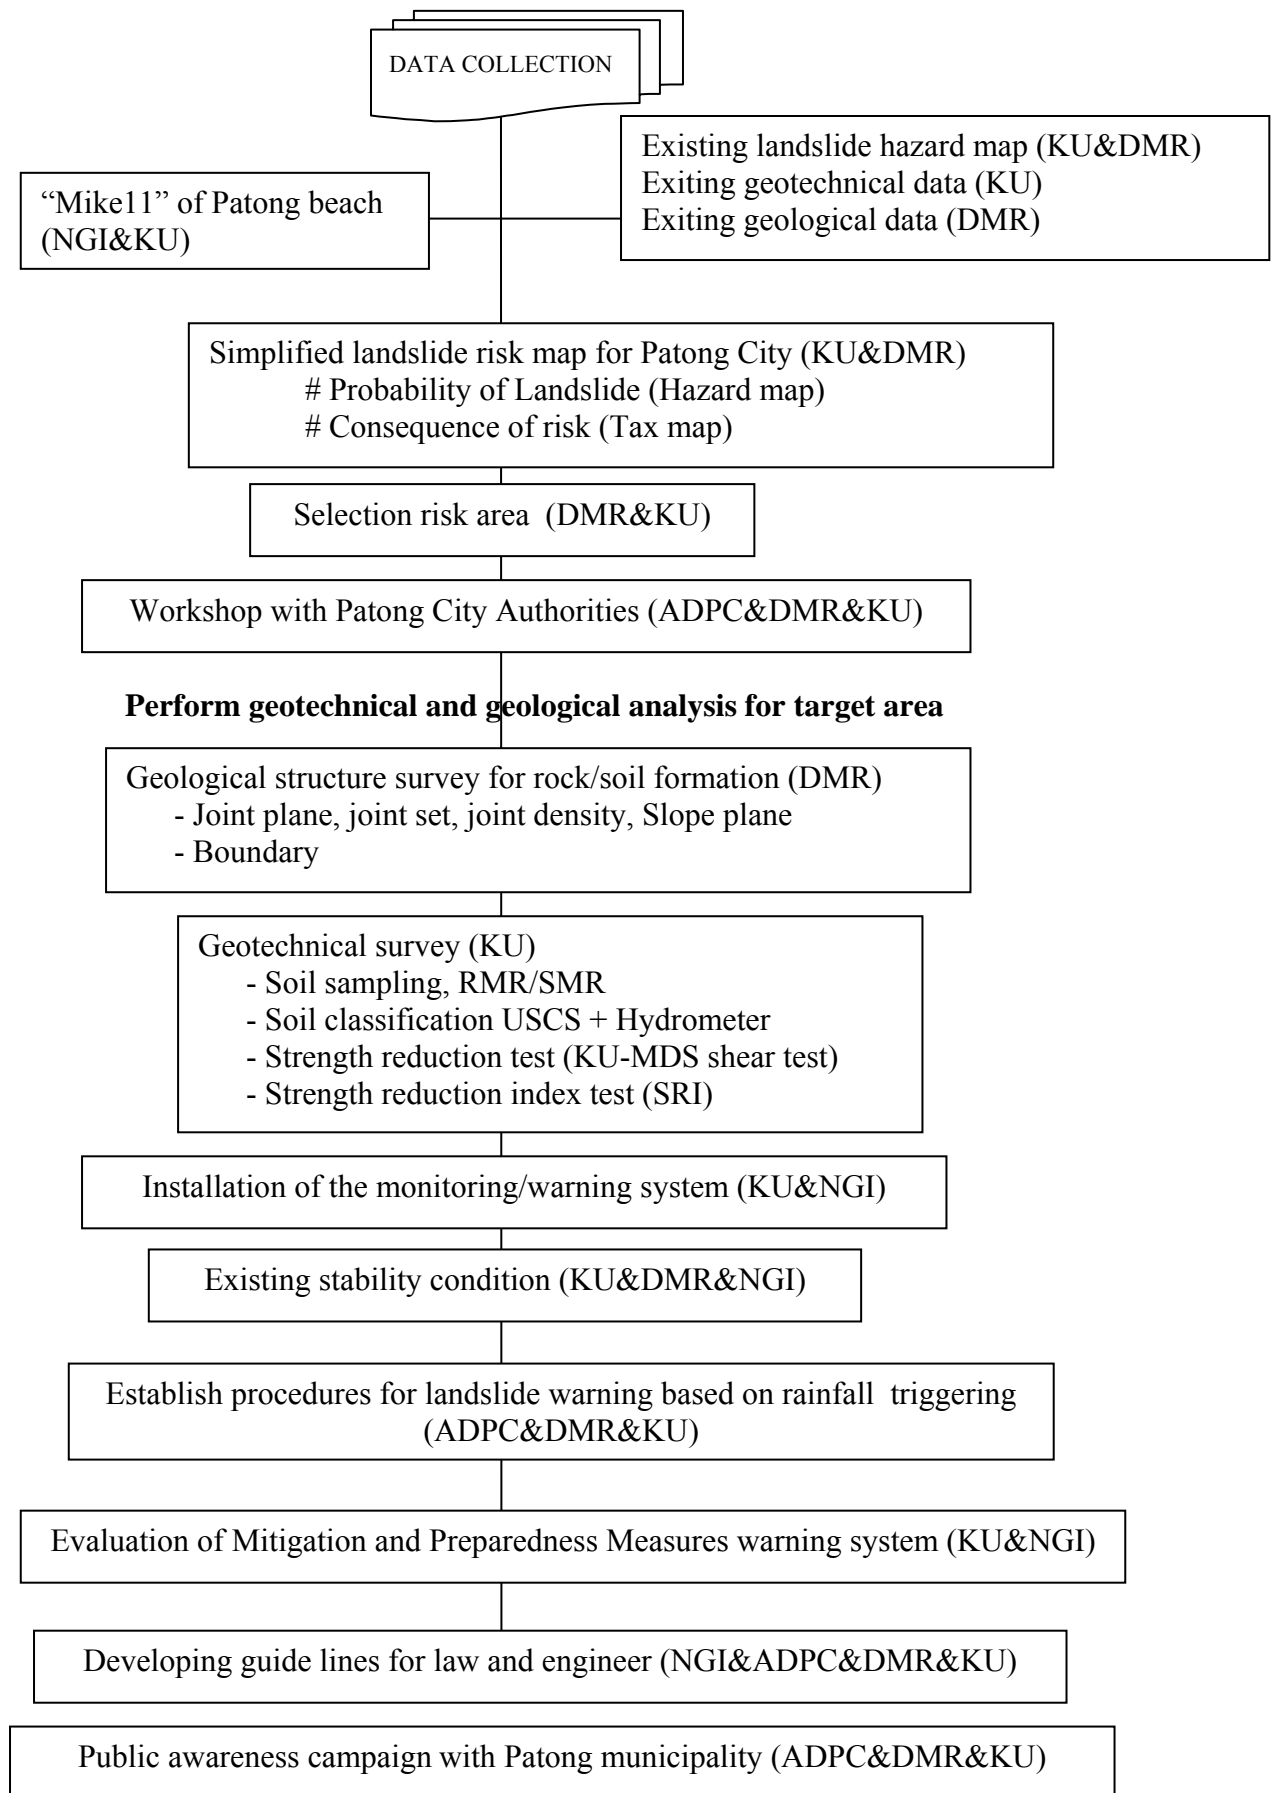
Fig 3 Flow chart of landslide mitigation project in Pathong City

Phuket is one of the provinces that has high potential of affecting by the landslide, Pathong city in particular. Therefore, it is necessary to perform detail analyses in order to provide the suitable regulation and mitigation measures to reduce the risk from landslide. Fig. 3 shows the flow chart of this project.

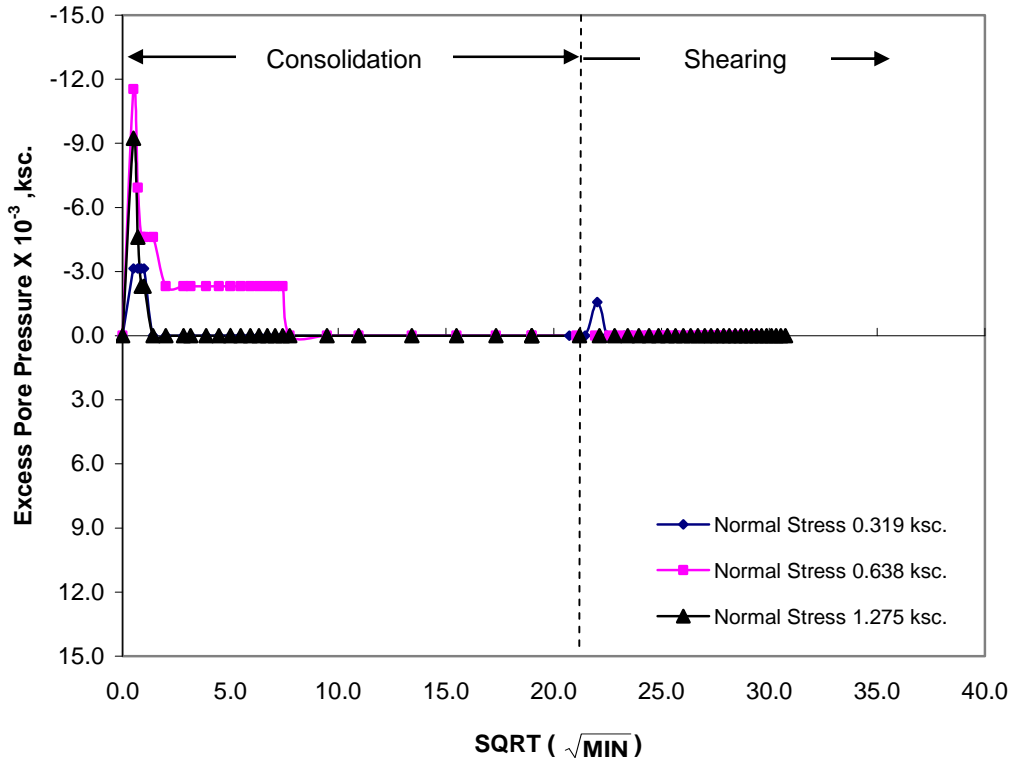
Fig. 6 Excess pore pressure measurement during the tests

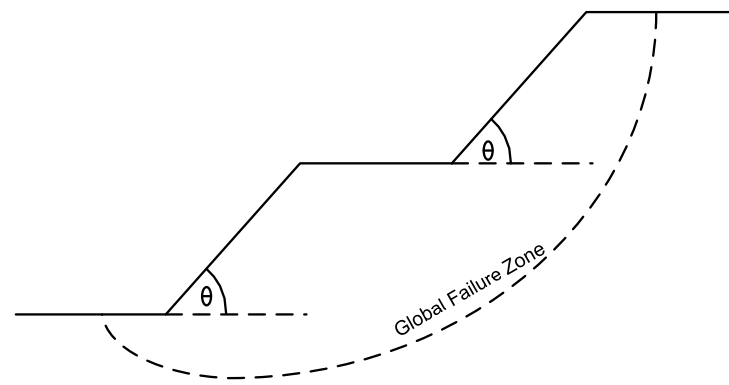
a) Two benching model

b) One benching model

c) Cut slope model

Fig. 10 Cross section models for stability analyses

Three kinds of cross section were investigated as shown in Fig 10. They are two benching section, local slope in the upper or lower bench and cut slope from road or construction cutting (2H:1X). The preliminary results show that the failure surface doesn't occur through two benching as an overall stability failure but it rather failed at the local slope either lower or upper one.

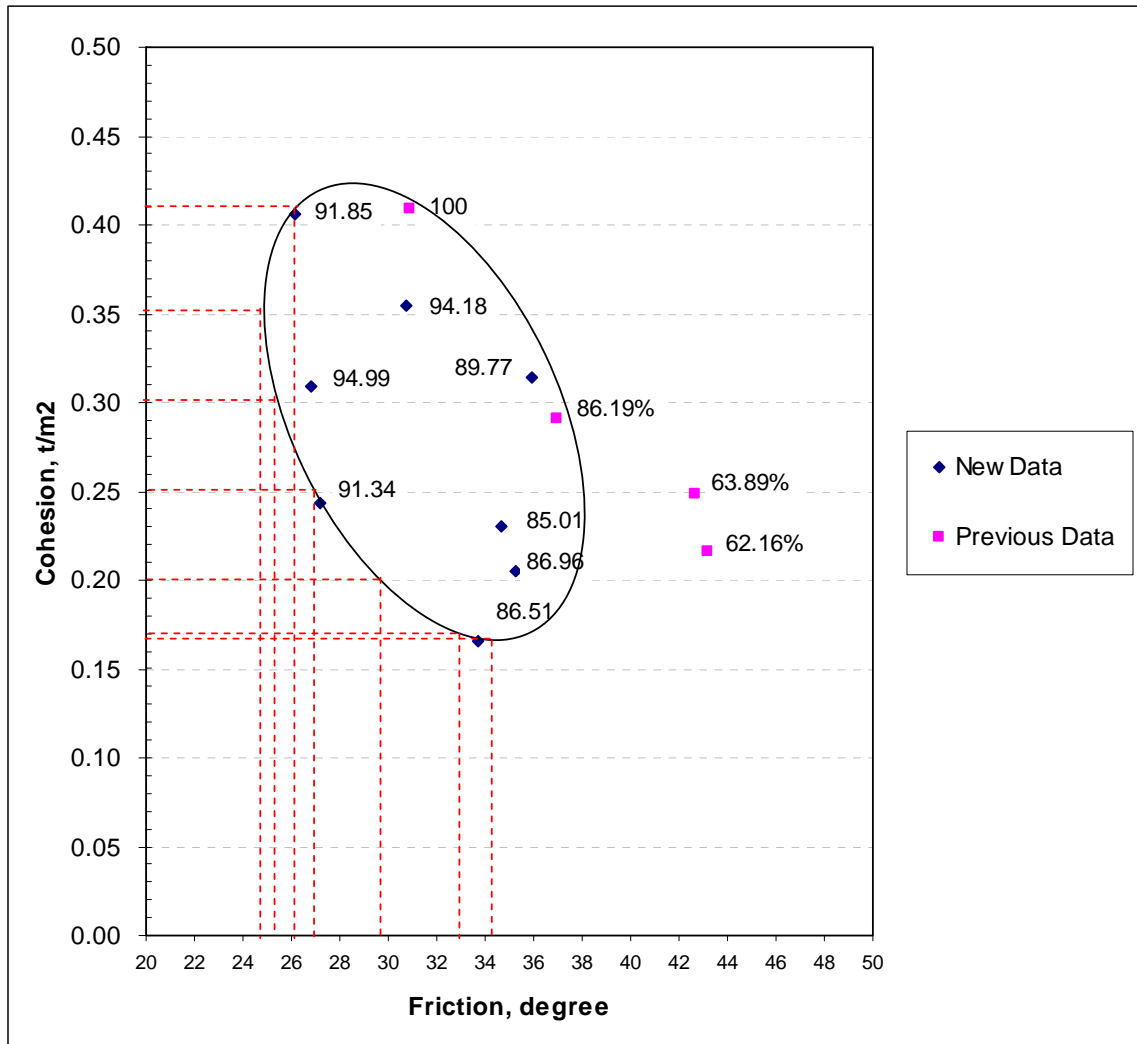
Cohesion	0.168	0.170	0.200	0.250	0.300	0.350	0.410
Degree	34.5	33.0	29.6	27.0	25.2	24.8	26.1

Fig 11 Boundary of strength parameters used for the analyses

The analyses were done with various degree of slope from 14 to 40 degrees of both natural (one bench) and cut slope as shown in Fig 23. Since the strength parameters are vary based on degree of saturation, therefore the slope analysis were done by trial strength parameters along the lower bound line to obtain the possible lowest F.S. (Fig. 11). The results are summarized in Fig 12-13. The results show that the cut slope has lower FS than natural slope as expected. The critical slope angle that cutting will be vulnerable for landslide is 17.1 degree corresponding to FS equal to 1.3. Therefore, any construction cutting in the natural slope with slope angle greater than 17.1 degree, the slope need to be analyzed and the counter measures need to be considered.

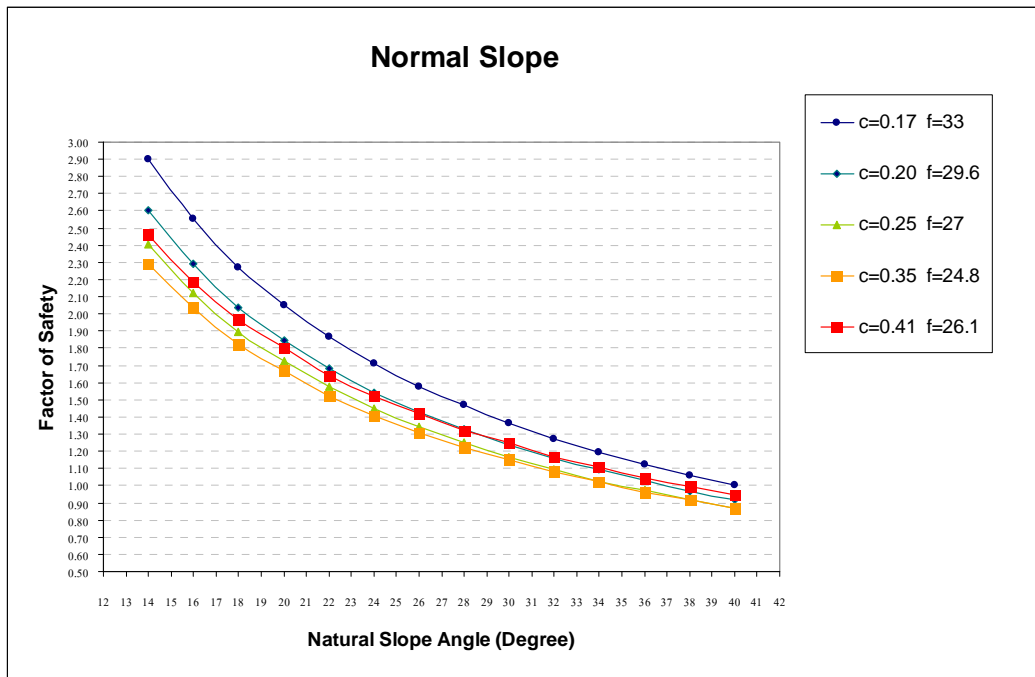
Fig. 12 Factor of safety with various slope angles

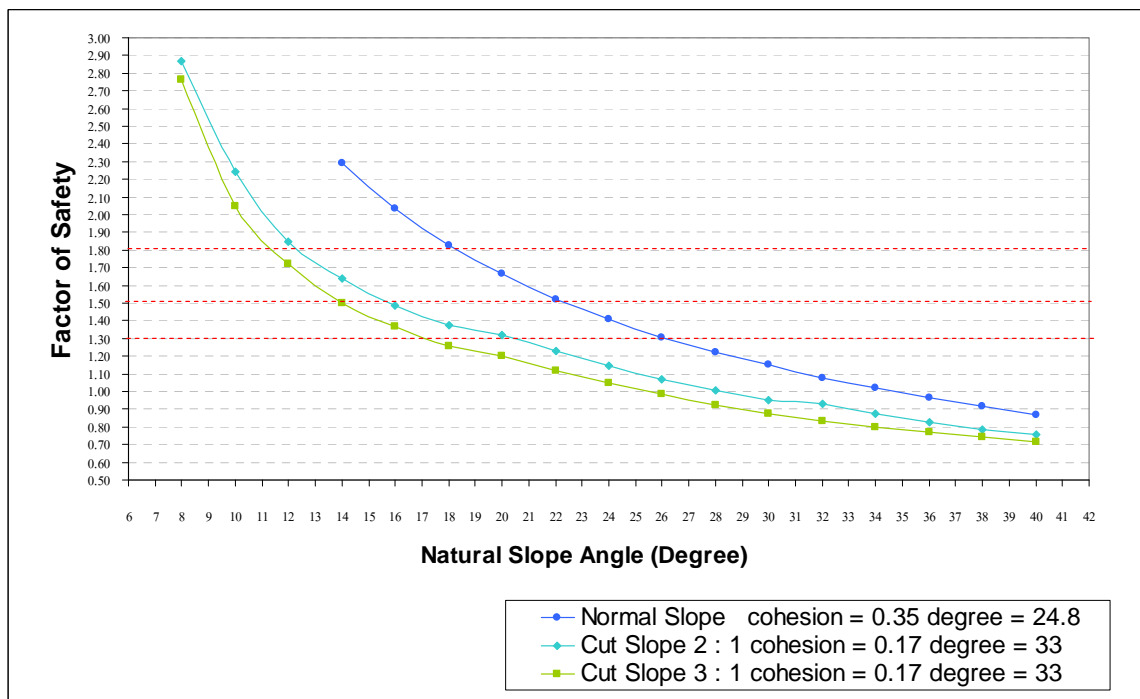
Fig. 13 Factor of safety with various slope angles and cut slope conditions

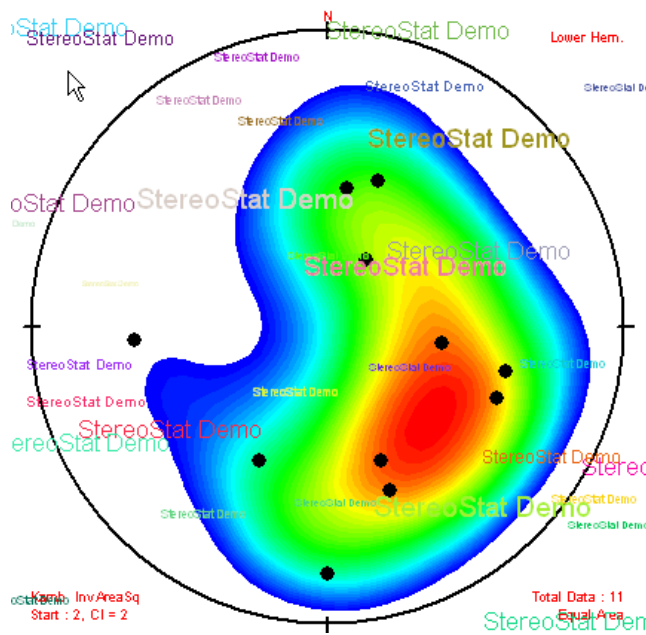
Fig. 15 Stereo net of rock fractures in Patong

In order to consider the influence of geologic structure, the bedding-slope relationship is considered. However, after collecting the rock structure data which are strike and dip direction in various locations in Patong, it found that the rock fractures in Patong area are quite random as shown in Fig 14 and 15. Therefore, this factor is not used in the analysis.

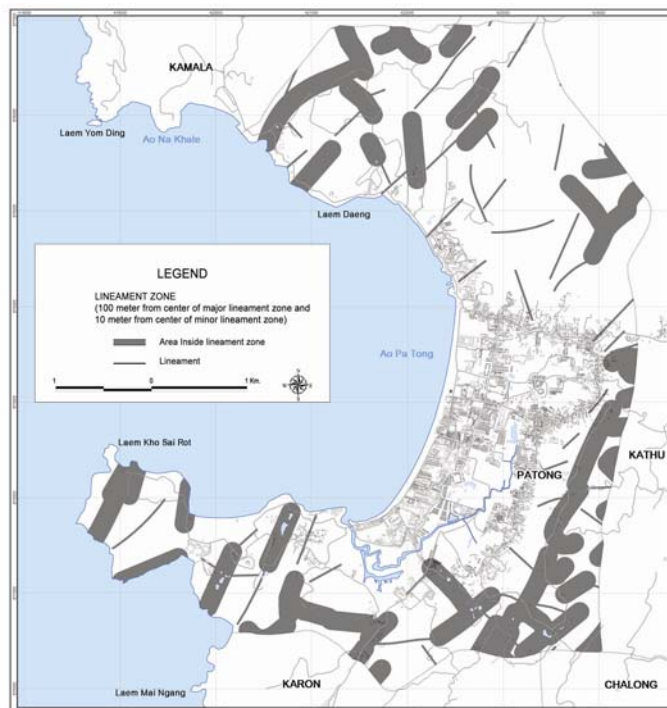
Fig. 19 Factor safety classification

Fig. 20 Lineament zone

Fig. 21 Distance from road

Fig. 22 Elevation

Fig. 23 Surface drainage area

Fig. 24 Land use and land cover

In determining the numerical rating of altogether 6 parameters Affected to the Landslide Potential in Patong, an area of 5x5 square meters grid cell has been employed for the analysis by GIS program. The weight-rating value of each parameter is determined in each square grid cell of each derivative map. Finally, the scores of weight-rating in each 5x5 square meters grid cell is obtained from the summation of weight-rating values of each derivative map to obtain the landslide susceptibility map. The map of each influencing factors is shown in Fig 19 to 24.
