Landslide Risk Prioritization in 6 Provinces Affected by Tsunami

Suttisak Soralump

Director, Geotechnical Engineering Research and Development Center
Civil Engineering Department, Faculty of Engineering
Kasetsart University

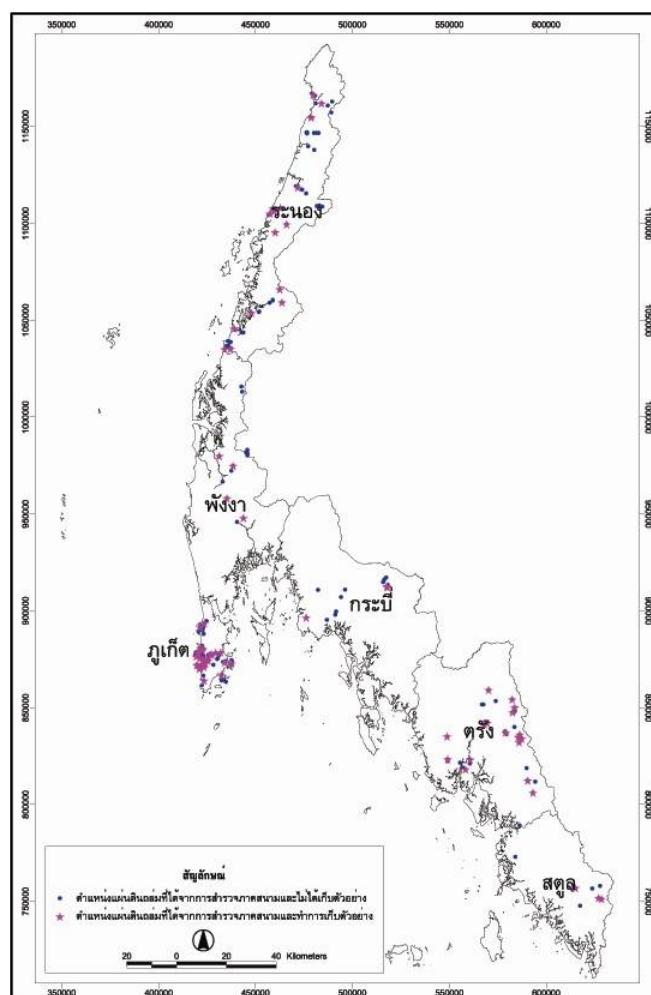
Figure 1 Study area

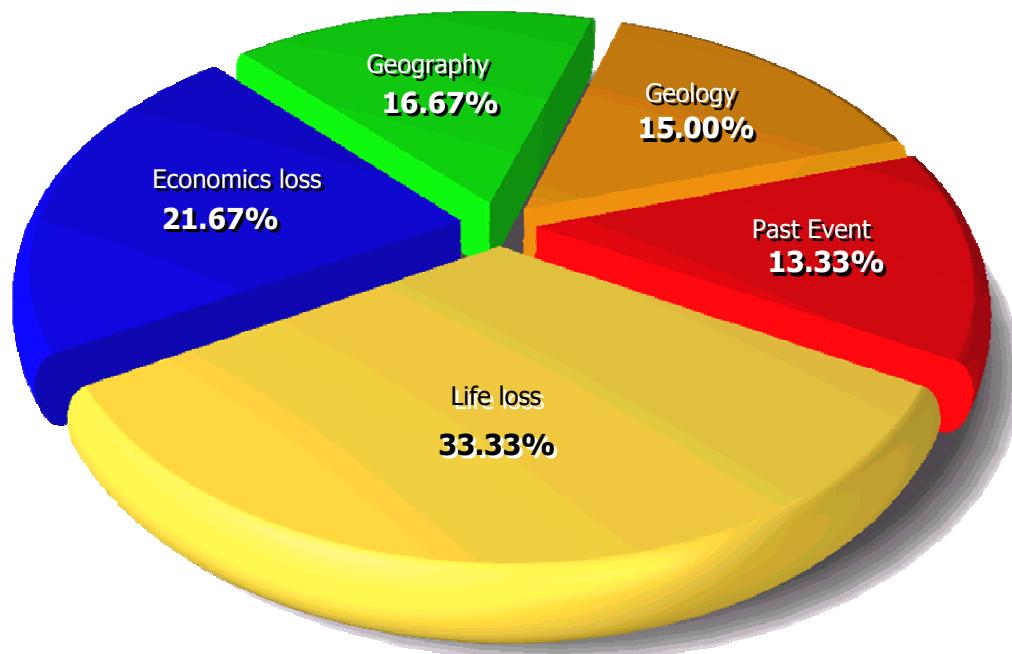
Figure 2 Weight of major factor in percentage

Weighting factor method was used to calculate risk score or risk index in order to rank the landslide hazard area. The analysis was done by assigning the weight to the major and minor factors by expert opinion using scoring matrix technique. The matrix works by comparing the important of a pairs of factor and give score from 1 to 5 which range from the most important to the least important. The major factors were weighted through the matrix as shown in Table 1 and Fig 2. The weighting procedure was done for minor factors as well. The conclusion of weight is shown in Table 2 and Fig 3.

Major factors		1	2	3	4	5	Total score	In percentage (%)
		Past Event	Life loss	Economic loss	Geography	Geology		
1	Past event	-	1	2	3	2	8	13.3
2	Life loss	5	-	5	5	5	20	33.3
3	Economics loss	4	1	-	4	4	13	21.7
4	Geography	3	1	2	-	4	10	16.7
5	Geology	4	1	2	2	-	9	15.0

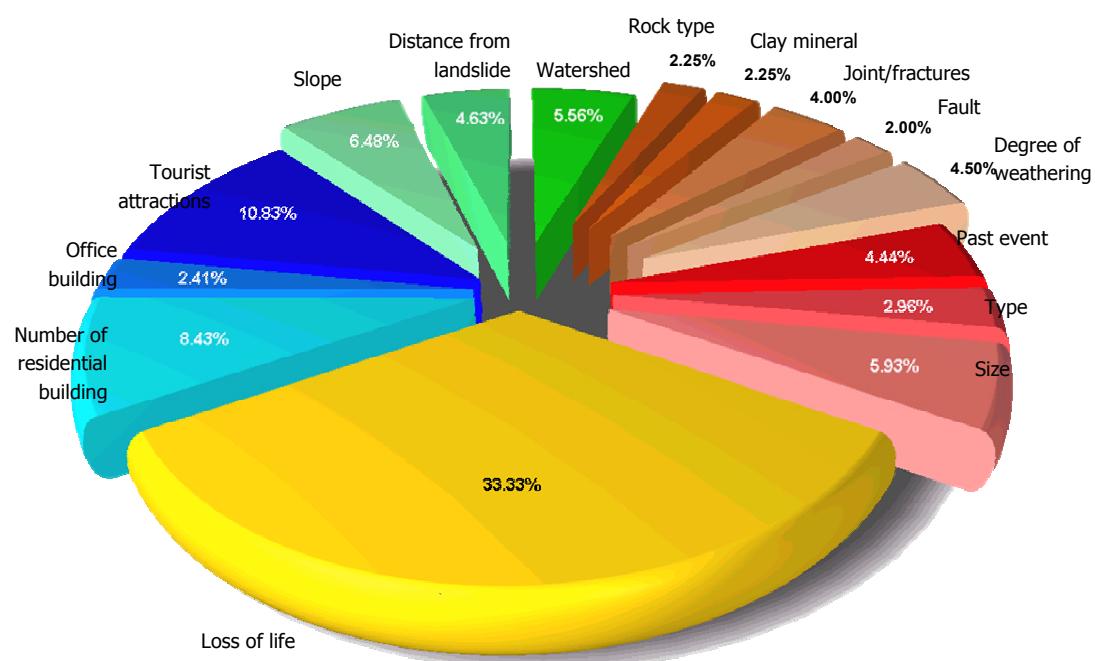
Figure 3 Weight of major and minor factors

Major Factors	Major Weight (%)	Minor Factors	Minor Weight (%)	Adjusted weight (%)
1	Past event	13.3	Number of past event	33.3	4.4
			Type of landslide	44.5	5.9
			Size of landslide	22.2	3.0
2	Life loss	33.3	Number of village downslope	100.0	33.3
3	Economics loss	21.7	Number of residential building	38.9	8.4
			Official building and road	11.1	2.4
			Hotel and torious attractions	50.0	10.8
4	Geography	16.7	Slope angle	38.9	6.5
			Diatance from landslide the nearest village	27.8	4.6
			Watershed area	33.3	5.6
5	Geology	15.0	Rock type	15.0	2.3
			Clay mineral content	15.0	2.3
			joint and fractures content	26.7	4.0
			Present of fault	13.3	2.0
			Degree of weathering	30.0	4.5
Total		100.0		500.0	100.0

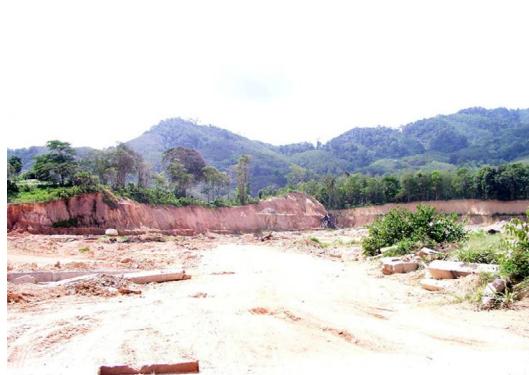
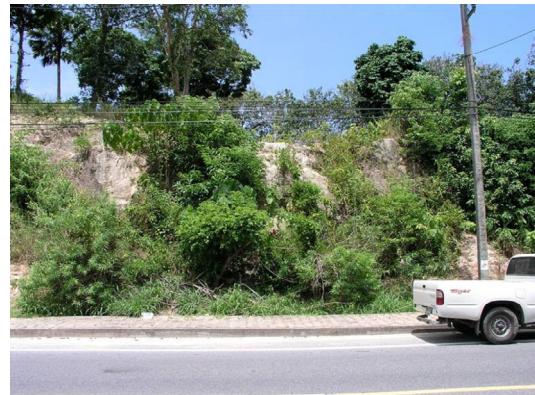
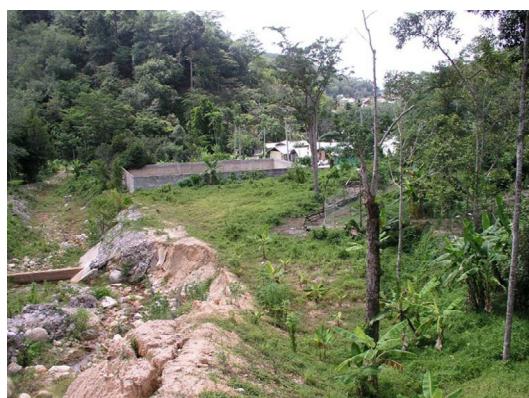
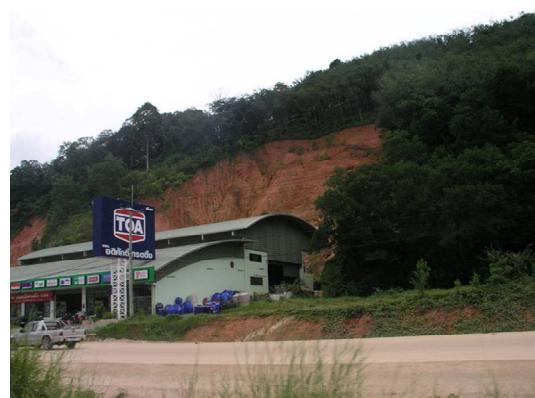
Score level 0

Score level 1

Score level 2

Score level 3

Figure 5 Example of scoring for distance and flow path factor

Fig. 4 shows how scoring was done. The scores were assigned to various conditions of minor factors. Data from field investigation were used to explain the range of conditions of each minor factor. The example of score for distance and flow path factor is shown in Fig 5.

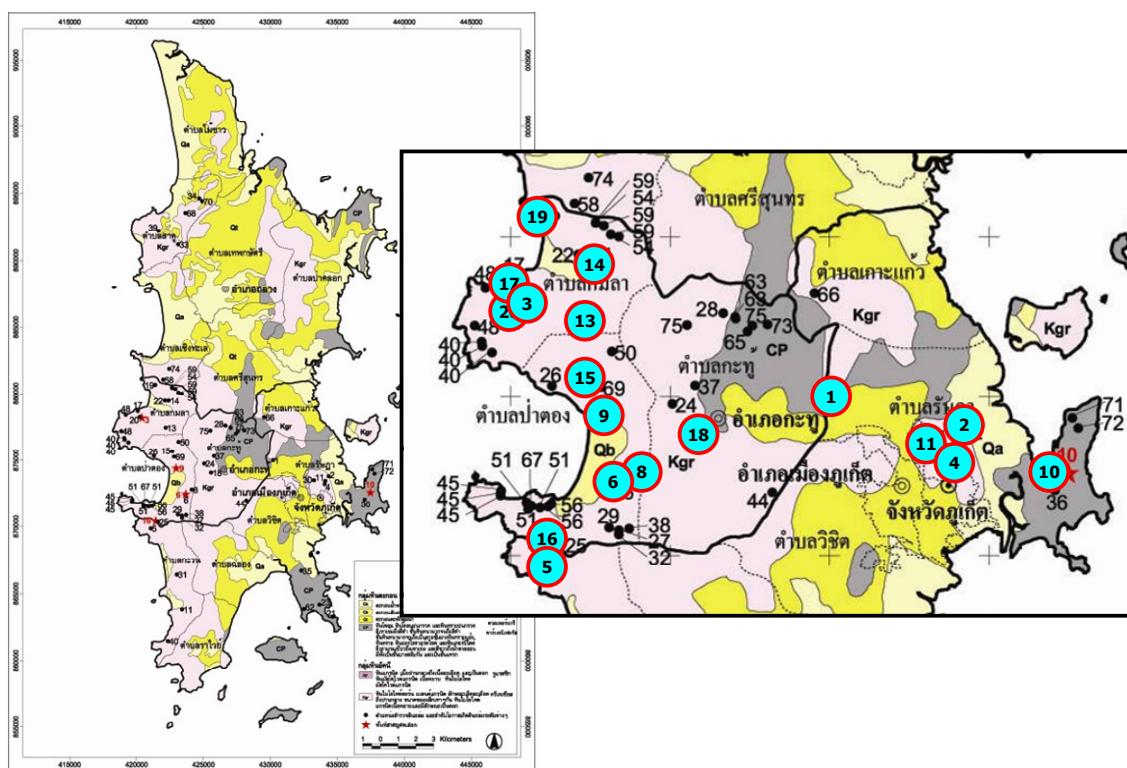
Figure 6 Landslide hazard areas in Phuket Island

220 locations of previous and existing landslide were scored and weighted in order to obtain risk score of each location. Part of results is shown in Table 3. Fig. 6 shows the first 20 risk area. It can be seen that those 20 areas are all situated in Phuket Island. It also shows that most of the landslide occurred was triggered by slope cutting instead of natural event. 7 out of 220 locations were selected in order to perform detail investigations and analyses.

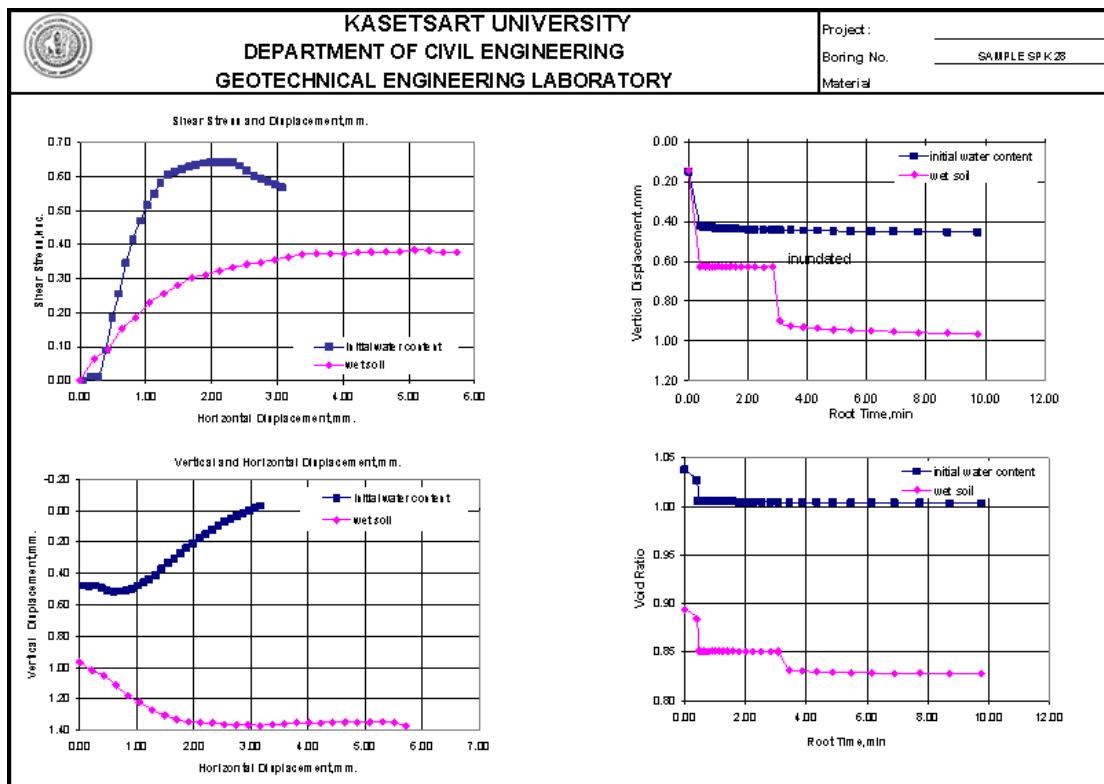
Figure 7 Example of the results of direct shear test for strength reduction index

118 undisturbed soil samples were collected and tested by conventional direct shear machine. Two types of test have been done including strength reduction index test and multi degree of saturation-multistage direct shear test (KU-MDS shear test). The later tests were done only in selected area in order to back analysis the event using the rainfall data. The prior tests were done in order to study the characteristic of residual soil weathered from various rock type. The test were designed to be rather quick and easy by testing the shear strength of soil sample at its natural water content and compare with the shear strength obtain from 24 hours saturated soil sample. The reduction of undrained shear strength due to saturation is called strength reduction index. Fig. 7 shows the example of test result. Several granitic soil were tested, the results revealed that the granitic soil in these 6 provinces has tendency of less than 40 percent strength reduction (Fig 8).

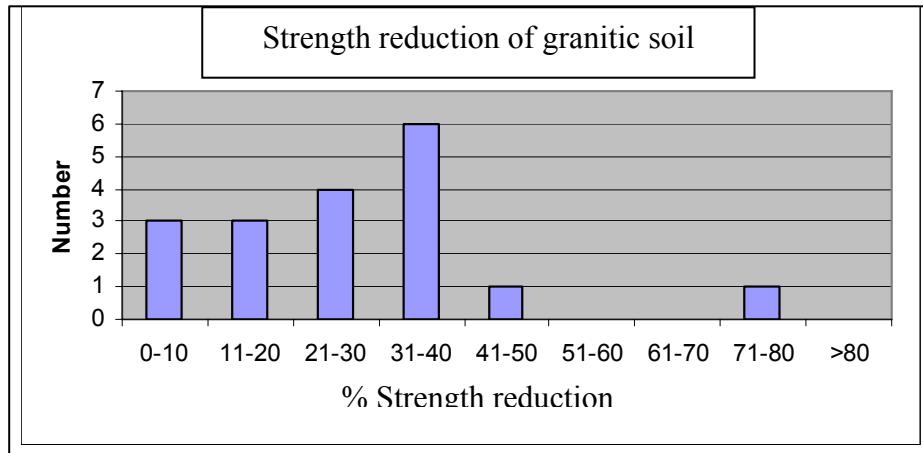
Figure 8 Percent of shear strength reduction of granitic soil in 6 provinces

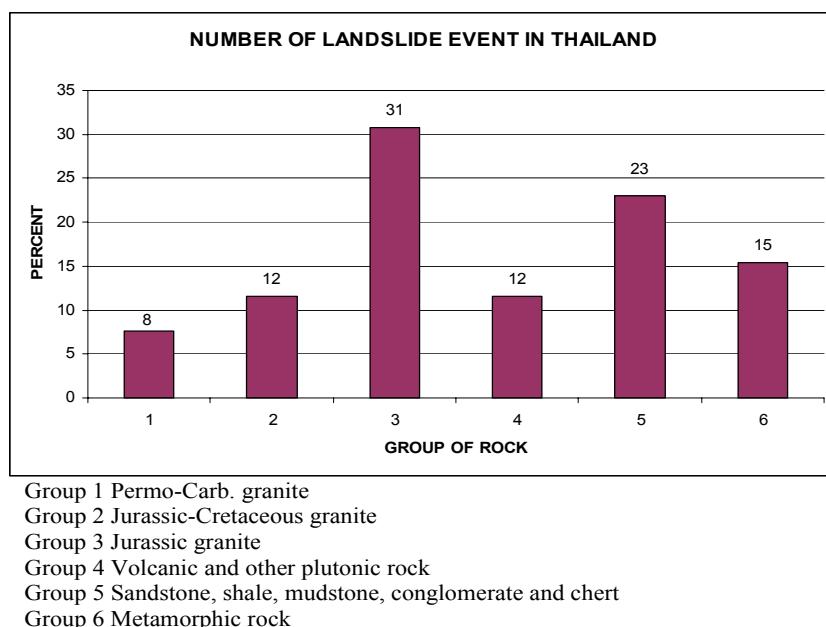
Figure 9 Landslide events in Thailand classified by rock group
