Cases of adverse geological and geotechnical conditions in Dam Construction in Khorat Rock Group

DR. NOPPADOL PHIENWEJ

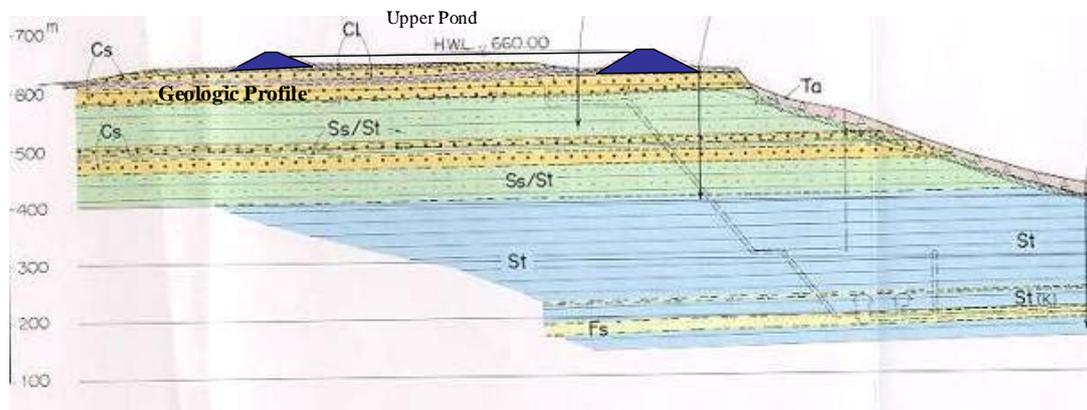
Fig. 2 Upper Pond and geologic section at Lam Ta Khong Pumped Storage site

The Upper Pond was constructed on the mountain top next to a hill slope (Fig. 2). It had a crest length of 2170 m and the storage capacity of 10.3 million cu m. The cut & fill method was adopted for the construction so that rocks from the foundation

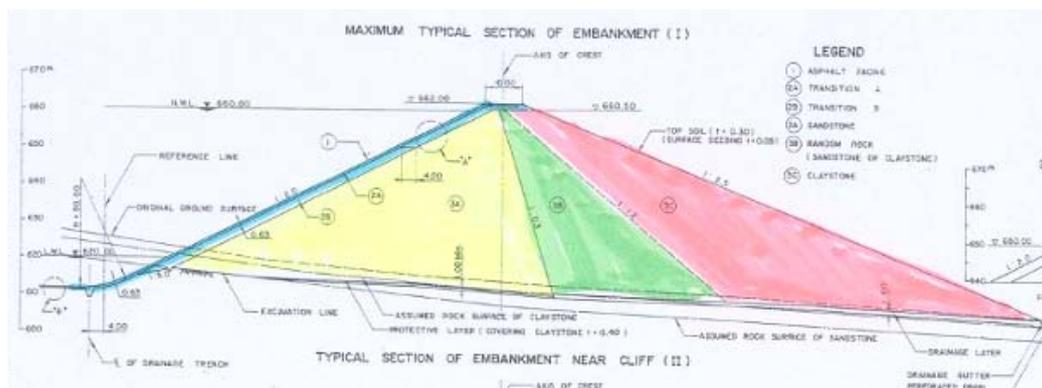
Fig. 4 Zoned rockfill embankment of Upper Pond

excavation could be used for the construction of the fill embankment. The pond was bounded on three sides by the rock fill embankment (Fig. 3). The maximum height of the embankment was 50 m. The design concept of impervious face zoned rockfill dam was adopted for the design of the embankment, for which good quality sandstone was used in the upstream zone 3A (Fig. 4). In order to make use of most rock materials coming out from the excavation, poorer quality rocks (siltstone and mudstone) were allowed in the downstream zone of the embankment (Zone 3C) by adopting a gentle embankment slope (1:2.5 V:H). The design slope was much gentler than the slopes of typical rockfill dams (1:1.3-1.15).

Asphalt face was adopted as the impervious lining of the pond. for reason of higher flexibility and ductility and more durability. The entire pond was lined including the upstream face of the rockfill embankment, the cut slope face and the excavated pond floor. A system of drainage trenches and tunnels was furnished below the bottom of the pond to handle leakage water and ground water movement in the pond foundation.

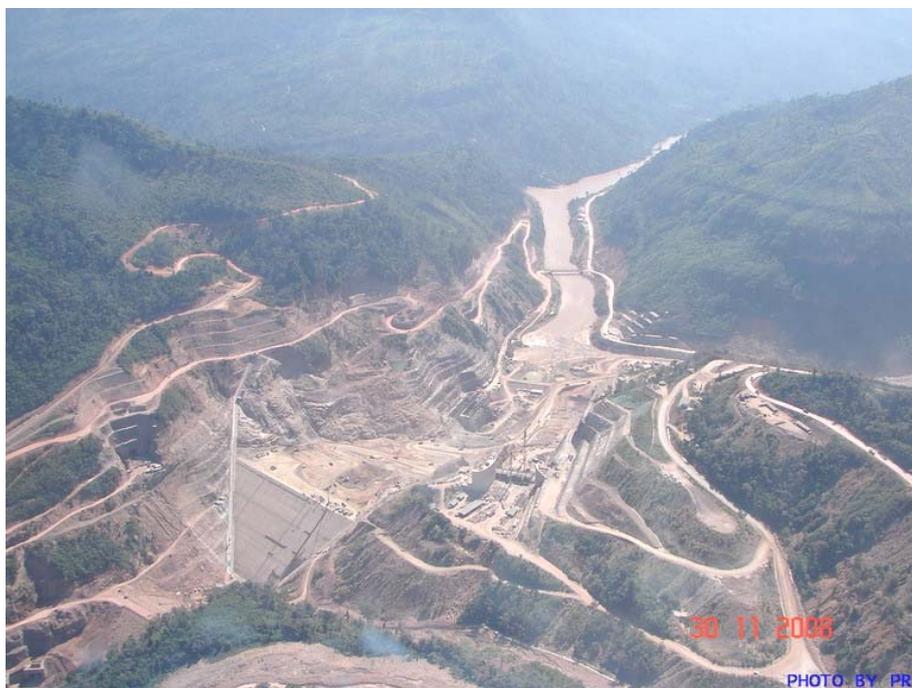
Fig. 9 Nam Ngum 2 HP Project Site under construction

construction experiences in past projects mostly in Northeast Thailand. After the start of the excavation works, the actual geologic structure of the rock formations was unconcealed which turned out to be much complicated than what initially interpreted. The geology of the site is quite complex. The structure of rock beds exposed along valley wall after clearing is shown in Fig. 10. Tectonically, it was subjected to a strong compression forces acting by the collision of tectonic plates. The area may be a suture zone, where two continental plates were collided. Due to the nature of interbedded layers of competent and incompetent rocks the strong compression created folded, and reverse and thrust faults within the formations. With the sliding of incompetent layers over a low angle competent base created This area is called a frontal thrust and folding zone. The zone is normally bounded the tectonic uplifting compression crustal core. The compression was so intense that shear failure would be also accommodated by large-scaled movement of strike-slip faults. Strongly sheared

rock would generally have a low strength, as the rock was already been sheared to the residual strength. Drag folds along the faults associated with this complex geology would also crushed the rock. Between the beds, the contact boundary would also be sheared dramatically. As the fold of a particular thick formation was locked into a tight position as a Chevron folds, the upper part of the fold hinge would collapse and the lower part of the fold would develop the formation of the limb thrust. The rock in this tight folding zone would be crushed into small fragments. Incompetent beds of siltstones and mudstones are heavily sheared and fractures. The competent beds of sandstone are also highly fractures at places especially near the fold hinges. Bedding shears in the incompetent beds of siltstones and mudstones are of very low strength against sliding. During excavation of quarry development in areas behind cliff faces of near horizontally lying sandstone beds, major landslide repeatedly occurred. After removal of the very thick overburden of soil and highly jointed and weathered rock

beds, the concealed existence of steeply inclined bed of tight folding was unearthed in the rear part of the quarry area. Shearing along weak bedding shear in siltstone in the presence of seeping groundwater caused the reactivation of this old massive landslide. The depth the slide was more than 100 m (Fig. 11). That was just one of the samples of a number of landslide problems experienced at the project. In the initial geological investigation report, landslide was not foreseen as a significant geological hazard at the project site.
