Deformation Characteristics after Impounding of Nam Ngum 2 Concrete Face Rock Filled Dam (CFRD) in Laos PDR

Warakorn Mairaing^{1,*} and Chinoros Thongthumachat²

^{1,2}Geotechnical Engineering Research and Development Center, Faculty of Engineering, Kasetsart University, Bangkok, Thailand

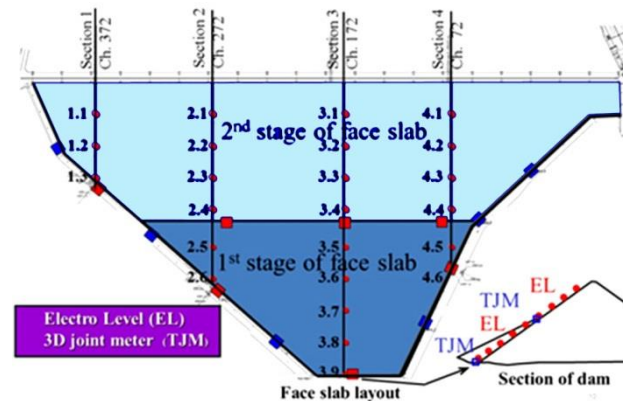
Fig. 14 Measuring Instruments on Dam Face Slab.

Electro-levels along the axis of slabs were used for monitoring changes in angle of rotation and deflection of face slab. The results need to be interpreted with the related 3D joint meters. The face slab deflections were interpreted at 4 sections as show in Fig 14.
