# OBSERVATION OF BUILDING DAMAGE PATTERNS IN KATHMANDU DUE TO EARTHQUAKE- DRAFT REPORT

Mr. Kiran Acharya  
acharyakiranraj@gmail.com

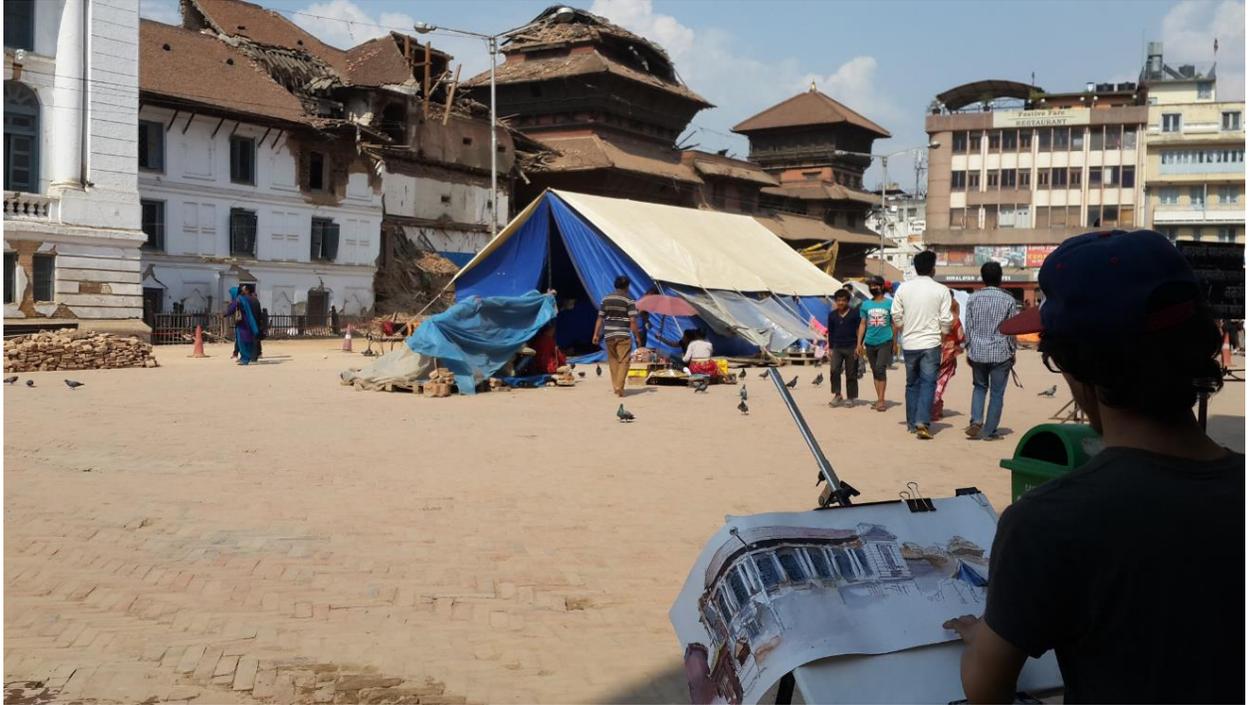
An artist depicting the ruined Palace in his canvas

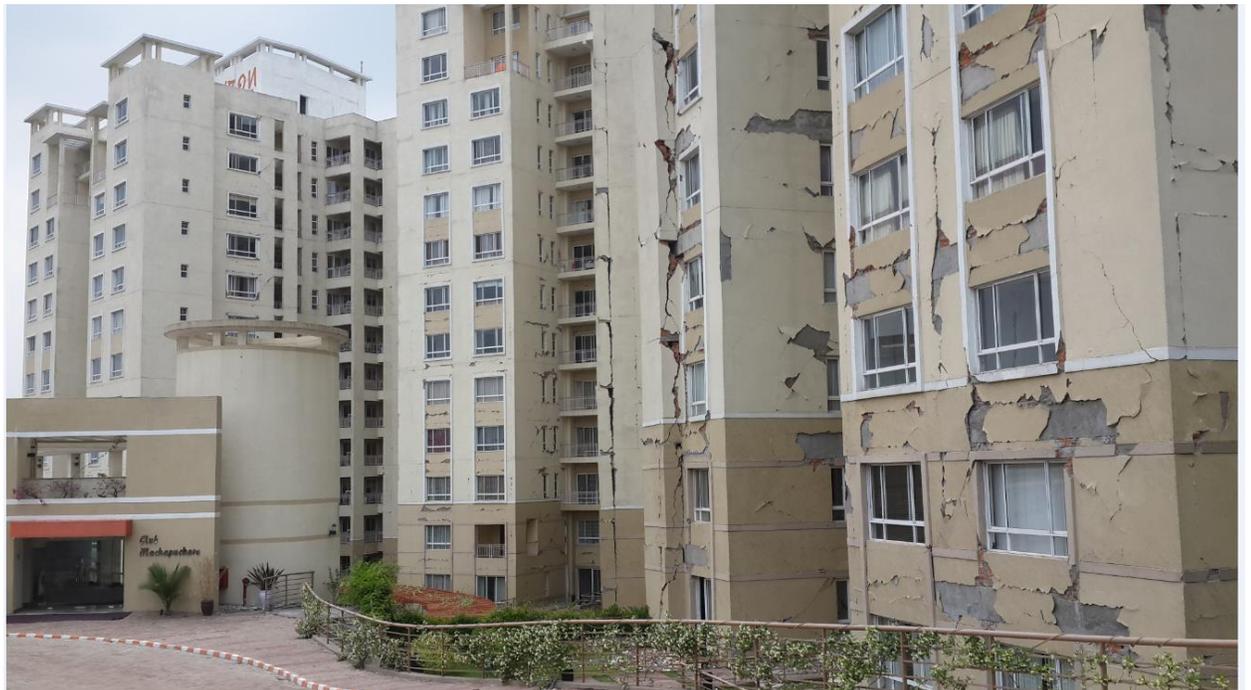
Left face of the building

Infill wall damage of a 17 storey tall apartment building in Kathmandu (Right face of the building)

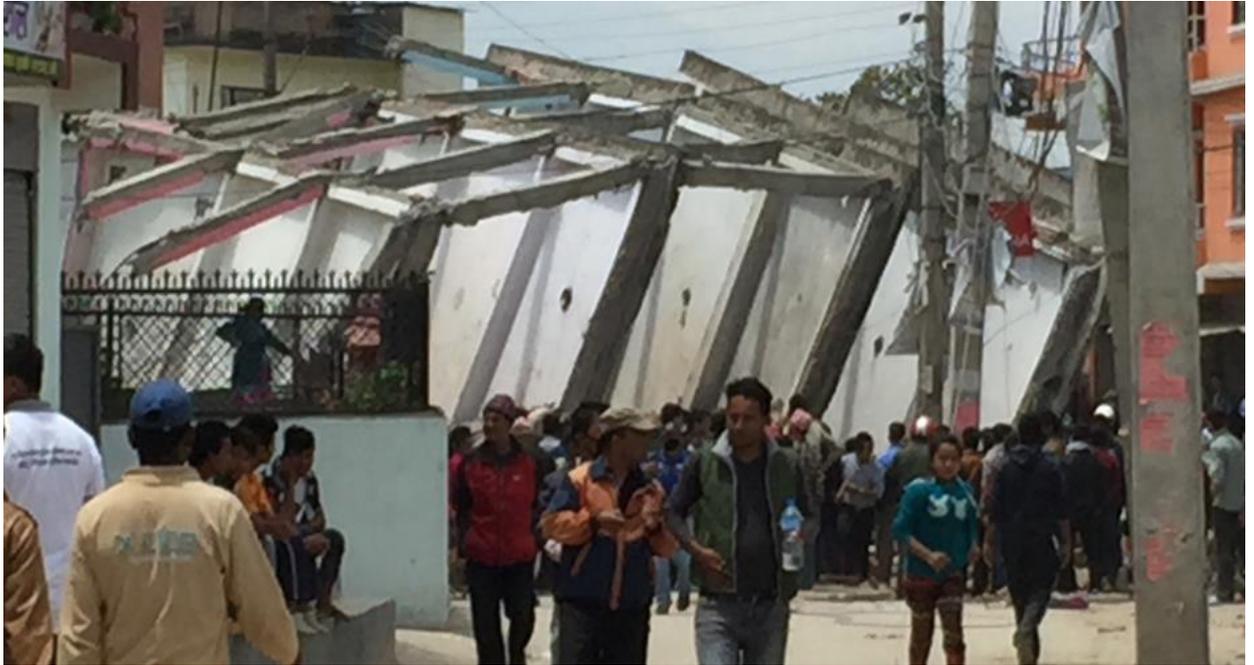
Longitudinal reinforcements were spliced at same location in the column and building overturned by lap splice failure at tension location

Another view of the 7 story tall building

- f) In some buildings it is observed that the building could not resist the overturning moment due to lap splice failure on the tension side.
- g) Most of the columns are failed by crushing of the concrete at below the beam or at column base leading to the subsequent buckling of the longitudinal bars.
