Rehabilitation and maintenance planning of Burapawithi's approach ramp, Bangkok-Chonburi expressway

Abstract : Burapawithi is the 55 km elevated expressway which connects between Bangkok and eastern seaboard. After almost 9 years of service, some highway ramps suffered the large deformation that caused the rotation of the transition boxes and question about its safety. Extensive investigation and analyses have been done including 26 soil borings, structure damage investigations, installation of instrumentations, analysis of structure and foundation safety and prediction of the affect of future settlement. It's found that only the ramps that located over the thick soft clay show the serious condition from the excessive of ground settlement. Most of the damages are not critical to the structural and foundation safety. However, the analyses show that the unappropriate repair and maintenance such as resurfacing of the pavement, might cause the failure of the transition piles. Furthermore, it's also found that the large deformation occurred in the middle of the transition zone where the pile tip of transition piles are above the stiff clay layer and float in the medium stiff and soft c

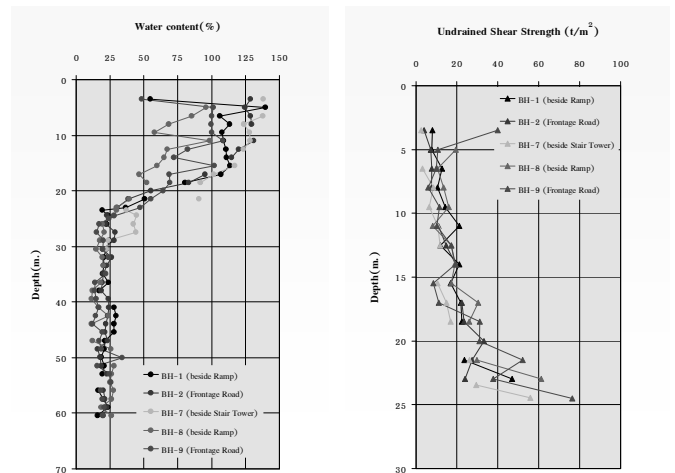
Fig.8 Soil moisture content and undrained shear strength beside and outside the ramp

In order to understand the subsoil condition, 20 of 30m deep boreholes and 2 vane shear tests were done. 4 of 60m deep boreholes were also done in the most critical ramps. Figure 6 shows the subsoil layers from bore holes data. It can be seen that the ramp and staircase structures that found to be in serious condition are located where the soft clay later is the thickest. Also the compression index(C_c) between KM 24 to 37 is found to be in a high value of 1.2-3.0 and the coefficient of consolidation(C_v) value is found to be 10^{-6} to 10^{-4} cm^2/sec where other section C_c is found to be about 0.2-1.0 and C_v is about 10^{-4} to 10^{-2} cm^2/sec (Figure 7). Furthermore, to see the effect of consolidation from the elevated pavement and at grade section, boreholes were drilled near the elevated pavement and outside the highway where undisturbed soil shall be found. Figure 8 clearly shows the consolidation effect in the upper soft clay layer where water content of the soil under elevated pavement is squeezed out causing lower in water content and higher in undrained shear strength comparing to the undisturbed zone.
