Investigation of Slope Instability of a Concrete-Faced Slope in Chiangrai

Keywords: slope stability, fill, concrete face, piezometer, pore water pressure

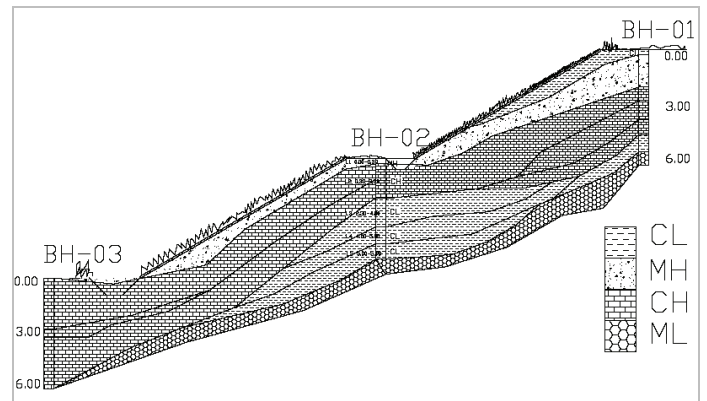
Figure 3: Typical ground profile of the study area.

The geology in Chiangrai province consists of rocks in the Upper Paleozoic Era, including siltstone interbedded with limestone, volcanic rock andesite tuff and rhyolite tuff (Department of mineral resources, 2007). The studied slope was constructed as cut and fills in 2002 on the siltstone and sandstone hill with a uniform slope angle of 30° and a 4 m wide berm at the middle part of the slope (Figure 2). The material on the slope was investigated by ways of hand auger borehole, and light weight dynamic cone test (or the so-called kunzelstab penetration test). The ground profile is shown in Figure 3 consisting of low plasticity clay, high plasticity silt, high plasticity clay and low plasticity silt. The basic properties of the materials are summarized in Table 1.

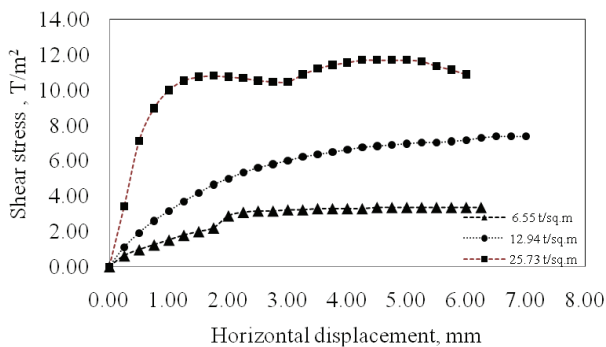
Figure 6: Typical results of slow direct shear.

In order to investigate the strength characteristic of the soil, a series of slow direct shear test (with a shearing rate of 0.01 mm/min) were conducted at normal stress range of 64 to 252 kPa on undisturbed samples. These samples were collected near the first bench of the slope about 1m into the slope. Undisturbed samples at greater depths were not taken due to limited sampling equipments and budget. The behaviour of the material at the surface is however thought to be approximately representative for the whole slope in this first stage of study. The stress-strain behavior observed in the shearing tests appear to be mainly strain hardening, which is typical of loosely compacted soils, as show in Figure 6 and Figure 7. Some trial tests were conducted in order to investigate the influence of shearing rate. The shearing rate variation (between 0.001 and 0.05 mm/min) was found to be insignificant for the values of strength determined.

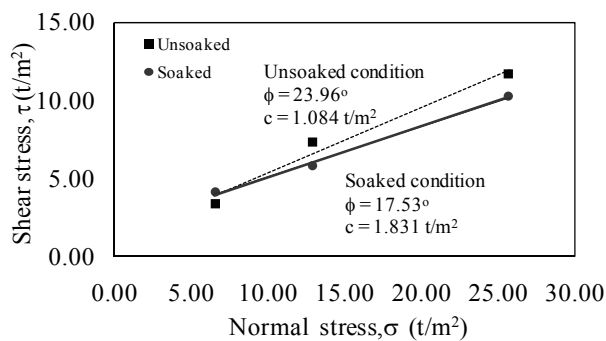
Figure 7: Failure envelopes from the slow direct shear tests on samples in soaked and unsoaked conditions.

The failure envelope of unsoaked sample is only slightly above that of soaked sample. This is because the unsoaked samples were nearly saturated (degree of saturation, $S_r = 86\%$) and the samples' suction could have been small.
