Research Paper

Damages and causative factors of 2015 strong Nepal Earthquake and directional movements of infrastructures in the Kathmandu Basin and along the Araniko Highway

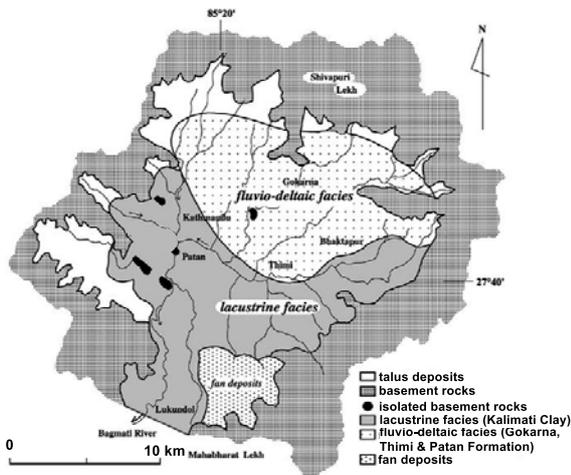
Furthermore, Kathmandu Basin is composed of fluvio-lacustrine soft sediments formed in the Plio-Pleistocene age (alternative layers of clay, silt and sand) of more than 550 m thick unconsolidated sediment at valley center (**Fig. 30**). The lower fluvial granular sediments (gravel, sand and silt) of about 200-250 m thick is overlain by lacustrine clay sediments of about 200-300 m thick

Fig. 30. Representation of geological map of Kathmandu Basin and its cross-section (Reference: Sakai et al., 2002).

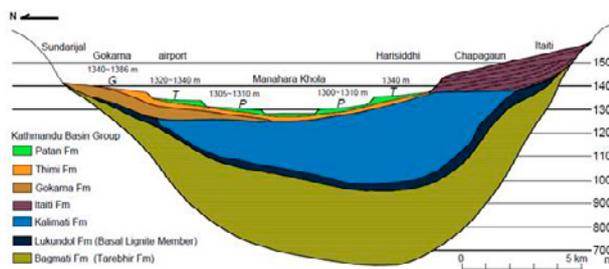
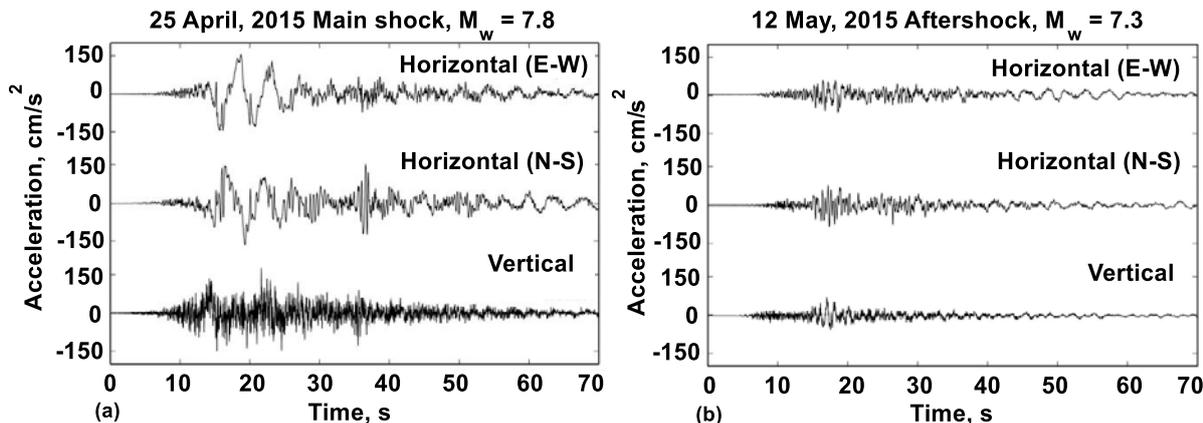
Figure 31 (a) and **(b)** represent the recorded ground motion data (USGS seismological section at KATNP) for 25 April mainshock ($M_w = 7.8$) and 12 May aftershock ($M_w = 7.3$) respectively. The accelerograms measured three horizontal (E-W), horizontal (N-S) and vertical components for both quakes. The Peak Ground Acceleration (PGA) of the ground motion was determined to be in the range between 150-170 cm/s^2 and 70-80 cm/s^2 for the 7.8 and 7.3 magnitude events respectively. It is notable that the PGA of 7.3 magnitude aftershock produced the most significant shaking at the recording station. The overall values for both quakes did not exceed the PGA estimates with 10 % probability of exceedance in 50 years for the recording station site, based upon current regional seismic hazard studies (JICA, 2002; Nath and Thingbaijam, 2012; Ram and Wang, 2013). Since the accelerograms demonstrated long period motions, shaking of the ground was primarily shown to include soft soil long period amplification attributable to the deep semi-unconsolidated fluvio-lacustrine Pleistocene sediments. The causative factor of

Fig. 31. Recorded ground motion data for (a) 25 April main shock and (b) 12 May aftershock (Reference: USGS, 2015).

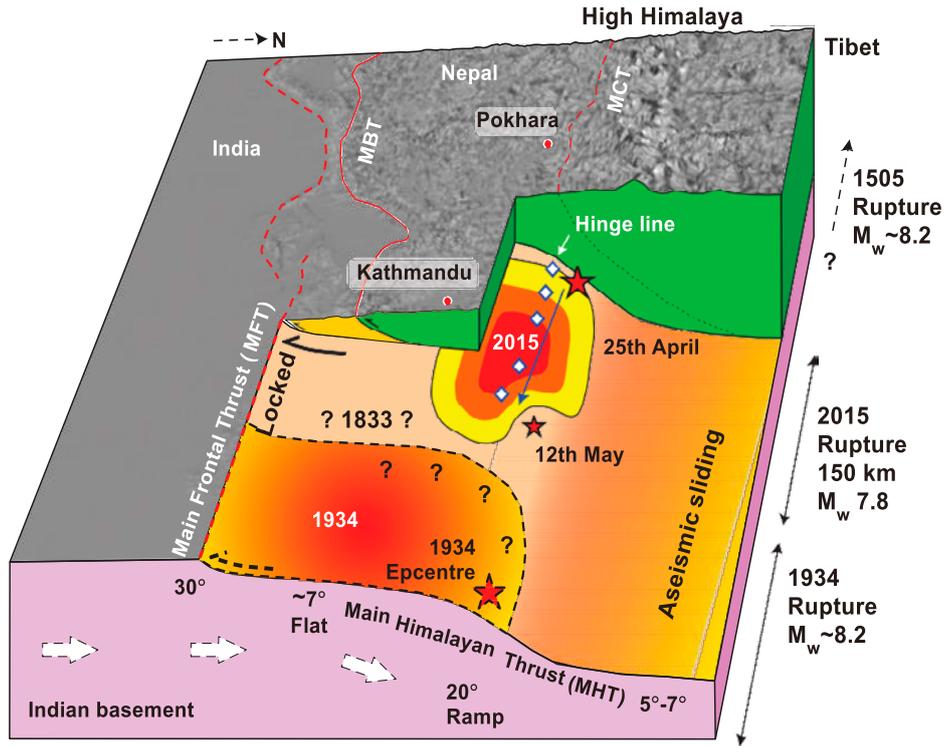
Figure 37 shows the placement of April 25, 2015 main shock and May 12, 2015 aftershock on the resolved MHT geometry illustrated by Elliott et al. (2016). High-frequency seismic sources are represented with diamond-shaped symbol which run through the hinge line between the ramp and flat. The 7.3 magnitude aftershock occurred at the eastern end of the rupture zone. In the figure, directions of rupture with their corresponding magnitudes are represented together with the locked tectonic interface zone.

Fig. 37a. Representation of April 25, 2015 main shock and May 12, 2015 aftershock on the resolved MHT geometry. Aftershock occurred at the eastern end of the rupture zone (Reference, Elliott et al. 2016). The infrastructures tilted due to this aftershock in the N-S direction, mostly in southern direction. Below rose diagrams reveal the directions of tilted/collapsed buildings, historical monuments, temples and other infrastructures in the study area.

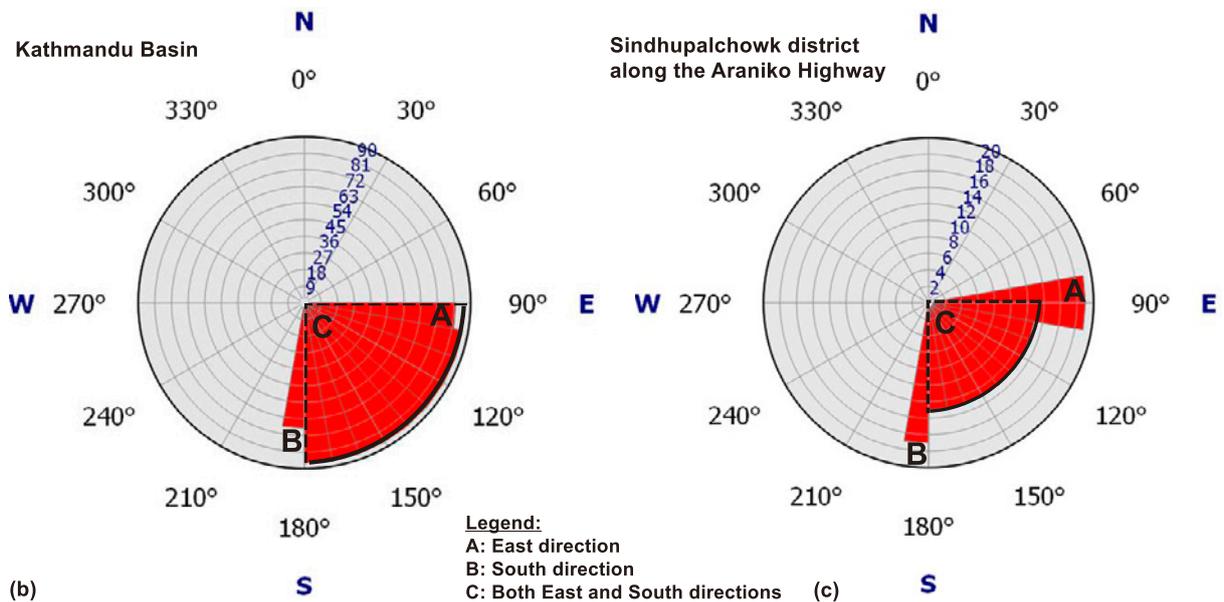
Proceeding, the major aftershock on May 12, 2015 does not reflect the direction of collapsed/tilted structures in the direction as with the main shock towards east. Overall affected structures have leaned towards a southern direction with occasional tilting towards a northern direction. **Figures 37 (b and c) and 39** distinctly represent the contrasting directions of the April 25 main shock and the May 12 aftershock (**Figs. 17b, 20-25**).

The data collection procedure was restricted to distinctly visible structures only. We did not survey directional movements of each building which were not visible from outside. Collected data were plotted in a rose diagram to interpret the directional movements. **Fig. 37 (b) and (c)** represent the overall directional movements of Kathmandu Basin and Sindhupalchowk district along the Araniko Highway. In figure, Legend A and B distinctly represent the directions of east and south respectively.

Fig. 37. Rose diagram showing tilted/collapsed directions (b) in Kathmandu Basin and (c) in Sindhupalchowk district along the Araniko Highway.

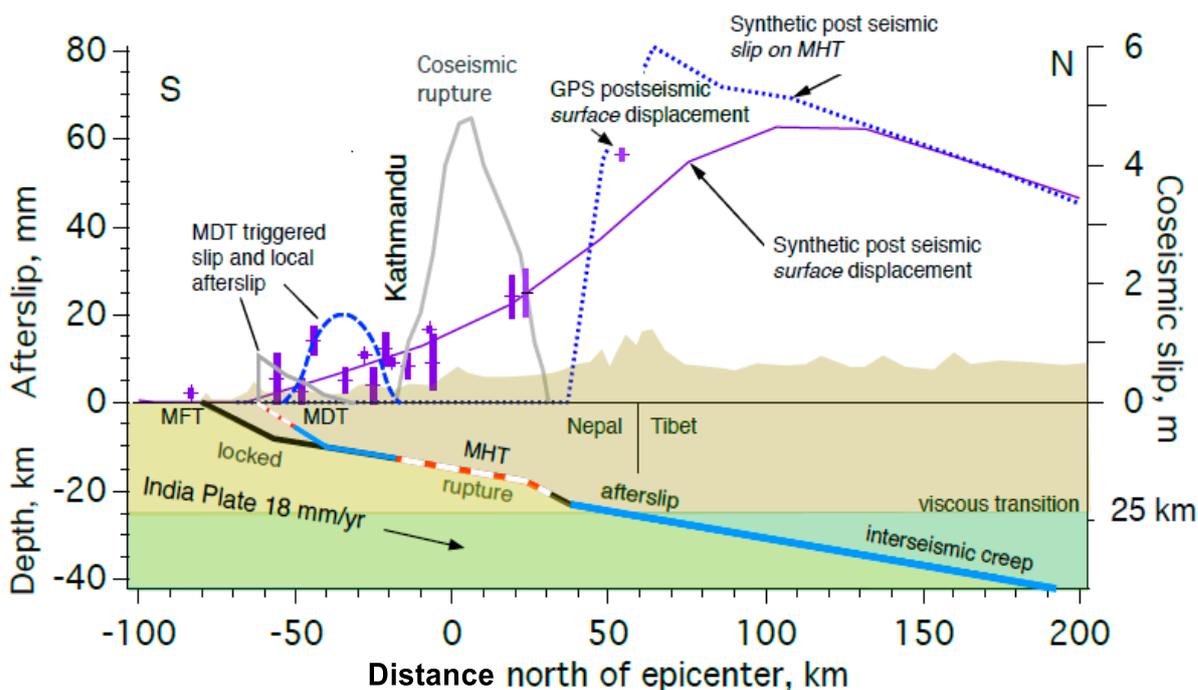
<25 mm minor afterslip occurred between Kathmandu and the MDT, their models show that the maximum 70 mm afterslip occurred north of rupture below 20 km as shown by **Fig. 38** (Annotated figure received by Roger Bilham to use in this paper).

Fig. 38. Representation of N-S cross-section for the comparison of afterslip and observed post-seismic displacement. The figure illustrates that the minor afterslip occurred on the MHT south of Kathmandu and most of the afterslip in 2015 occurred on the region of interseismic creep below the base of rupture (annotated Figure 3 from the publication of Nature Geosciences, 13 June, 2016; received courtesy Prof. Roger Bilham).

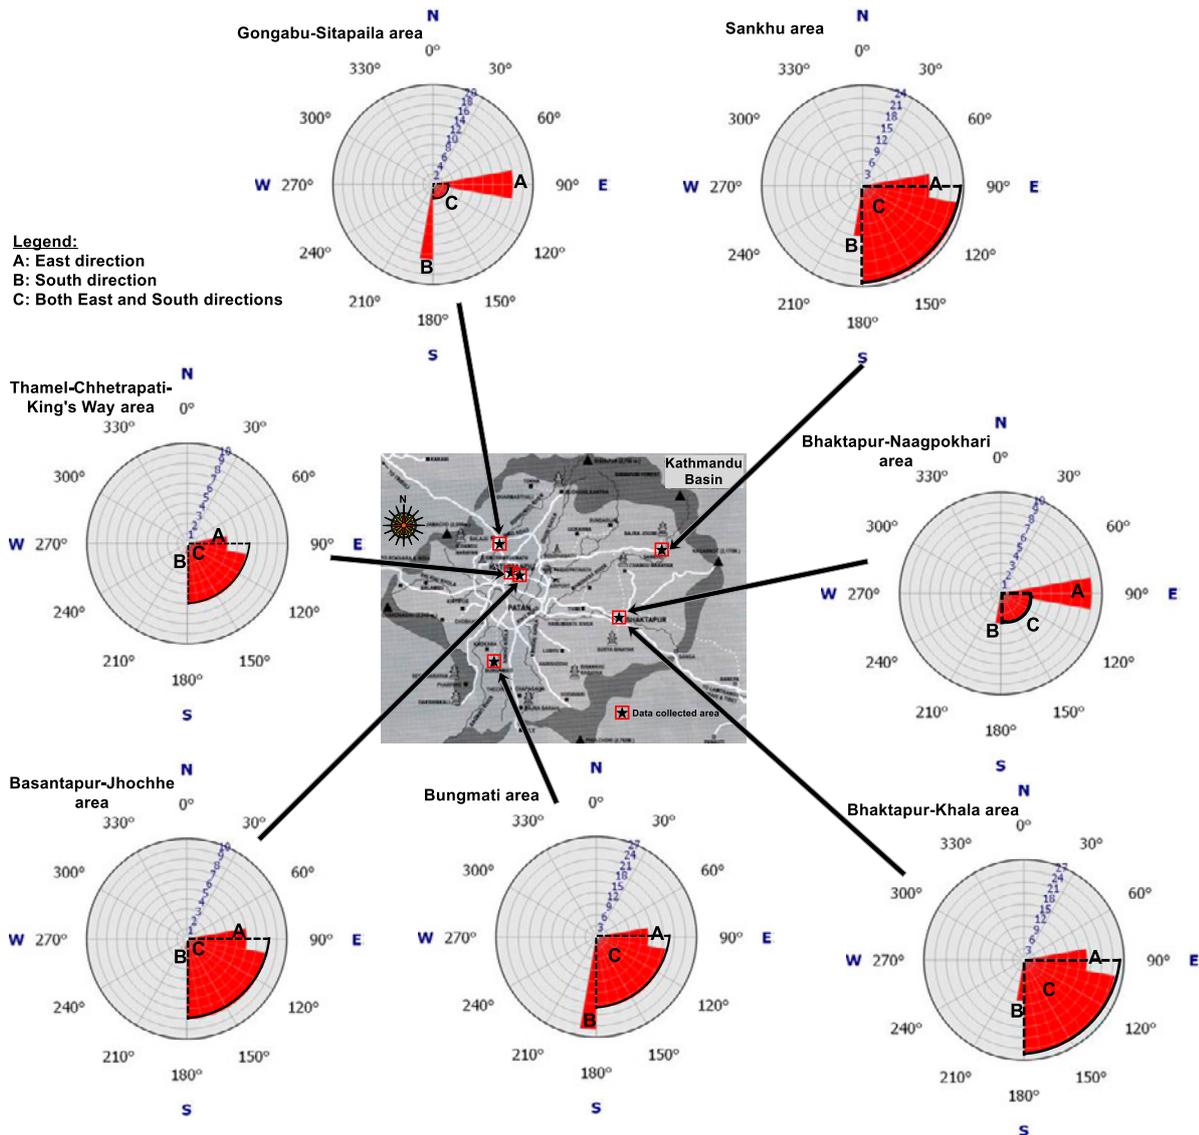
Similarly, rose diagrams were plotted and represented in **Fig. 39** from the Kathmandu Basin. In this case also, similar procedures of representation of rose diagrams have been incorporated.

Fig. 39 . Representation of Rose diagram of tilted/collapsed buildings, historical monuments including temples of the Kathmandu Basin during April 25, 2015 main shock ($M_w = 7.9$) and May 12, 2015 aftershock ($M_w = 7.3$). It is noteworthy that the major shock affected the overall infrastructure, deforming toward the east direction while the major aftershock deformed in the north-south direction. Legend A and B denote the single tremor (main shock and after shock) events whereas Legend C denotes the effects of both tremors and tilting in both directions.

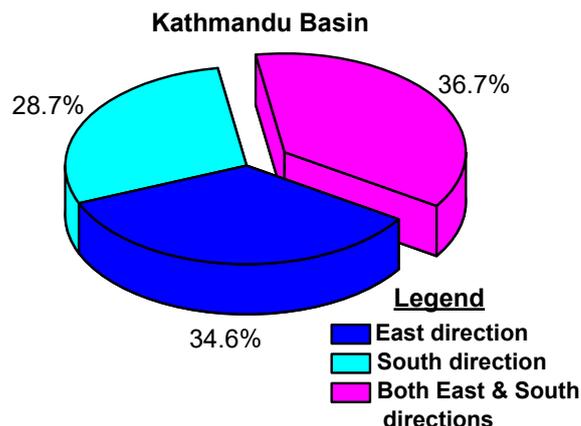
Rose diagrams represent the directional movement of structures due to quake towards east, south and combinations of both directions around the rupture zone. **Figure 40** shows the percentage distribution of movement direction in the Kathmandu Basin. The Kathmandu Basin showed around 35 % of buildings and historical monuments tilted and collapsed towards east due to main shock. On the other hand, 29 % contributed towards south direction due to intensive aftershock. Remaining 37 % revealed structures were tilted in both east and south direction. Similarly, in Sindhupalchowk district along the Araniko Highway, 39 % of observed

Fig. 40. Pie chart representing percentage distribution of directional movements in the Kathmandu Basin due to main shock and aftershock.

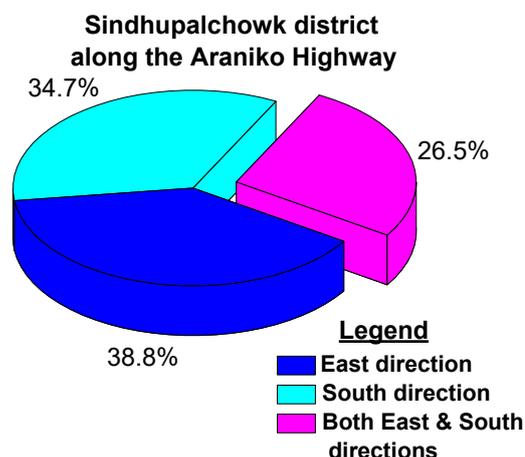
houses revealed to south direction. Remaining houses intensively affected with both quakes and tilted both in east and south directions (26 %) as shown by **Fig. 41**. Since the data collections are not specified to the conditions of each and every house and other structures, the percentage distributions of directional movements may vary accordingly. However, the effects of both shocks preserved the direction unless and until the structures are either completely demolished to build new ones or renovated with necessary improvements adopting specified codes.

Fig. 41. Pie chart representing percentage distribution of directional movements in the Sindhupalchowk district along the Araniko Highway due to main shock and aftershock.
