Impacts of 2014 Chiangrai Earthquake from Geotechnical Perspectives

Suttisak Soralump¹, Jessada Feungaugorn², Sirisart yangsanphu³, Montri Jinagoolwipat⁴,
Chinoros Thongthamchart⁵, Rattatam Isaroranit⁶

¹ Director of Geotechnical Engineering Research and Development center (GERD)
^{2,3,4,5,6} Researcher, Geotechnical Earthquake Engineering Unit, GERD
Faculty of Engineering, Kasetsart University, Bangkok, Thailand

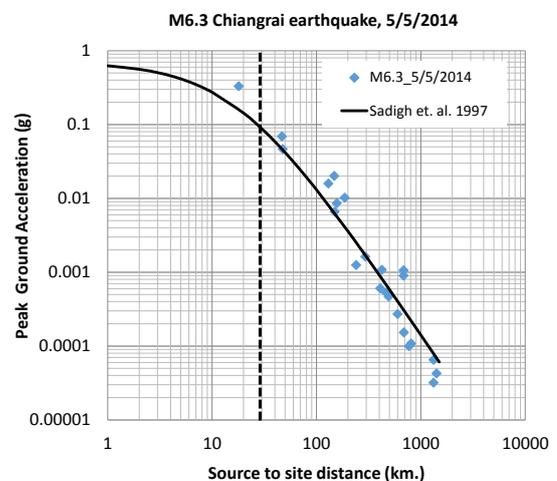
Figure 3: Recorded acceleration at 6.3 Magnitude, Chiangrai Earthquake

The epicenter is considered to be located at the low to moderate population area. The acceleration attenuation curve is plotted by using the peak ground acceleration from various seismic stations and shown in Fig 3. The plotted attenuation curve fitted well with the relationship proposed by Sadigh et al. (1997). According to the plot and fitted relationship, the peak acceleration of 0.1g was possible at the 30km radius distance from epicenter. This matches well with the actual condition where most of the damage is found within 30 km radius from epicenter.

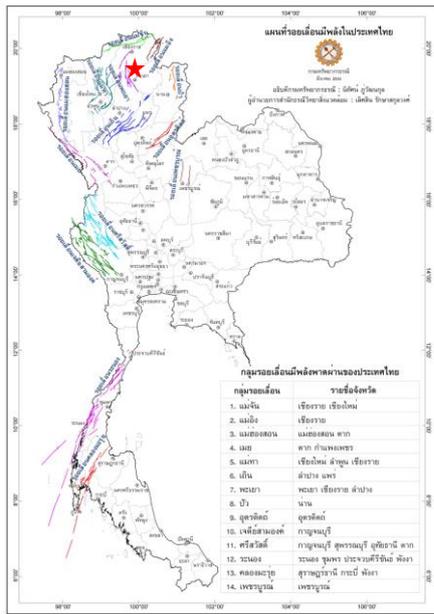
Figure 4 : Epicenter location of 6.3 Magnitude, Chiangrai earthquake (DMR, 2005)

The epicenter located in the PhaYao fault zone, which is one of the 14 active faults in Thailand (Fig 4). Fenton et al. (2003) estimated the maximum magnitude that this fault could produce to be 6.6. Many aftershocks have been observed (Fig 5). Eight events occurred with the magnitude more than 5.0. The hypocenter depths of all the aftershocks were shallow and generated between two fault lines as shown in Fig 6.

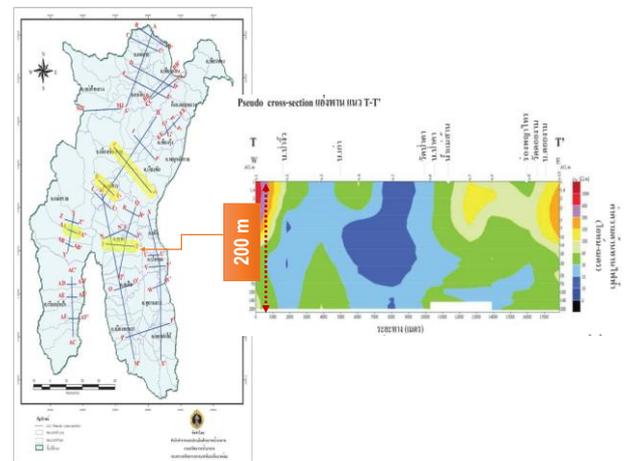
Figure 8 : Thickness of soil deposit from resistivity survey (DGR, 2009)

Quaternary deposit area. The thickness of the deposit may be more than 200 m, according to the resistivity survey as shown in Fig 8 (DGR, 2009).

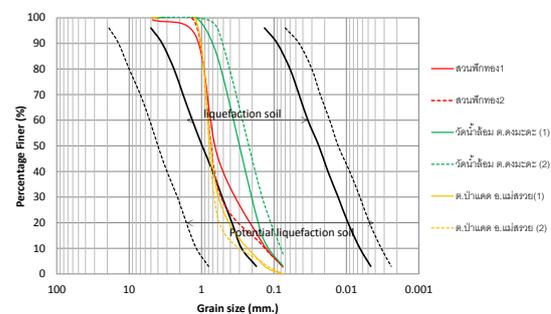
Figure 12 : Gradation of liquefied soil plotted in liquefiable range

Liquefaction was found within the radius of 20 km from epicenter and located in the quaternary deposit (Fig 10 and 11). It means that the peak acceleration should be over than 0.15g to cause liquefaction, according to the attenuation model discussed earlier. The subsoil investigation found the loose saturated sand in the shallow depth. Furthermore, the gradation of the soil particle found to be a uniform grade and fitted within the range of liquefiable material (Fig 12). The liquefaction potential analysis using Seed' method (Seed et al., 1971) also found that the soil will be liquefied if the peak acceleration is more than 0.15g (Fig 13).

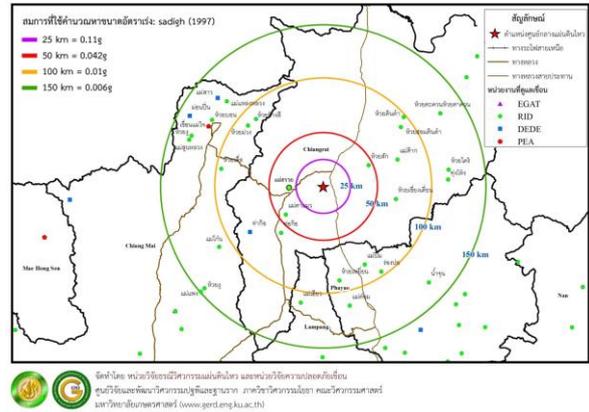
Figure 19 : Dam location within 20 km radius

Fig 18 shows the location of dams over the seismic hazard zone of Thailand. One large dam (50 m high) and several small dams are located within 20 km from the epicenter (Fig 19). All of them performed well since it has been designed to resist the
