Weak Plane Failure of Phyllitic Sandstone: Back Analysis for Slope Stabilization and the Use of Probabilistic Approach for Design Optimization

Abstract The main access road of Mae Mao dam hydropower project, Chiang Mai province, Thailand, has failed during a sunny day. The question has been raised of what might have triggered the failure. At the day of failure, the precipitation amount was very small and the accumulated rainfall amount in the past days was also not significant to trigger the failure. Detail geotechnical investigations were carried out including the geological survey, seismic refraction survey, bore holes drilling and various laboratory testing. The rock found at site was Phyllitic and Quartzitic sandstone. It appears that the engineering properties of Phyllitic sandstone are more susceptible for slope failure. Rock and soil slope stability analysis have been done, however none of them was found to be the cause of failure. After carefully reexamining the geologic structure, it was found that there is a weak plane layer that resulted in the failure. A suitable stabilization method has been selected as the economical remedy of the slope failure. In this case, flatten

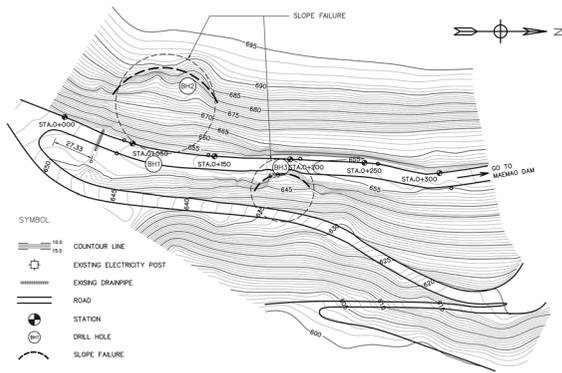
Fig. 1 Topographic elevation of the failure area

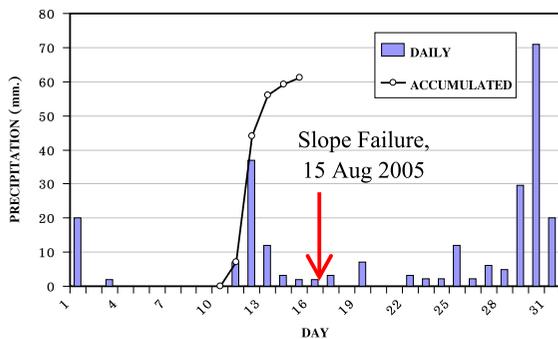
Fig. 3 Daily rainfall record in August 2005. (Mae Mao Hydropower Project 2006)

could have been accumulated for several years to eventually cause the slope failure. However, this paper is not intended to investigate the exact cause of the failure and is just limited for the safe reparation of the failed slope.

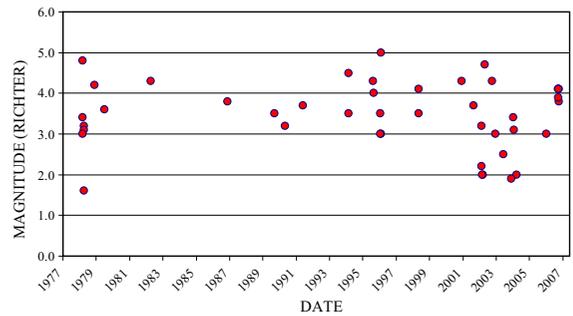
Fig. 4 Seismic record (Magnitude) from 1978 to 2007, epicenter recorded within 100 km radius from site. (Thai Meteorological Department 2007)

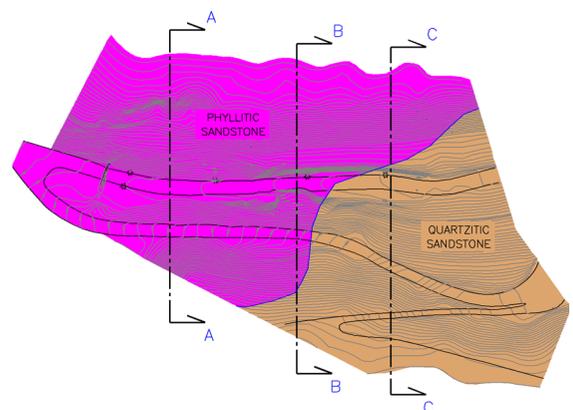
From the geological investigation, in the failure area it was found that the 15–35 m thick of Phyllitic sandstone is overlaying the Quartzitic sandstone. Figure 5 is the plan view showing the contact boundary between these two rocks. Combining with the boring log data, the schematic of geologic structure is shown in Fig. 6. The rock structures consist of fault, shear and foliation. It's the foliation plane that is firstly suspected to be the plane of failure. The orientation of this foliation plane consists of strike and dip angle of 330/30. Figures 7 and 8 show the photographs of fractures and planes. Figure 9 shows the fracture orientation data analysis on the stereonet (Markland 1972). It is found that the possible mode of rock failure is the combination of planar and wedge failure.

Fig. 5 Plan view showing the contact boundary between Phyllitic and Quartzitic sandstone

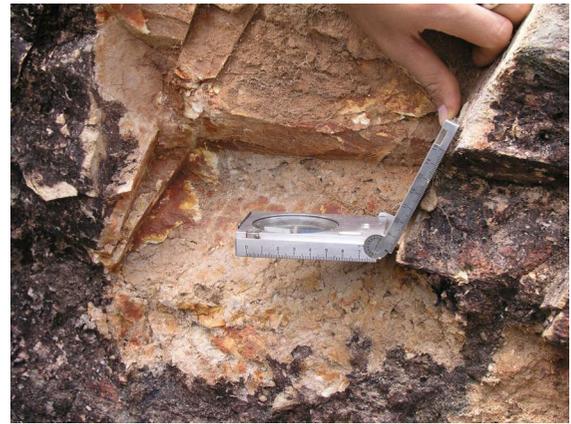
Fig. 8 Fracture planes

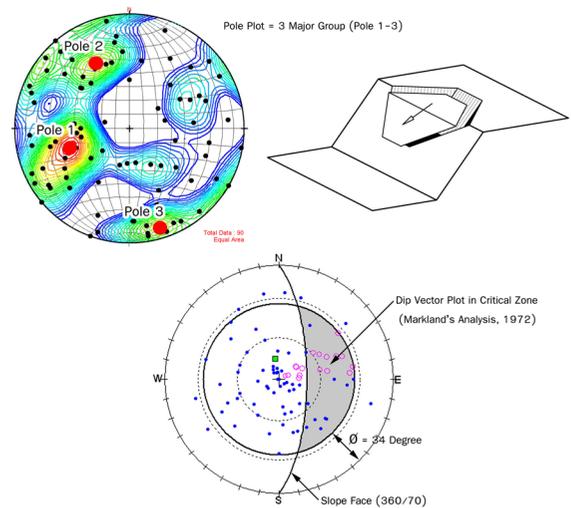
Fig. 9 Fracture orientation data analysis on the stereonet

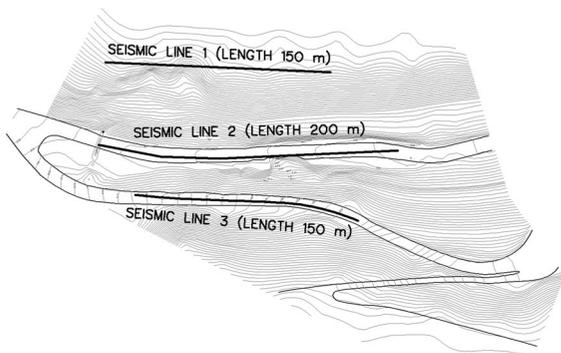
- a. RMR (Bieniawski 1973) and SMR (Romana 1985) determination of the rock mass was done in the area vicinity to the failure. The results are shown in Figs. 10 and 11. It was found that the Phyllitic sandstone is mostly classified as poor to bad rock while the Quartzitic sandstone is classified as normal to good and fair rock.
- b. Seismic refraction survey (Hagiwara and Omoto 1939) was done in order to investigate the thickness of weak strata. The result from seismic survey line 3 (lower slope) shows that the rock mass in this area is more solid compared to that of line 1 located in the upper slope (Figs. 12, 13).

Fig. 12 Seismic refraction survey lines

This information is very useful in making the decision on repairing method.

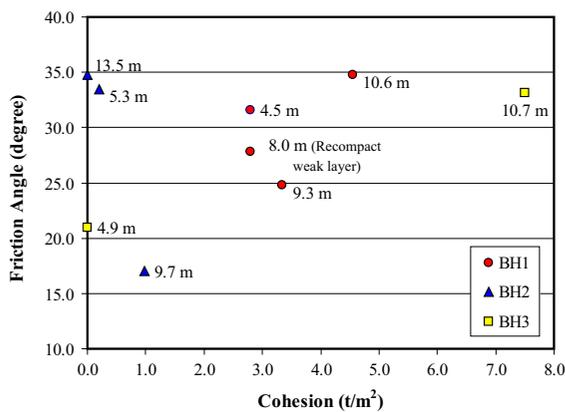
described earlier. Decomposed material in the weak layer was collected and recompacted to the estimated undisturbed state density and water content to prepare the reconstitute sample for direct shear test. Slow shearing rate was used to obtain the effective strength parameters of the weak layer material. The joint strength of Phyllitic sandstone mass was tested using the direct shear machine to obtain shear strength parameters of the natural joint and saw cut joint (ASTM 2002.). The total of 9 samples were performed and the results are shown in Table 1 and Fig. 17.

Fig. 17 Result of direct shear test

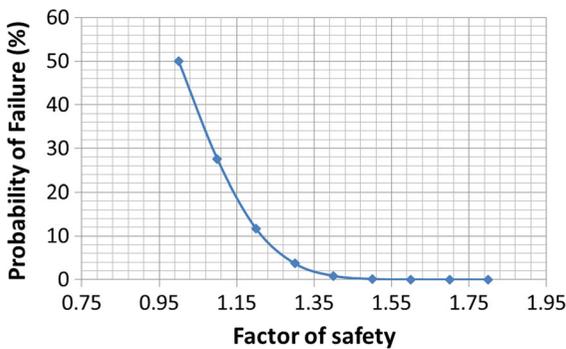
and cost optimization. The relationship between Probability of Failure (Pf, %) and Factor of safety (FS) has been plotted in Fig. 24.

Fig. 24 Factor of safety versus probability of failure

Minimum design factor of 1.25 may be used for routing Highway (FHWA 2006). Furthermore, Santamarina et al. (1992) suggested that P_f between 1 and 2% may be used for existing large cut to low consequences of slope failure. Hence, a cut slope with factor of safety 1.3 and probability of failure of 3.69% was used for the stabilization of this slope. In order to understand the situation correctly, the results obtained were plotted in the curve proposed by Silva et al. (2008) and hence the project can be classified between category II and III (Fig. 25). The design of the project was carried out in category III considering the quality and efficiency of the contractor. The cut slope during its construction and after its completion is shown in Fig. 26.

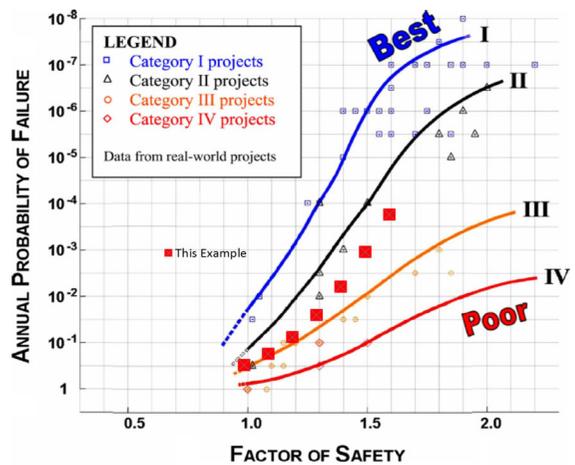
Fig. 25 P_f obtained from real world projects. Adapted from Silva et al. (2008)
